The Influence of Overhang Construction on Girder Design

Thesis

The University of Texas at Austin

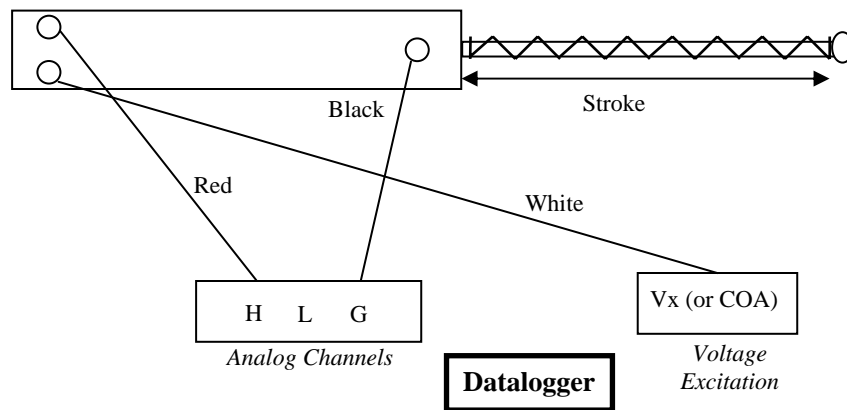
Figure 3-36 Linear Potentiometer

The linear potentiometers used with the PDG are from ETI Systems, model LCP12-S. For these potentiometers, the red wire represents the signal, the white wire represents the power, and the black wire represents the ground (see Figure 3-36). Potentiometer measurements are recorded using single ended channels on the datalogger. Thus, the wiring should be as seen in Figure 3-36.

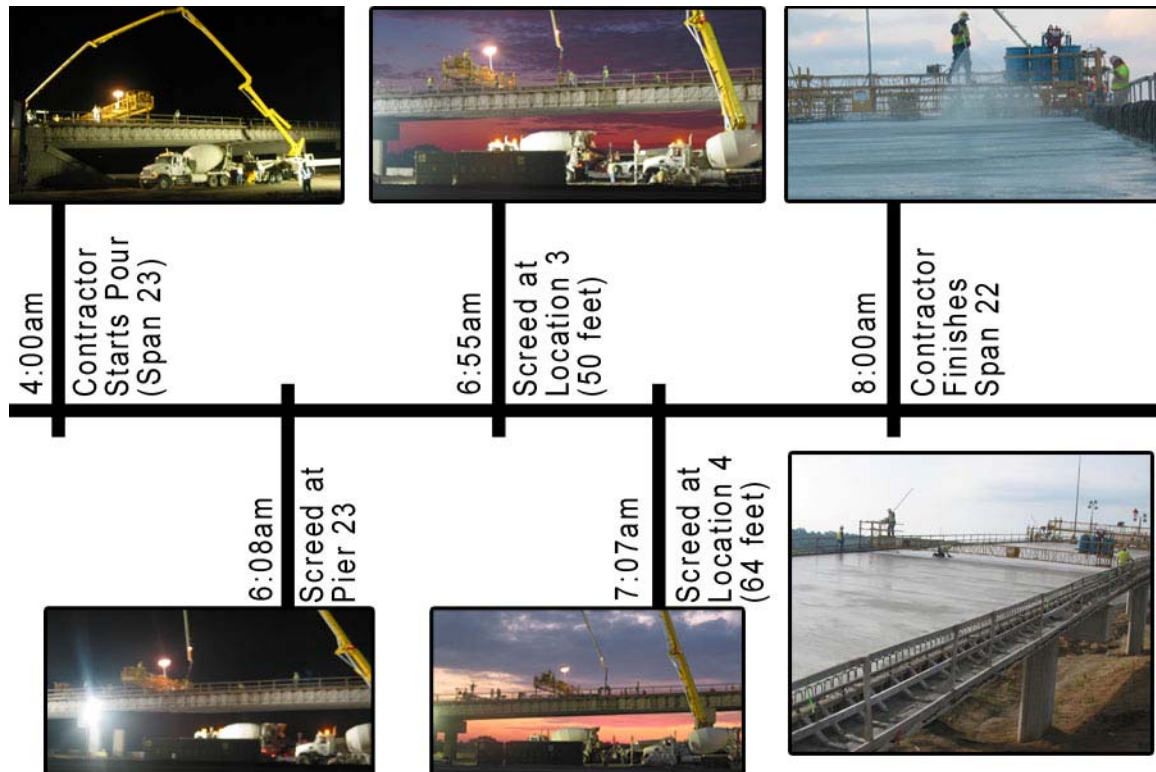
Figure 4-1 Timeline For Deck Pour at SH 71-SH 130 (Span 22)

The concrete deck for Span 22 was poured on September 19, 2007. Figure 4-1 highlights the timeline for the deck pour. The deck pour started at approximately 4:00am; however, since the contractor was pouring three spans (Spans 21 through 23) that morning, the first two hours did not affect the instrumentation on Span 22. The contractor poured the three decks in reverse order, starting with Span 23 and ending with

Span 21. Pier 23 represents the start of concrete placement on the instrumented span. With a total volume of nearly 400 cubic yards of concrete poured, it took almost 6 hours for the contractor to finish all three spans. The contractor used one screed and two finishing bridges during the deck pour. The screed weighed approximately 13 kips, while both finishing bridges weighed nearly 4 kips each.

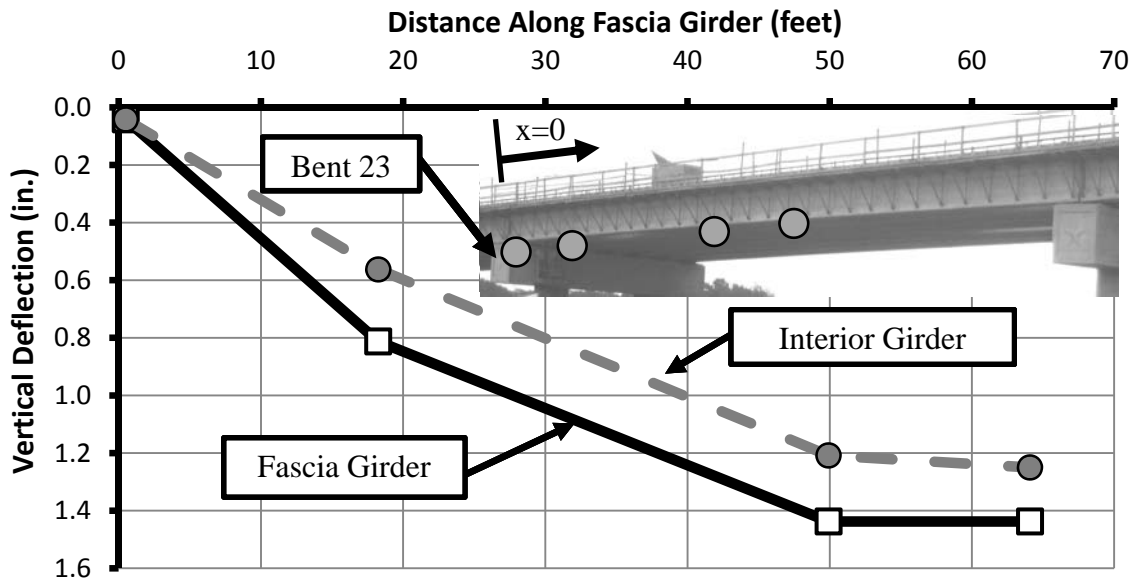
Figure 4-2 Vertical Deflection Due to Deck Pour

The vertical deflections were measured using the procedure described in Section 3.1.1.1. The initial measurements were taken the morning of the deck pour when the construction equipment—one screed and two finishing bridges—was located on Span 23 and no concrete had been placed on Span 22. As noticed in Figure 4-2, the fascia girder deflected more than the interior girder, which can be attributed to the distribution of the applied loading during concrete placement. The deflections that were measured represent

the deformations that occurred during the placement of the wet concrete; however the thickness of the fresh concrete differs due to the forming systems that are used across the bridge width. Between interior girders, the deck is formed by precast concrete panels, as shown in Figure 4-3. The precast panels contribute to the deck height, thereby partially loading the girders when the initial measurements were taken. For instance, if a 4-inch thick panel is used and an 8-inch deck is specified, only 4 inches of additional concrete is needed for the deck. In contrast, the full deck height of concrete is poured at the overhangs of fascia girders since removable wooden forms are used in these regions. Therefore, the wet concrete load is often higher on the fascia girders as compared to the interior girders since the interior girders have already deflected due to the precast forms. As a result, the larger amount of wet concrete load on the fascia girders during the deck pour caused more deflection than the interior girders as shown in Figure 4-2.

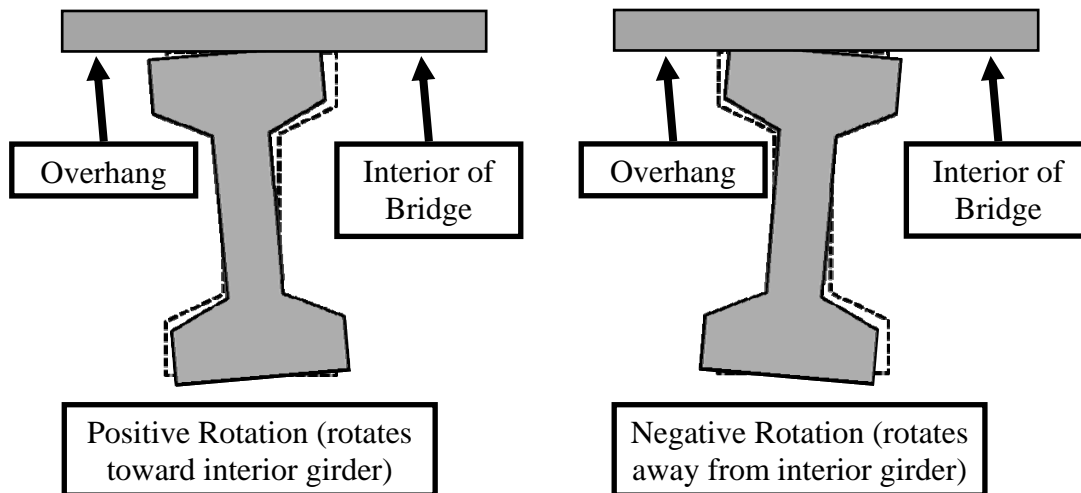
Figure 4-4 Sign Convention of Rotations

consistency can be obtained by comparing data from the early morning hours before and the day after the concrete has been placed. By comparing rotations from the morning before the deck pour to a morning after the deck pour, a change can be determined which represents the effect of the deck pour. Figure 4-4 shows the sign convention of rotations used at the SH 71-SH 130 Bridge, in which rotations toward the middle of the bridge were considered positive. Therefore, with an orientation from Bent 22 towards Bent 23, a counterclockwise rotation is defined as positive at Girders 1 (fascia) and Girder 2 (interior). The overhang bracket creates a force couple such that the bottom of the overhang pushes inward and the top pulls outward; thus, inward movement is positive because it is the direction expected from the overhang load.

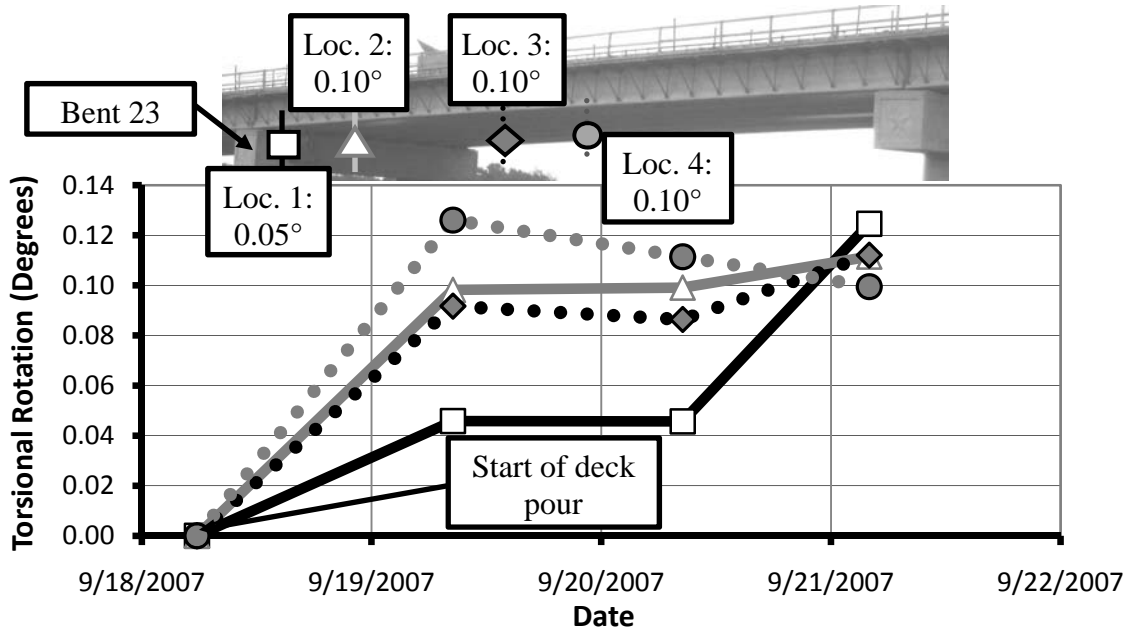
Figure 4-5 Torsional Rotation of Fascia Girder After Deck Pour

The boxed rotation values in Figure 4-5 and Figure 4-6 are the average rotations from the tilt sensors for all three mornings (9/19/2007 through 9/21/2007) and represent the induced rotation from the deck pour. Readings at different times for each morning were used so as to match the temperature channel of the tilt sensors on the morning of the deck pour as closely as possible. By matching the voltages on the temperature channels of the tilt sensors from morning to morning, the error from sensor drift due to temperature fluctuations is minimized. Looking at the graphs, it can be noticed that all data points for a given sensor, except G1-1, are within the precision of the instrumentation, 0.03° . As such, the data from each morning was averaged to determine the boxed rotation values.

Figure 4-5 shows the distribution of twist for the fascia girder, Girder 1, at each tilt sensor for the three mornings after the deck pour. As can be seen from the data, Location 1 (TS-G1-1) recorded a relatively small rotation (0.05°) on the first two mornings, which is approximately half the magnitude of the measurements at the other three locations. The other three locations had recorded rotations of 0.10° , 0.10° , and 0.11° along the length. Comparing the rotation along the length, the rotations did not seem to be a rigid body rotation phenomenon, as was seen at the US 79 bridges near SH 130 in Hutto. Instead, the girders at Span 22 seemed to rotate as a function of the torsion from the overhang.

On the third morning, the recorded rotation for Location 1 (TS-G1-1) jumped to 0.12° . If the first two mornings are ignored, the rotation at Location 1 is within the precision of the tilt sensors at the other three locations. Thus, all four locations would have similar rotations, which is a rigid body deformation mode. Due to the high torsional

stiffness of the girders, rigid body deformation dominating the twist is logical. However, the first two mornings might be correct if the sensor malfunctioned on the third morning.

Figure 4-7 shows the variation of rotation along each girder. This graph consists of the boxed twists reported on Figure 4-5 and Figure 4-6. Both girders behaved in a similar fashion at the support, with very little rotation. However, away from the supports, the behavior of the girders differed, with more rotation occurring at the fascia girder. The error bars on the graph represent the resolution (0.03°) of the tilt sensors. From the graph, the error of the tilt sensors is close to zero rotation for the interior girders. At the fascia girder rotations were on the order of 0.10° . However, the rotation at SH 71-SH 130 was very small when compared to the US 79 bridges around SH 130 in Hutto, which rotated nearly 3° .

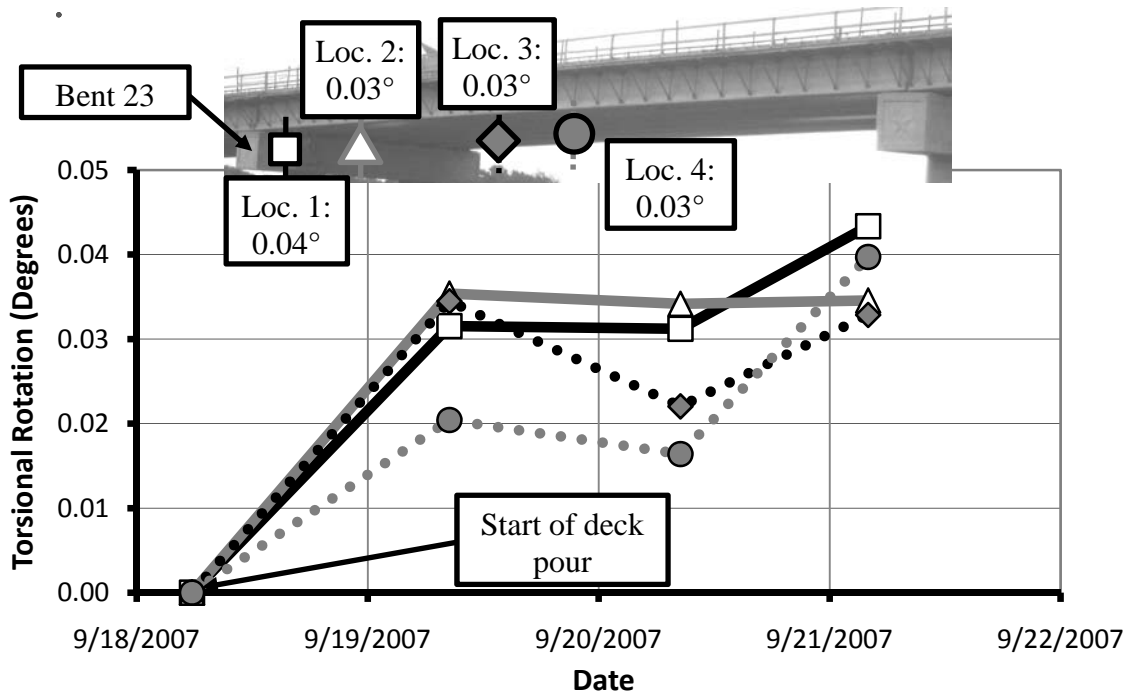
Figure 4-6 Torsional Rotation of Interior Girder After Deck Pour

Looking at Figure 4-6, there is a different trend for the interior Girder 2 rotations as compared to the fascia girder. As can be seen, the rotations enclosed in the boxes are relatively small with values less than 0.04° . Due to a sensor resolution of 0.03° , most of the average values show negligible rotations along Girder 2. As such, the interior girder essentially did not rotate during the deck pour. Little to no rotation was expected in the interior girders since the torsional load is negligible due to symmetric loading.

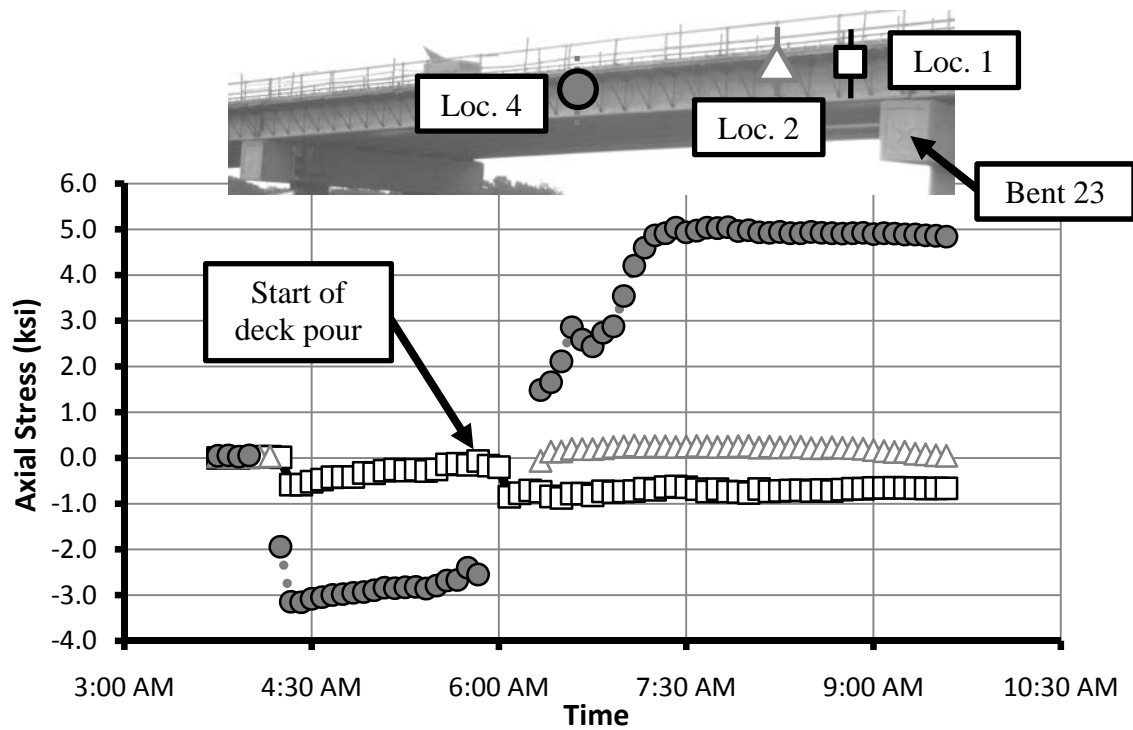
Figure 4-8 Stress of Bars on East Side of Bridge During Pour

Figure 4-8 and Figure 4-9 show the distribution of stress in the top bracing bars from the start of the data acquisition system to the end of the deck pour at Span 22 (~9:45am). The readings were zeroed relative to the initial strain reading from the datalogger. As discussed in Section 3.1.1.3, two strain gages at each location are needed to correct for any bending in the top bracing bar. On the East side of the bridge (Figure 4-8), only two locations had both strain gages intact after the deck pour. In contrast, strain gages at all four locations on the West side of the bridge were still functioning (Figure 4-9).

Though only two locations (Location 1 and 2) had both strain gages intact on the east side, one of the strain gages at Location 4 is graphed with the Location 1 and 2 gages on Figure 4-8. As seen from the figure, the values from 4:00am to 6:00am are not shown for Locations 2 and 4, as the values fluctuated out-of-range during this time frame when no construction activity was present on the span. The data acquisition system recorded out-of-range values, which tends to represent gages that are no longer bonded to the bars. However, once load was applied to the bridge, the strain gages seemed to stabilize. The strain gages at Location 1 seemed to drift, with two distinct drops at 4:20am and 6:00am, when no load was applied to the bridge. Thereafter, the gages stayed at the same strain level. Location 2 was a spot where the strain gages did not record significant changes. At Location 4, the data is characterized by only one strain gage since the second strain gage malfunctioned. The gage results were graphed because it recorded the highest stress change for a single gage, on the order of 5 ksi. However, it should be noted a portion of that 5 ksi is due to bending in the bar. Looking at the bars from the West side of the bridge, the bending was found to be significant. Thus, it is expected that the axial stress at Location 4 would be lower than 5 ksi.

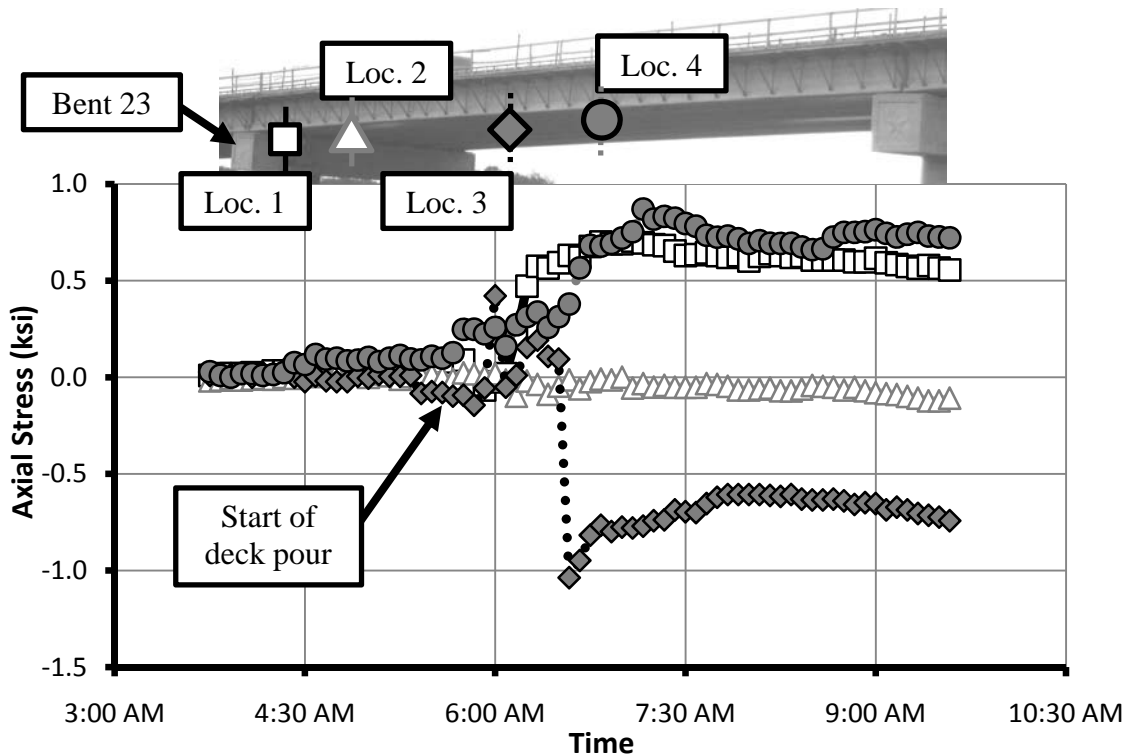
Figure 4-9 Stress of Bars on West Side of Bridge During Deck Pour

Initially, all of the strain gages on the West side of the bridge behaved as expected since the values are near zero stress from 3:40am until 5:45am (Figure 4-9). During this time, no load was present on Span 22 since all the construction equipment was on Span 23. Gages at Locations 1 and 2 on the West side had gage readings similar in magnitude to those on the East side of the bridge, with just the opposite sign. Location 3 indicated tension at the beginning of the pour, yet near the time when the concrete was poured over the gages and the screed passed over Location 3, the gages switched to compression. A peak in the data can be noticed at Location 4 around 7:15am, which corresponds to when the screed passed over Location 4. On the West side of the bridge, the highest stresses, 0.7-0.9 ksi, are at Locations 1 and 4. Considering that #5 rebar were used for the bracing bars, the bar at Location 4 provided about 300 pounds of restraint, which is a small amount.

Theoretically, the fascia girders are expected to twist outward causing a tensile force to develop in the top bracing rebar. In addition, it would be expected that with

larger rotations, the bars are engaged and caused a larger stress to develop. Location 4 followed these expected trends with a tensile stress and was the highest since the most rotation occurred at Location 4. However, one of the highest stress levels was recorded at Location 1, which experienced the smallest amount of rotation recorded directly after concrete placement. This discrepancy could be attributed to the presence of the timber blocking, which tends to complicate the behavior of the bridge. Finally, it is possible that the timber blocking can lead to compressive forces developing in the top bracing bars. This aspect of the research will be analyzed in the parametric study FEA portion of the study that is being completed by another student.

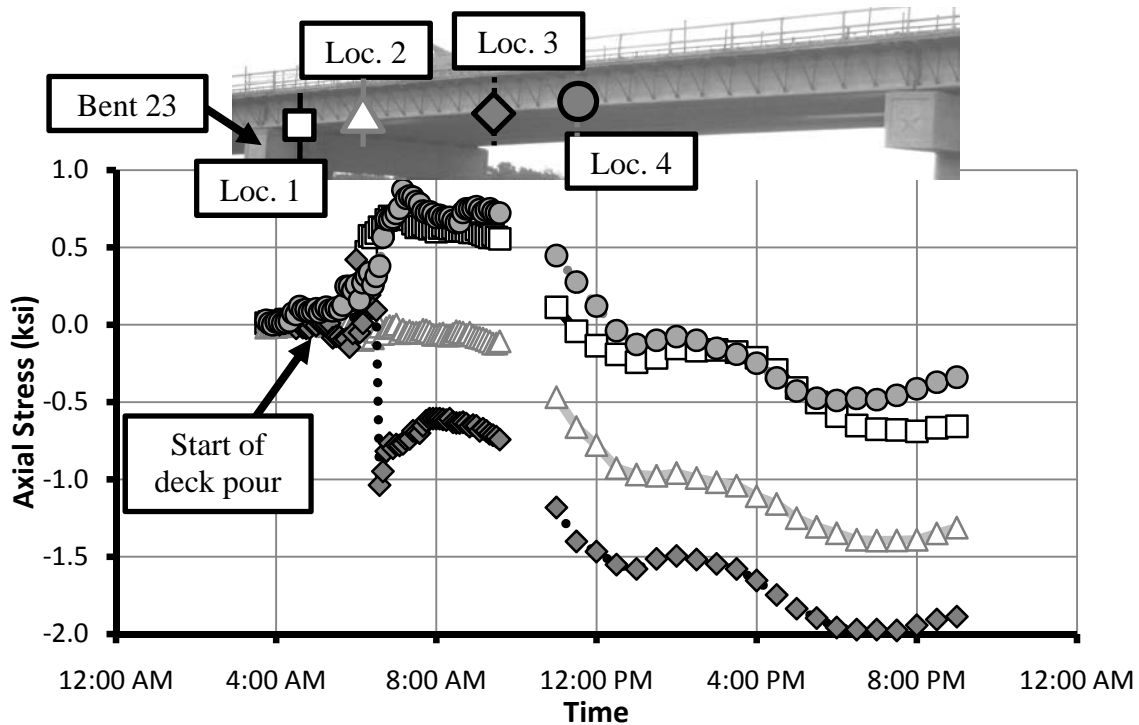
Figure 4-10 Behavior of Strain Gages on West Side of Bridge After Deck Pour

The behavior of the strain gages after the deck pour is more complicated, as noticed in Figure 4-10 and Figure 4-11. There was a discontinuity in the data from 9:35am until 11:00am, when the data acquisition system was turned off to download data. After measuring the vertical deflections, the system was turned back on to scan the

instrumentation at 30 minute intervals. Once turned on, as seen in Figure 4-10, all of the gages recorded a drop in stress of approximately 0.5 ksi and the trend continued throughout the day. Through the process of the concrete cooling and drying, the deck will shrink. The shrinking of the concrete will provide a compressive stress, negative value, to the bars, which is seen in the data (Figure 4-10). At about 1:00pm, the data starts to stabilize a little before decreasing again.

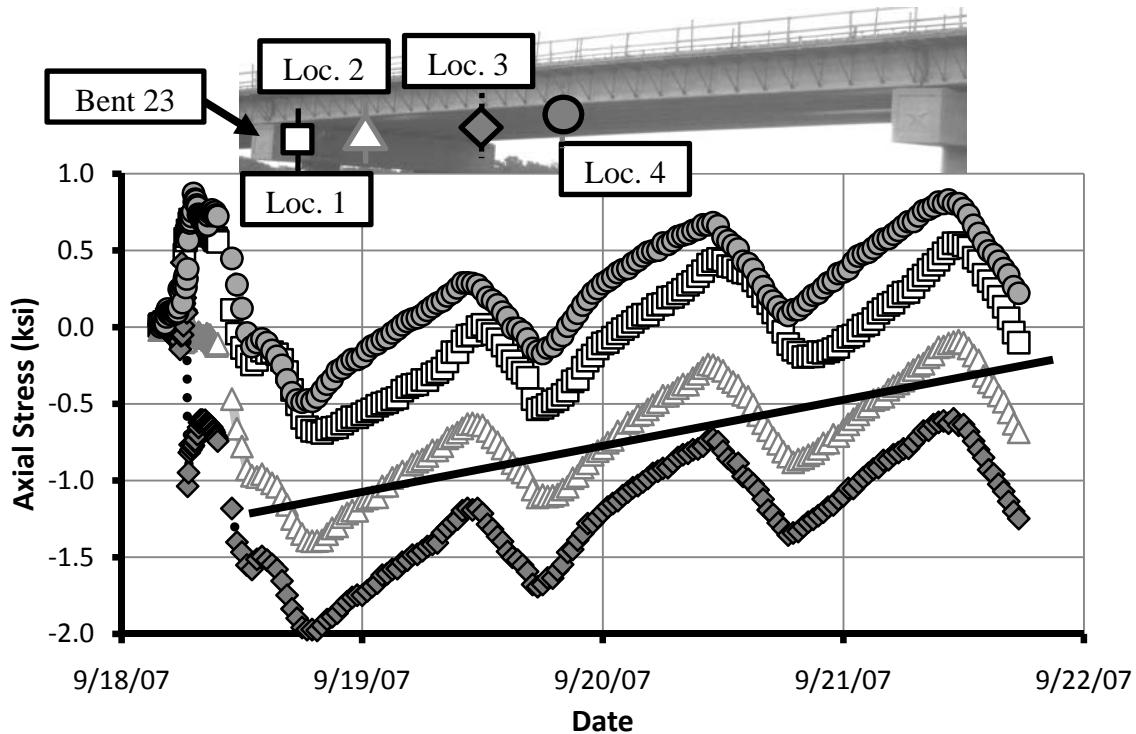
Figure 4-11 Behavior of Bars on West Side of Bridge After Deck Pour

After the concrete sets, two additional trends can be seen in the behavior of the deck after the concrete pour. Looking at Figure 4-11, a line could be added to the graph, as seen at Location 2, which shows a trend of the data increasing with each passing day. Though the datalogger was stopped on the third day (9/21/2007), it seems that the data had started to level off around that time, especially at Location 1. As can be noticed, the values on the third morning (9/21/2007) had nearly reached the levels achieved the morning of the deck pour before the concrete had set. This upward trend was likely due to relaxation of the concrete, which would apply a tensile stress in the bars. The second

trend involves the behavior of the bars from day to day. As noticed, the stress cycles around the line added to Figure 4-11. This cyclic behavior can be attributed to deck expansion and contraction, which comes from daily temperature swings.

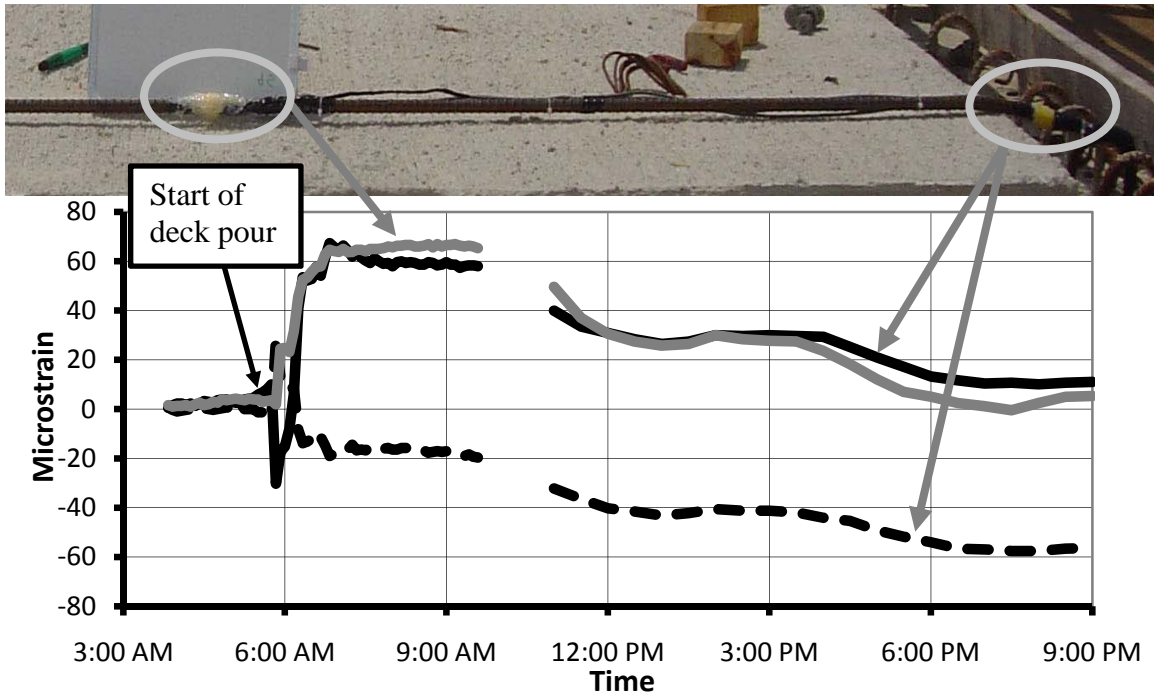
Figure 4-12 Strain At End and Middle of Bar on West Side of Bridge (Location 1)

At four locations on the bridge, strain gages were placed at the ends of the bars and the middle of the bars. Nonetheless, some of the gages were destroyed in the deck pour as a result of the pumping and consolidation of the concrete. Since the strain gages at the middle of the bar are more exposed than at the end, a majority of the middle strain gages were lost during the deck pour. One of the west end strain gages at Location 1, near Bent 23, survived the construction process and is plotted with the strain gages at the ends for Location 1. As can be seen from Figure 4-12, the solid lines tracked each other very well. Unfortunately, the second strain gage was destroyed; thus, a comparison of the average stress in the middle and end of bar cannot be evaluated. If the bar is in tension from the overhangs on either side of the bridge, the two locations should have the same stress level.

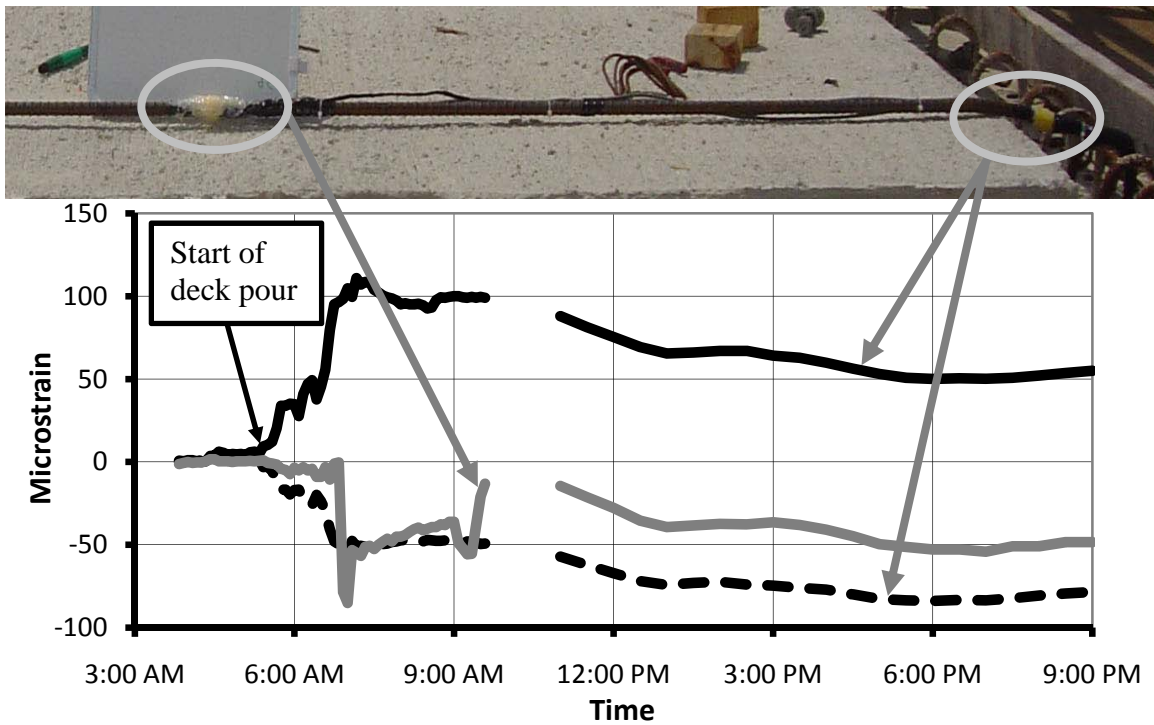
Figure 4-13 Strain At End and Middle of Bar on West Side of Bridge (Location 4)

Figure 4-13 shows the comparison of strain at Location 4 (west end) for gages at the end compared to one gage in the middle of the bar. The agreement between the strain gages located at the middle and end at Location 4 were not as good as observed at Location 1. A difference could arise if friction exists in the bar, such as at the panel-bracing bar interface. Since the second strain gage in the middle of the bar at Location 4 was destroyed, a comparison between the stress in the middle and end of the bar cannot be made.

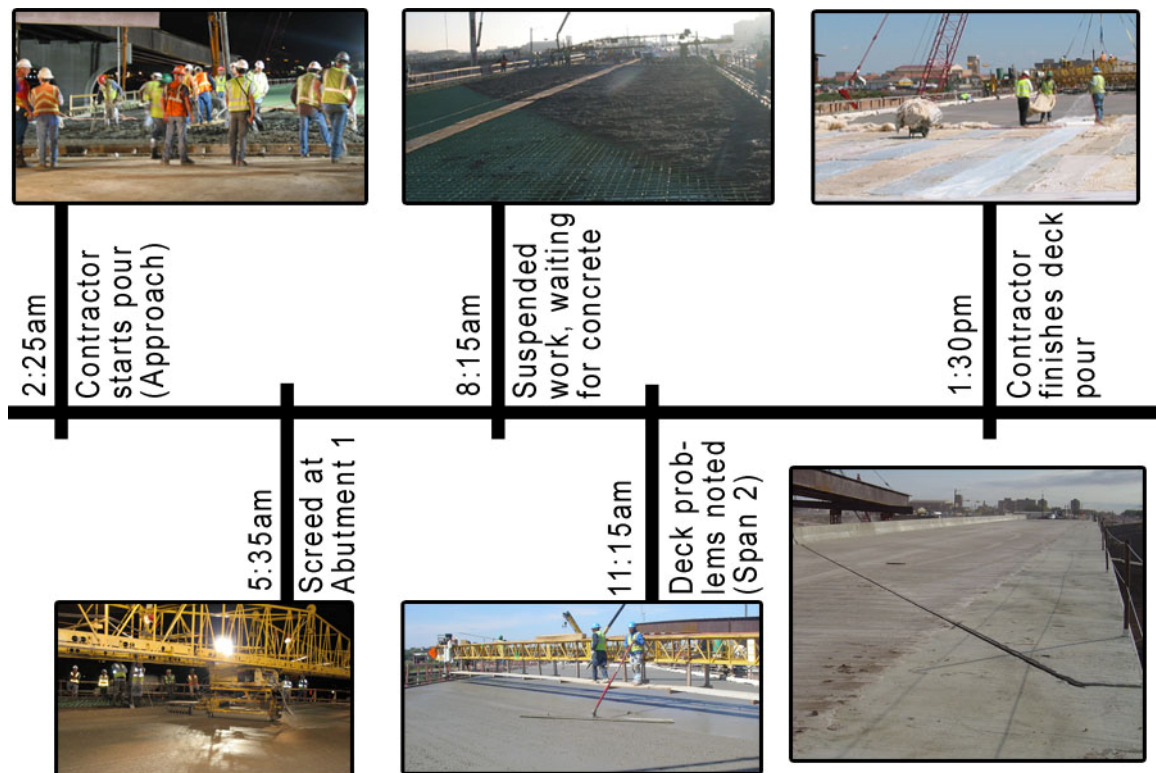
Figure 4-14 Timeline For Deck Pour at US 82-19th Street Bridge

The concrete deck for the 19th Street Bridge over US 82 was poured on October 4, 2007. Figure 4-14 highlights the timeline for the deck pour. The deck pour started with the west approach at approximately 2:25am. At approximately 5:30am, the screed was positioned over Abutment 1 and started loading Span 1. The contractor continued at a constant pace until 8:15am when work was suspended, at approximately 105 feet from Abutment 1 along Girder 6. The stoppage in concrete placement was done to pre-load Span 2 near Abutment 3 to minimize vertical movement of the bridge during the pour. Since the bridge is continuous, loading the bridge on one span can lead to large movements on the opposite span. Thus, concrete was placed near Abutment 3 to cause a downward deflection, which counteracts the upward movement at Abutment 3 caused by the screed moving towards the middle support. However, because the concrete trucks were delayed, work did not restart until more than 30 minutes later. Around 11:15am, problems were noted with the deck at Span 2. As a result of the delay, the preloaded concrete had started to bond and was therefore no longer plastic before being finished.

Despite the problems, the contractor kept pouring the deck. The total volume of concrete was approximately 570 cubic yards. It took almost 12 hours for the contractor to finish the west approach and the two bridge spans. During the deck pour, one screed and two finishing bridge were used. The screed and one of the finishing bridges weighed approximately 16.7 and 8 kips, respectively, in part because they were oriented parallel to the skew of the bridge. The second finishing bridge weighed 4 kips since it was oriented perpendicular to the bridge width.

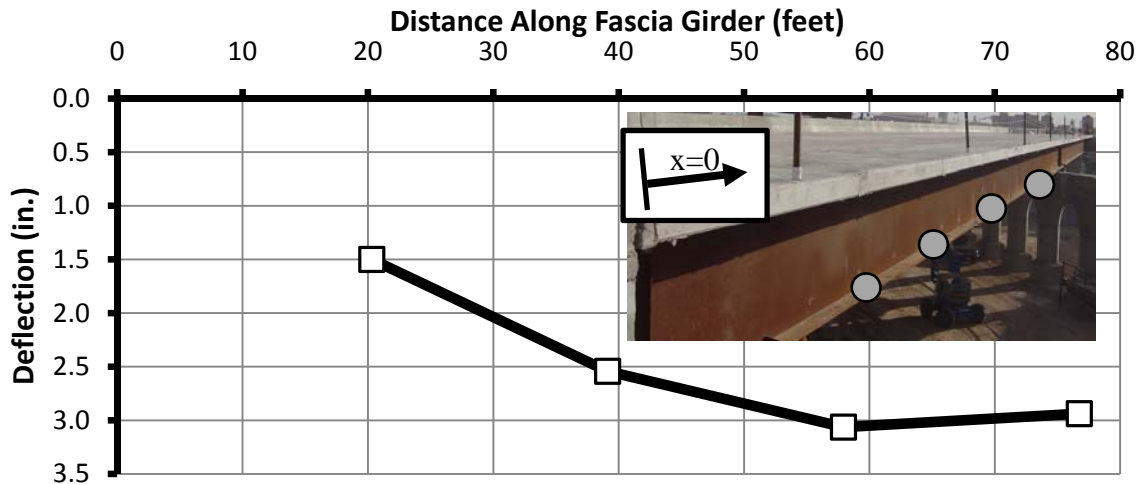
Figure 4-15 Vertical Deflection of Fascia Girder Due to Deck Pour

the bridge. Figure 4-15 shows the deflection of the fascia girder due to the deck construction.

Table 4-2 details the measurements recorded during the deck pour for the fascia girder (Girder 6). The final measurements were recorded at approximately 12:30pm when the last finishing bridge (4 kips) on Span 1, was within 25 feet of Bent 2 as measured along Girder 6. As seen from the table, all three readings from most of the locations were identical. For the locations where all three readings were not identical, two readings were the same with the third reading being within the error (1/16 of an inch) of the laser distance meter. Thus, the procedure was very repeatable.

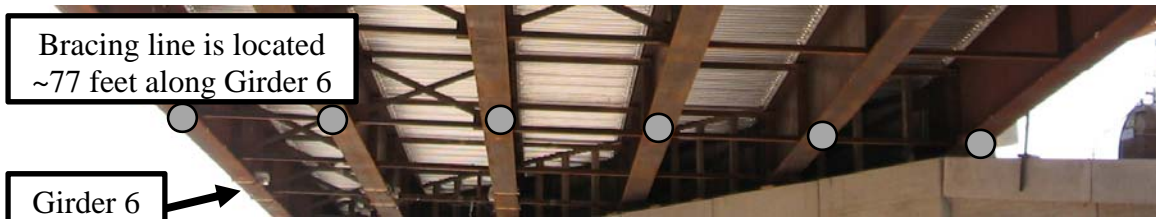
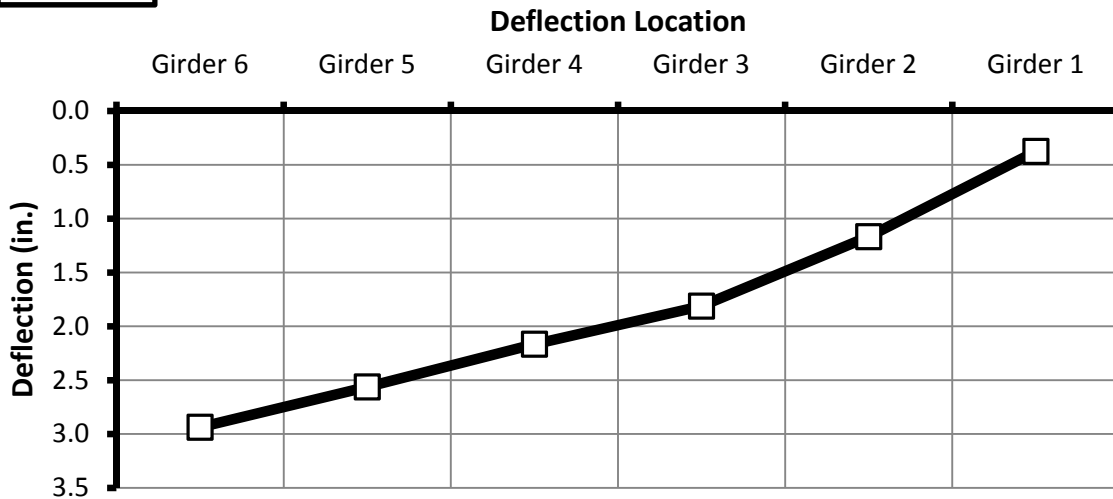
Figure 4-16 Vertical Deflection Along Fifth Intermediate Bracing Line

Figure 4-16 shows the vertical deflection across the bridge for a bracing line located ~77 feet along Girder 6 (measured from the end abutment). This line is the fifth intermediate (not counting the bent plate diaphragm at the support) bracing line along Girder 6. As can be seen from the graph, the girders deflected together, in almost a straight line. Due to the relative location along each girder, Girder 6 was expected to deflect the most and Girder 1 (bracing line is located ~77 feet along Girder 6 and ~7 feet along Girder 1) the least, which is seen from the data. Thus, trends in the deflection measurements recorded from the bridge were as expected.

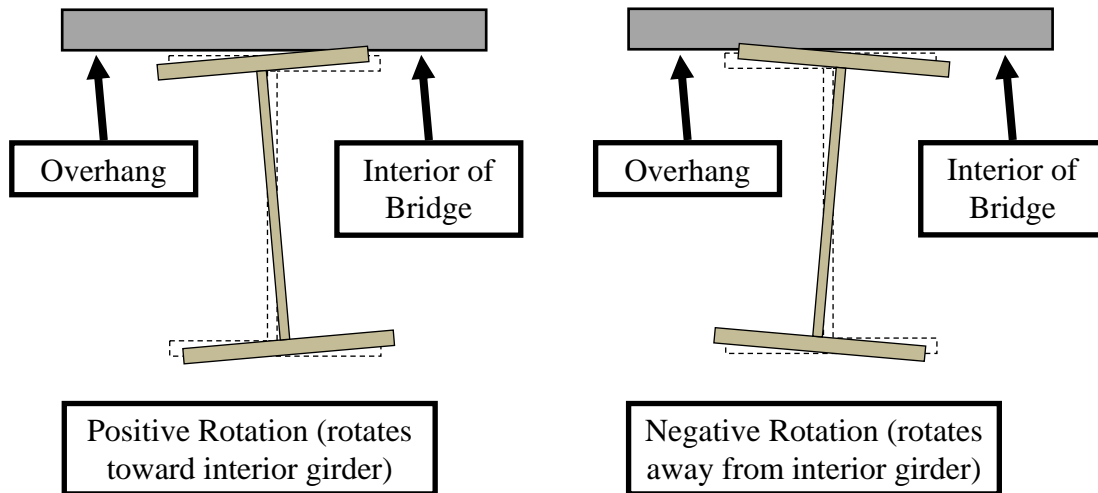
Figure 4-17 Sign Convention of Rotations

A similar sign convention as used with the concrete girders was used for the steel girders and can be seen in Figure 4-17. Looking back-station, or from Abutment 3 towards Abutment 1, counterclockwise rotation is considered positive for Girders 3 through 6.

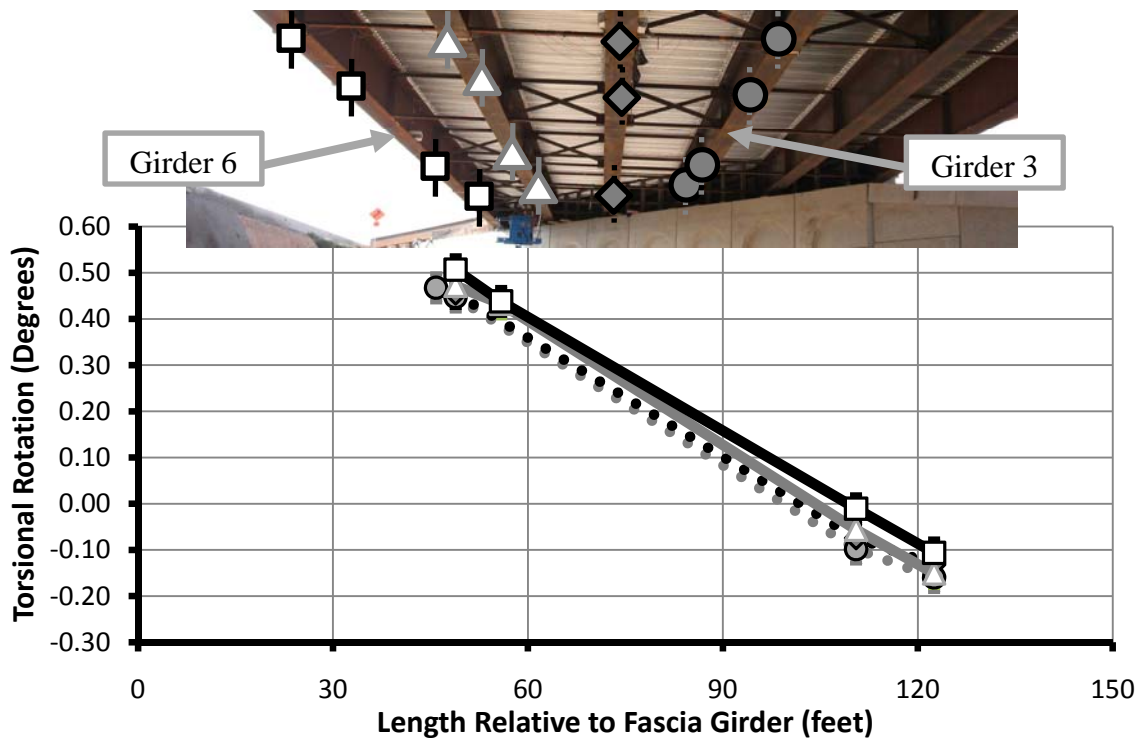
Figure 4-18 Torsional Rotation Along Span 1 of Girders 3-6 Relative to Girder 6

Figure 4-18 shows the variation of rotation for Girders 3 through 6, which used rotations derived from Figure 4-19 through Figure 4-23. As can be seen from Figure 4-18, rotations of nearly 0.50° were recorded during the deck pour. Due to the skew of the bridge, the relative location of the tilt sensor along the fascia Girder (Girder 6) is used as the reference point so that twists at the same cross frame or strut could be examined. If the data was plotted relative to its position on each girder, then, due to the skew of the bridge, the lines would be out of phase. From Figure 4-18, the interior and fascia girders behave similarly at each tilt sensor locations, with twists of approximately the same magnitude. This result reinforces what was seen with the vertical deflections in Figure 4-16: the individual girders are moving together as a unit due to the distribution of cross frames and struts throughout the bridge.

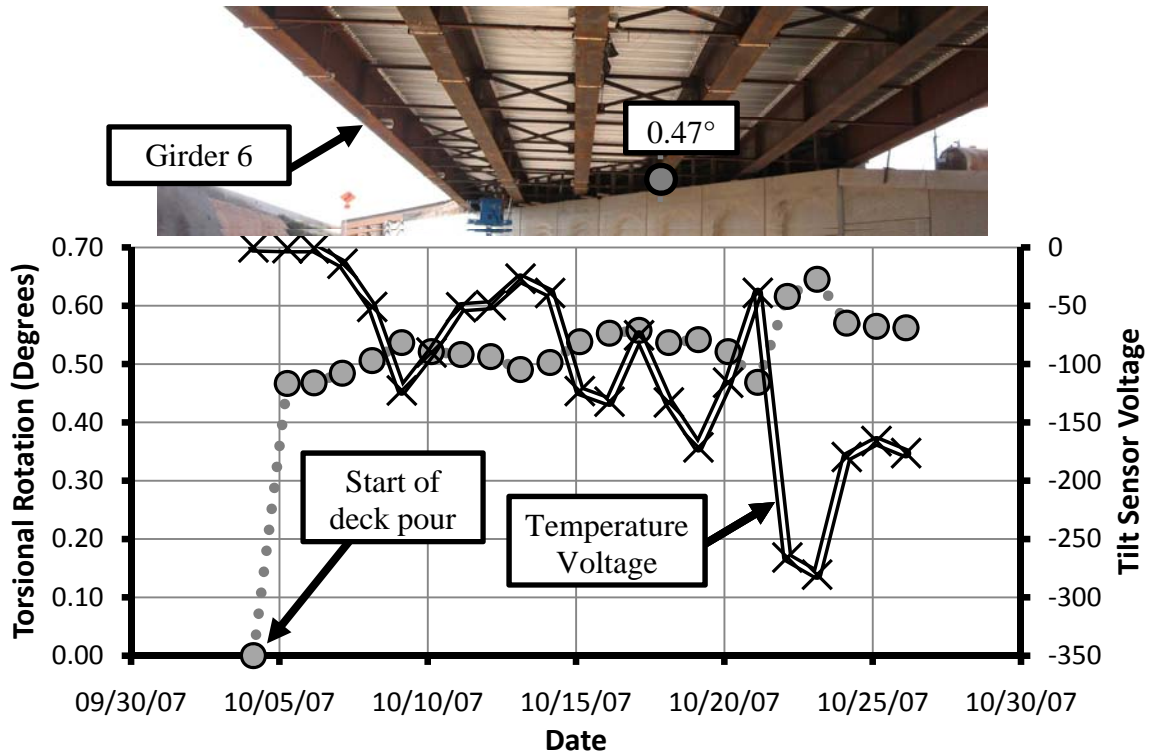
Figure 4-19 Change in Torsional Rotation After Deck Pour (TS-G3-1)

To show the effect of temperature on the tilt sensor, Figure 4-19 details the distribution of rotation of TS-G3-1 throughout many days after the deck pour. Starting with three days after the pour (10/07/2007), the data points shown below were determined by averaging 5 readings from 1:00am to 3:00am every morning. The first few data points shown on the graph were determined by matching temperature readings, as discussed at the beginning of this section. In addition to the rotation data, the temperature of the datalogger at 3:00am each morning is plotted on a secondary axis.

As seen on Figure 4-19, the data varies from as little as 0.45° to as much as 0.65° . Once the deck cures, the steel girders and concrete act compositely and little rotation is expected since any applied torsion is resisted by the entire bridge. As a result, in the early morning, when the temperature is relatively constant for the day—no large temperature differential with time—no net rotation on the bridge is expected. For the difference of 0.20° from minimum to maximum rotation in Figure 4-19, the temperature channel of the tilt sensor recorded a difference of nearly 300 millivolts. If that is

contrasted to a difference of 0.003° (10/11/2007 versus 10/12/2007) from a 0.1 millivolt change on the temperature channel, it can be seen that error is minimized when the values from the temperature channels are matched. By using data from 10/05/2007 and 10/06/2007, an average rotation of 0.47° was determined at TS-G3-1. TS-G3-1 is located approximately 1 foot along Girder 3 which corresponds to a distance of 42.87 feet from the abutment on Girder 6 (the approximate beginning of the bridge).

measurement techniques used. As seen in the preceding data, the rotations obtained from the tilt sensors matched very well with the rotations from the lateral displacements. For instance, the rotation at Abutment 1, Girder 6, was 0.58°. The rotation at TS-G6-1 (Figure 4-19), which was located approximately 46 feet away from Abutment 1, was 0.51°. From the lateral displacement method, the rotation of an interior girder at Abutment 1 was 0.53°. From a tilt sensor, the rotation at TS-G3-1, approximately 1 foot from Abutment 1, was 0.47°, which is very close to the rotation of 0.53°.

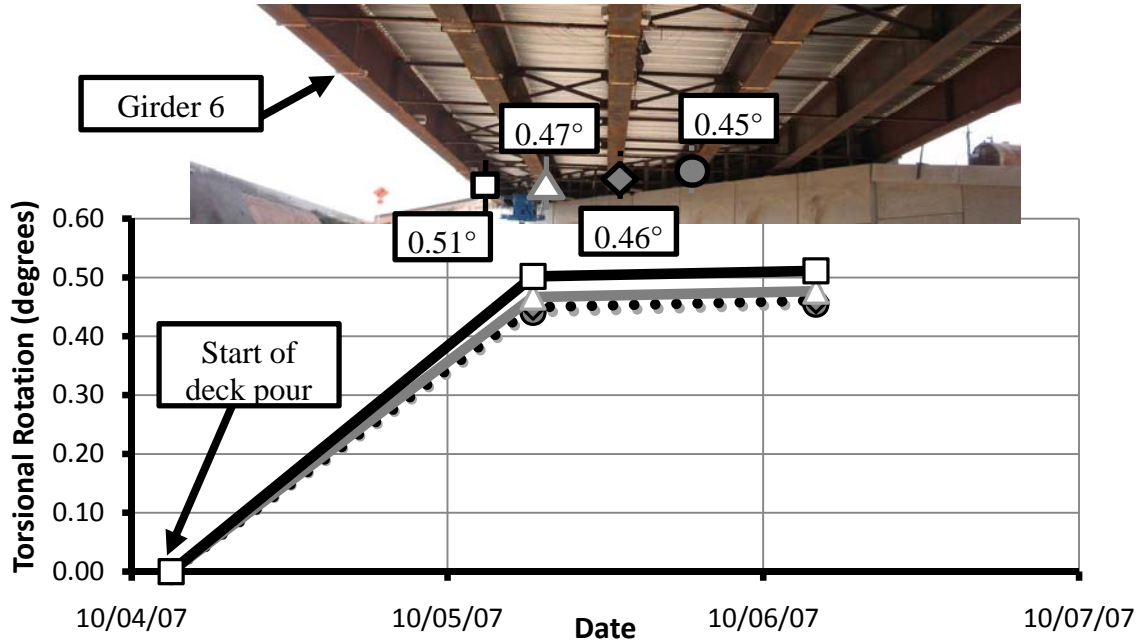
Figure 4-20 Change in Torsional Rotation After Deck Pour (Location 1)

The next two figures show the rotation of the girders at a line of bracing (Figure 4-20) and at approximately the midpoint of the fourth panel (Figure 4-21). The tilt sensors at Location 1 are at a line of cross frames or struts, which measured approximately 49 feet along Girder 6. Location 2, near the panel midpoint, was located approximately 56 feet along Girder 6. As seen in Figure 4-20, there was slightly more rotation at the exterior girder than at the interior girders, 0.51° compared to $\sim 0.46^\circ$. In addition, all of the interior girders are within the resolution of the tilt sensor of each other.

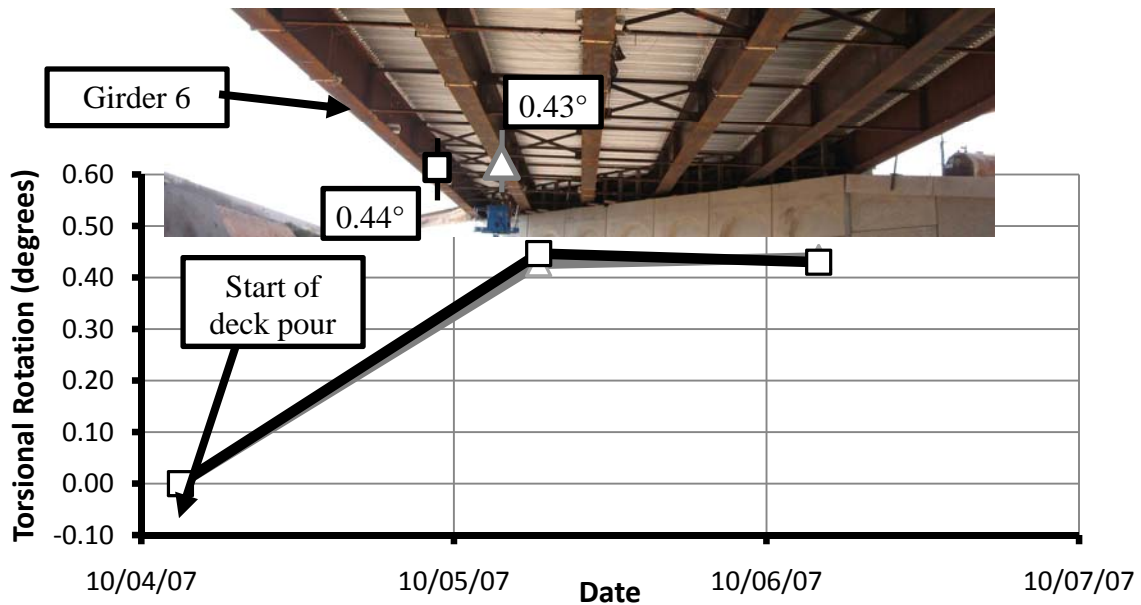
Figure 4-21 Change in Torsional Rotation After Deck Pour (Location 2)

Due to a malfunction of one of the tilt sensors, only two tilt sensors are shown at Location 2. At Figure 4-21, the rotations are essentially the same for the exterior girder and the interior girder.

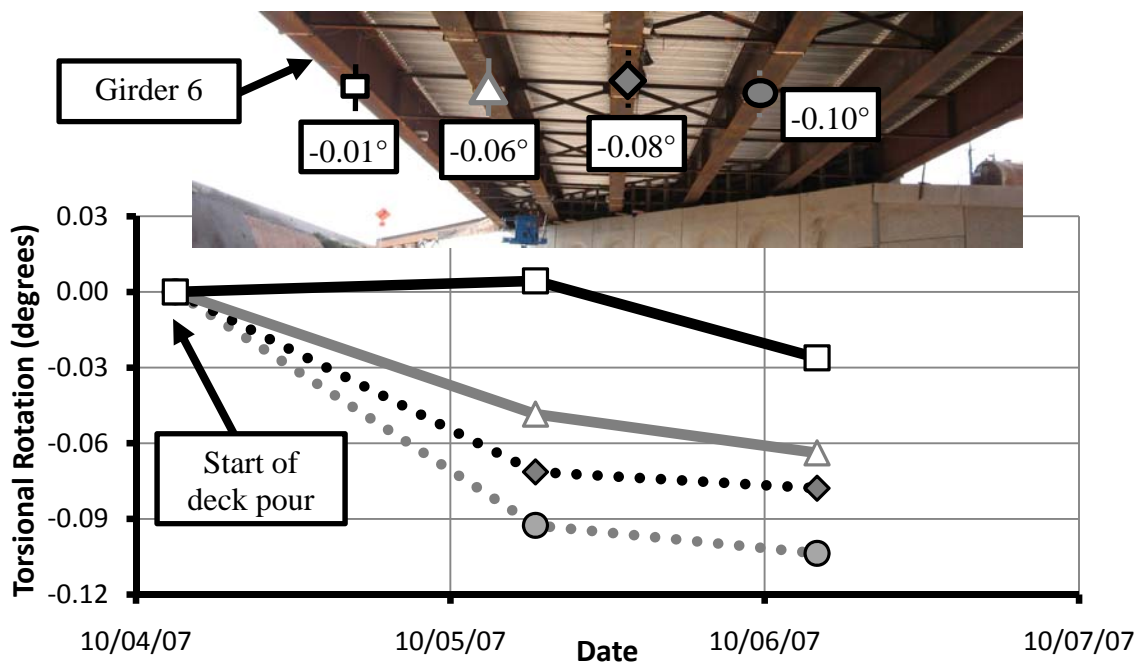
Figure 4-22 Change in Torsional Rotation After Deck Pour (Location 3)

All of the tilt sensors at Location 3 had a negative rotation (Figure 4-22), which looking backstation means the girders rotated clockwise or the bottom of the girder kicked outward from the bridge. From the effect of the overhang load, this type of movement would be counterintuitive for a bridge with normal supports. However, since the bridge is heavily skewed, a negative rotation can occur. As can be seen from Figure 4-22, the exterior girder had less negative rotation than the interior girders. Location 3 was located approximately 110 feet from the end of Girder 6 and is near the midpoint of the seventh panel.
