The Influence of Overhang Construction on Girder Design

Thesis

The University of Texas at Austin

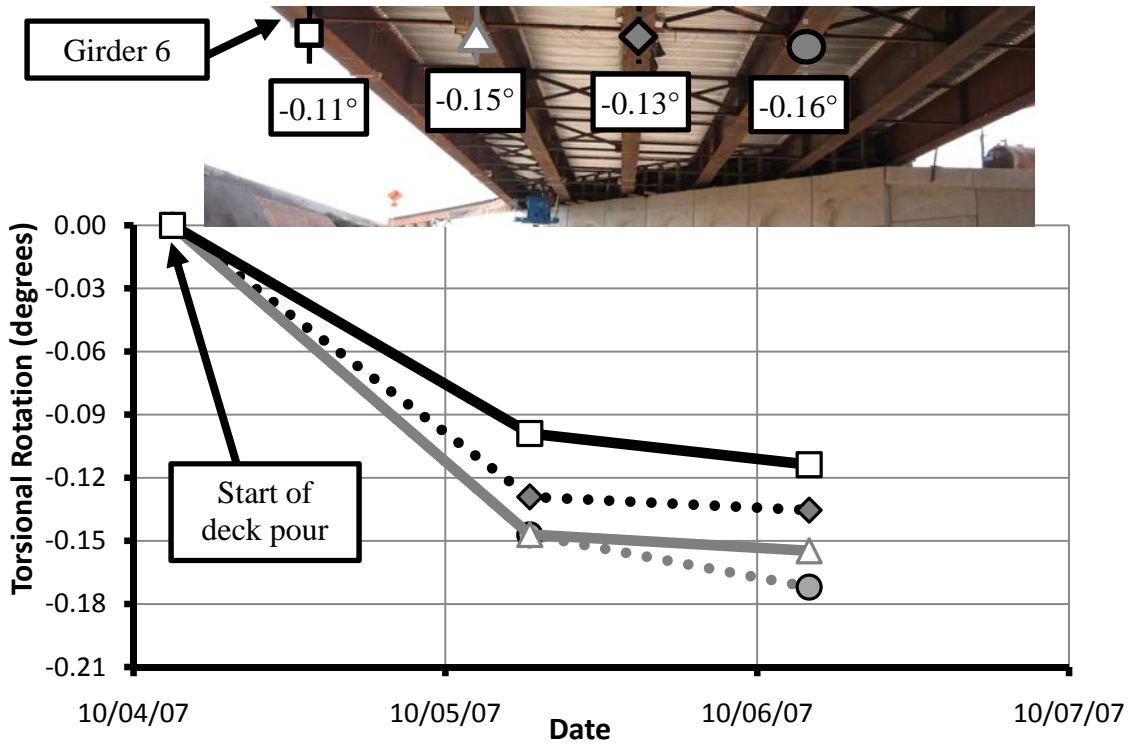
Figure 4-23 Change in Torsional Rotation After Deck Pour (Location 4)

Figure 4-23 shows the distribution of rotation after the deck pour for Location 4, which was at the end of the seventh panel. Location 4 is located approximately 122 feet along Girder 6. The exterior girder rotates slightly less outward than the interior girders. All of the interior girders are within 0.03° of each other. Looking at the rotation data, it can be seen that Girders 3 through 6 experienced larger negative rotations closer to the middle support, which is expected due to the continuous behavior of the skewed bridge.

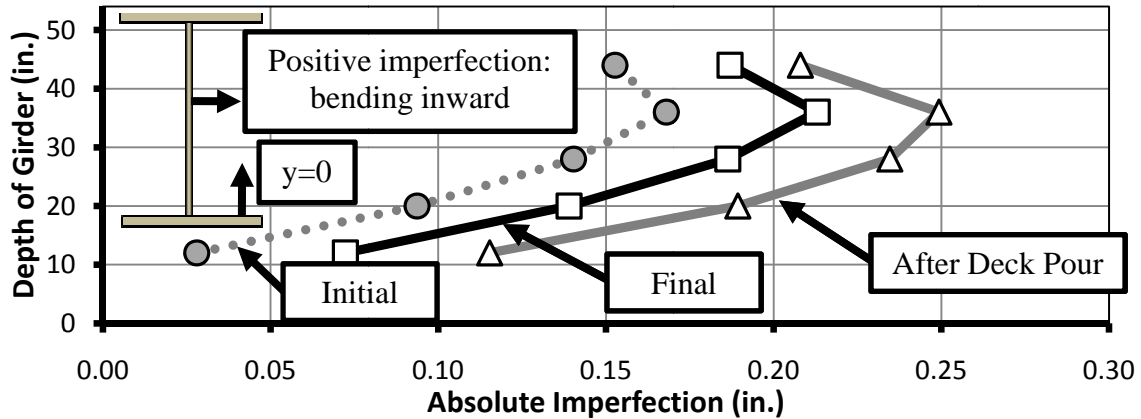
Figure 4-24 Sign Convention & Typical Web Imperfection at 19th Street Bridge

The imperfection of the web at each of the phases was determined by correcting the data relative to a zero reading obtained from a flat reference surface in the laboratory, as discussed in Section 3.2.1.3. Figure 4-24 shows the distribution of absolute imperfection of the three phases for a typical location, as well as depicting the sign

convention. For an overhang bracket bearing on the outside of a girder, the load from a deck pour is expected to cause the web to bend inward. Thus, a positive imperfection is in the direction of expected bending.

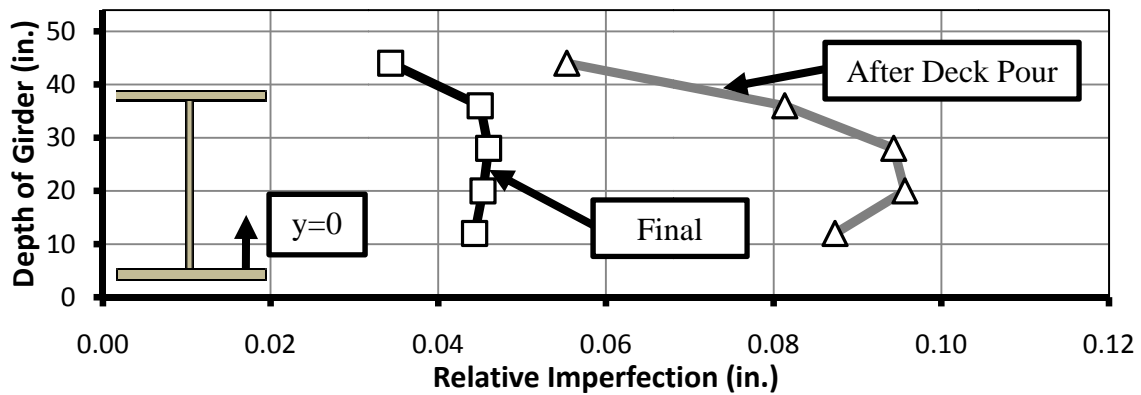
Figure 4-25 Typical Relative Web Imperfection Due to Deck Pour

From the absolute imperfection figures, the relative imperfection can be determined and used to analyze the impact of the deck pour. The relative imperfection, as seen in Figure 4-25, is found by subtracting the initial measurement from the later two measurements. For convenience, in subsequent figures of individual locations, the absolute and relative imperfections are plotted side by side.

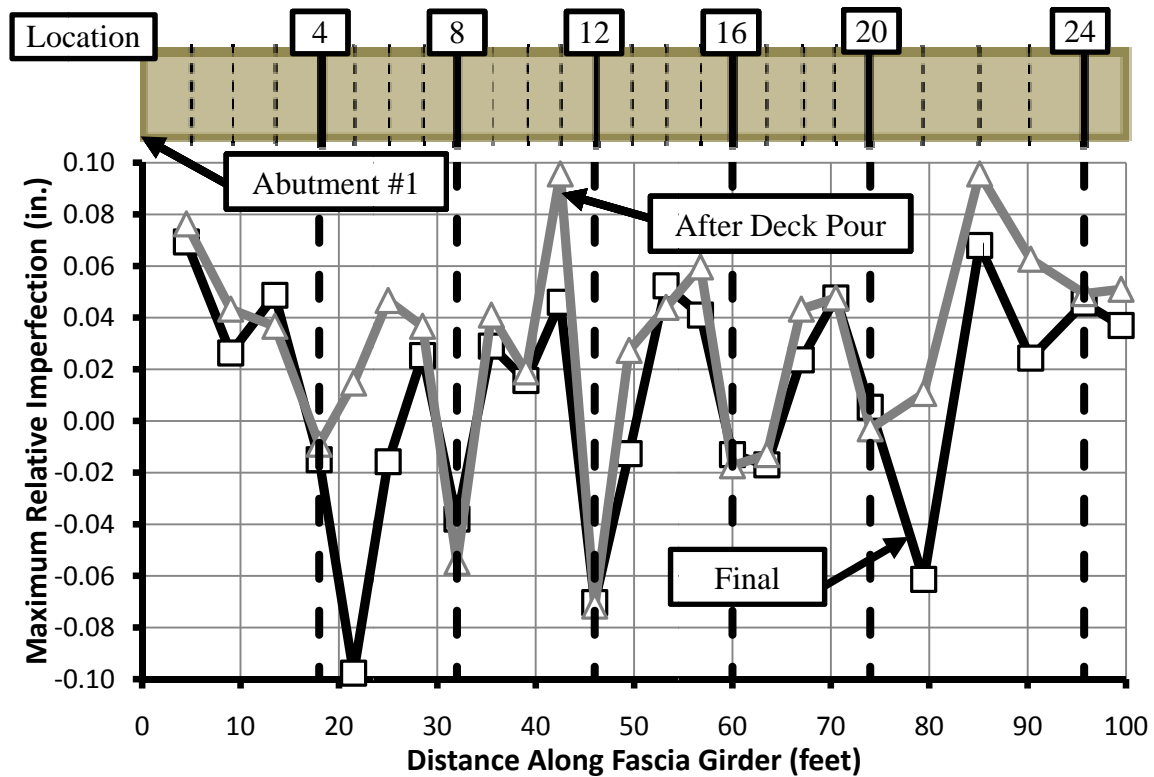
Figure 4-26 Maximum Relative Imperfection of Fascia Girder

Figure 4-26 shows the maximum relative imperfection in the web across the length of the fascia girder. Dashed lines on the graph represent cross frame or strut locations. The figure above the graph is a legend of the girder, in which each line represents a web imperfection measurement location. From the graph, it can be seen that the range of relative imperfections is about 0.2 inches, as the values vary from 0.10 inches to -0.10 inches (D/540). Thus, the change in imperfection due to the deck load is less than 1/8 of an inch for all cases. For a 54 inch deep web, a 1/8 inch imperfection due

to the deck pour is not significant, for it is an imperfection of $D/540$, much less than the $D/150$ limit allowed for fabrication. In fact, the imperfections were so small at fabrication and the deck pour that when added together, the largest absolute imperfection was 0.31 inches, which is still less than the $D/150$ limit of 0.36 inches.

At a majority of the locations, the change in imperfection was positive, which means that the imperfections grew inward, as expected, due to the deck pour. Of the eight locations where the change due to the deck pour caused a negative change in imperfection, five of those were at a line of bracing (Locations 4, 8, 12, 16, and 20). Those locations are slightly more complicated, as they feature cross frames and struts, which can push the webs in the opposite direction. Thus, a negative imperfection can occur at cross frame locations due to load distribution from the cross frames.

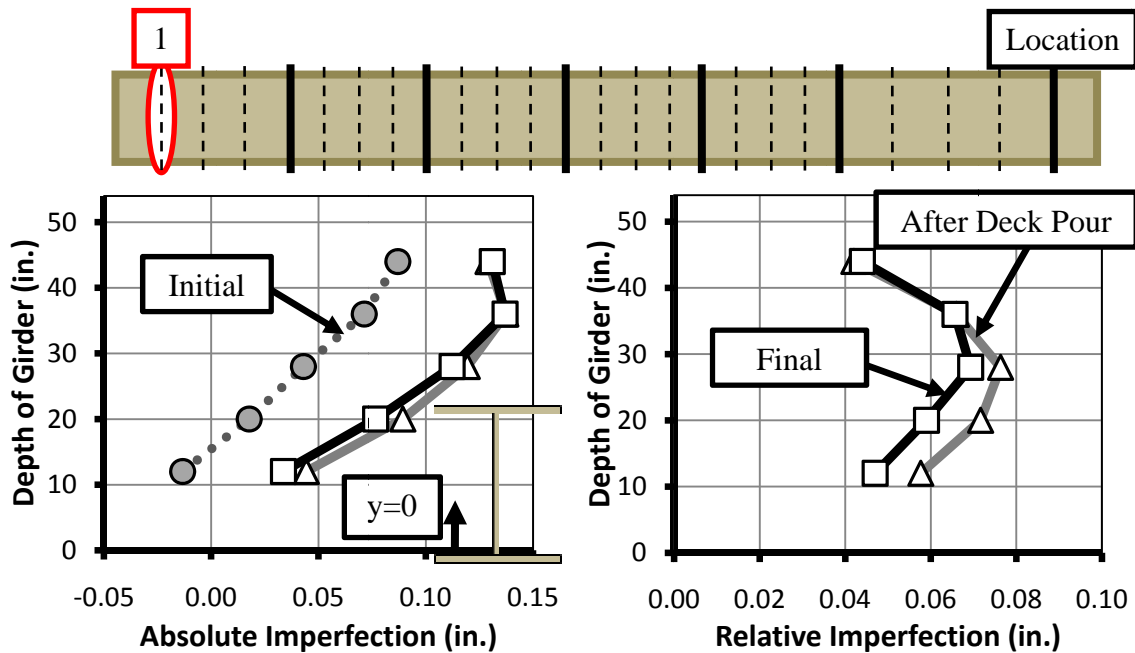
Figure 4-27 Relative Imperfection of Fascia Girder at Location 1

Figure 4-27 shows the imperfections due to the construction loading of the fascia girder at Location 1. As seen in the graph of absolute imperfection, the imperfection is

negative at the bottom and positive at the top in the initial profile, causing an S-shaped curve. In contrast, when looking at the other two absolute imperfection profiles, after the deck pour and the final reading, the shapes are those of a half-wave shape. Therefore, as seen from the plot of relative imperfections, the web moved inward after the deck pour. With a relative imperfection of nearly 0.08 inches (D/710), this location has one of the higher changes due to the deck pour.

Another interesting aspect of Location 1 is that the imperfections decreased slightly at the final measurement—after the removal of the overhang brackets. However, the recovery was relatively small. The relatively small recover can be attributed to two aspects: 1) the lateral load from the overhang bracket was applied relatively close to the bottom flange, and 2) the stiffened concrete provides some restraint to web recovery. In most cases, the location of maximum imperfection is at either the midpoint of the web or the point above the midpoint. If the lateral load from the bracket had a significant impact, the maximum imperfection should have been located lower on the web due to the position of the bracket and caused a larger recovery when the bracket was removed.

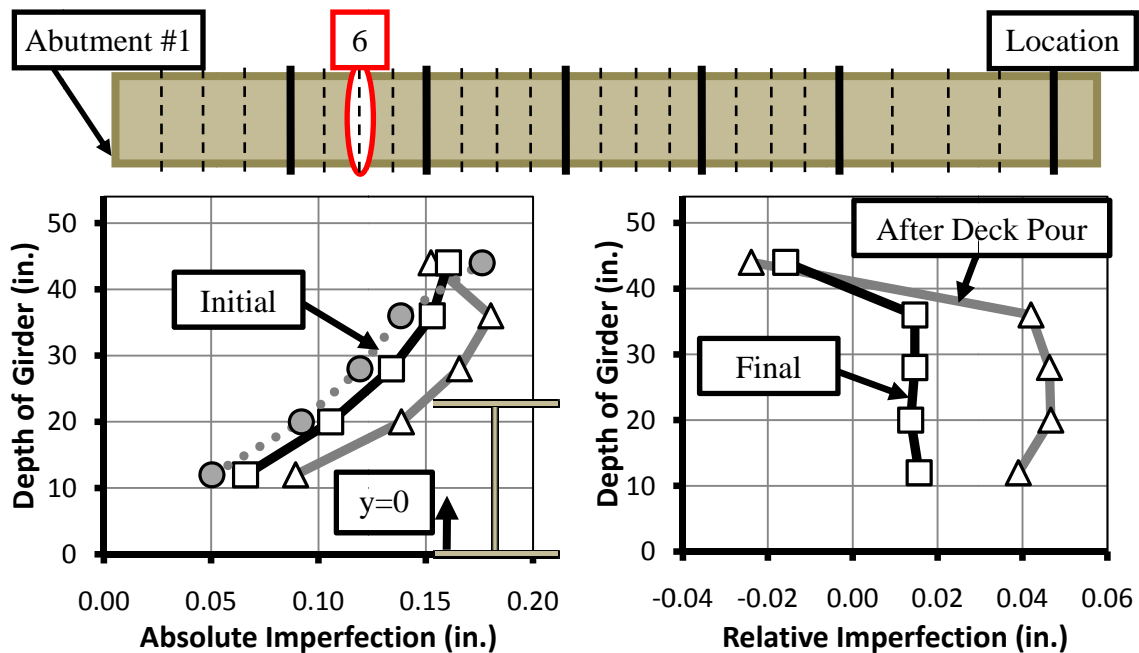
Figure 4-28 Imperfection of Fascia Girder at Location 6

Looking at another location, it can be seen that the deck pour helped to smooth out the profile of the web imperfections. From Figure 4-28, all three web profiles are bending in a half-wave pattern. The initial profile is somewhat jagged, yet when the deck is poured, the half wave becomes smoother. From the relative imperfection figure, it can be noted that an S-shaped curve, one where the bottom bends inward (positive) and the top bends outward (negative), was needed to smooth out the curves. With the imperfections at the bottom increasing (positive value) due to the deck pour, the bottom behaves as expected from applying a concentrated load from the overhang load. After the overhang bracket is removed, the imperfections decrease; thus, there is some recovery after removing the overhang brackets. However, the maximum relative imperfection at this location is on the order of 1/20 of an inch ($D/1150$), which is very small. This small imperfection can be partially attributed to bending in an S-shape.

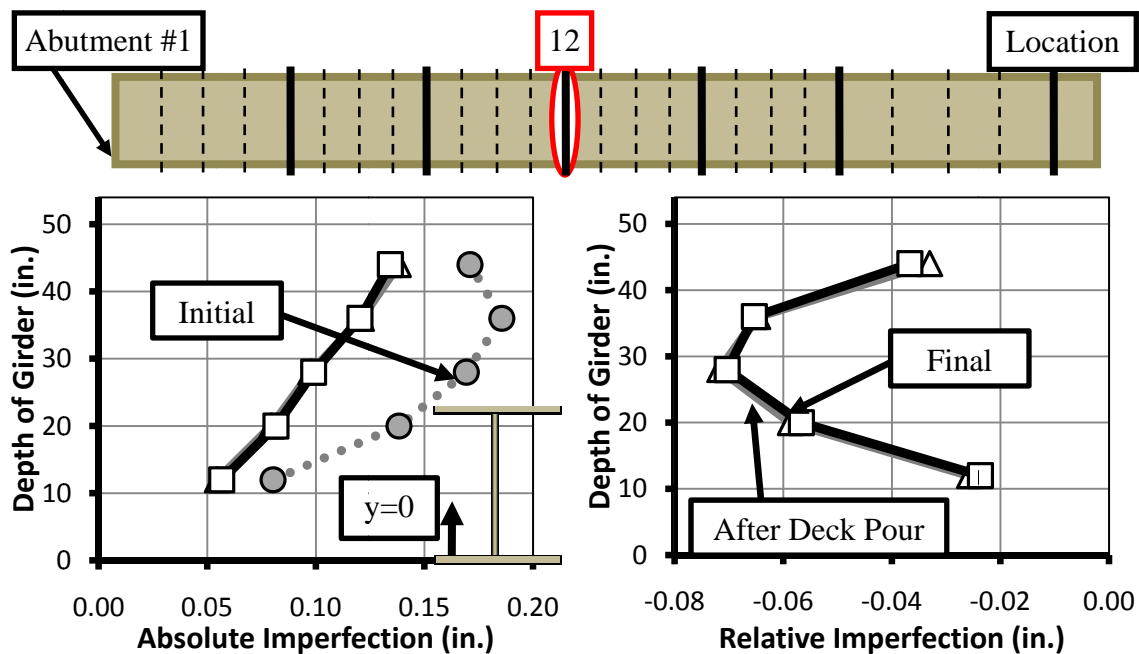
Figure 4-29 Imperfection of Fascia Girder at Location 12

The behavior of imperfections at a bracing line is interesting, as it is different from the majority of the other locations. All “bracing line locations” are actually located within 6 inches of the bracing line to allow for access by the LDPG. All of these locations are near stiffeners, which are needed to connect the braces to the girders and

help reduce imperfections. Location 12 (Figure 4-29) has the largest relative imperfections of the bracing line locations measured. At this location, the relative imperfections are negative, which indicates the web was bending outward. This movement can be seen from the absolute imperfection plot since both lines are to the left of the initial profile. As discussed earlier, the negative imperfections can be due to the force of the brace, which could be greater than the overhang bracket force. When the overhang bracket is removed, the imperfections hardly vary from those measured after the deck pour; thus, there is essentially no measurable recovery after removing the overhang brackets at the stiffener locations. Still, the maximum relative imperfection at this location is just over 1/12 of an inch ($D/750$). Therefore, significant deformation was not found at this location.

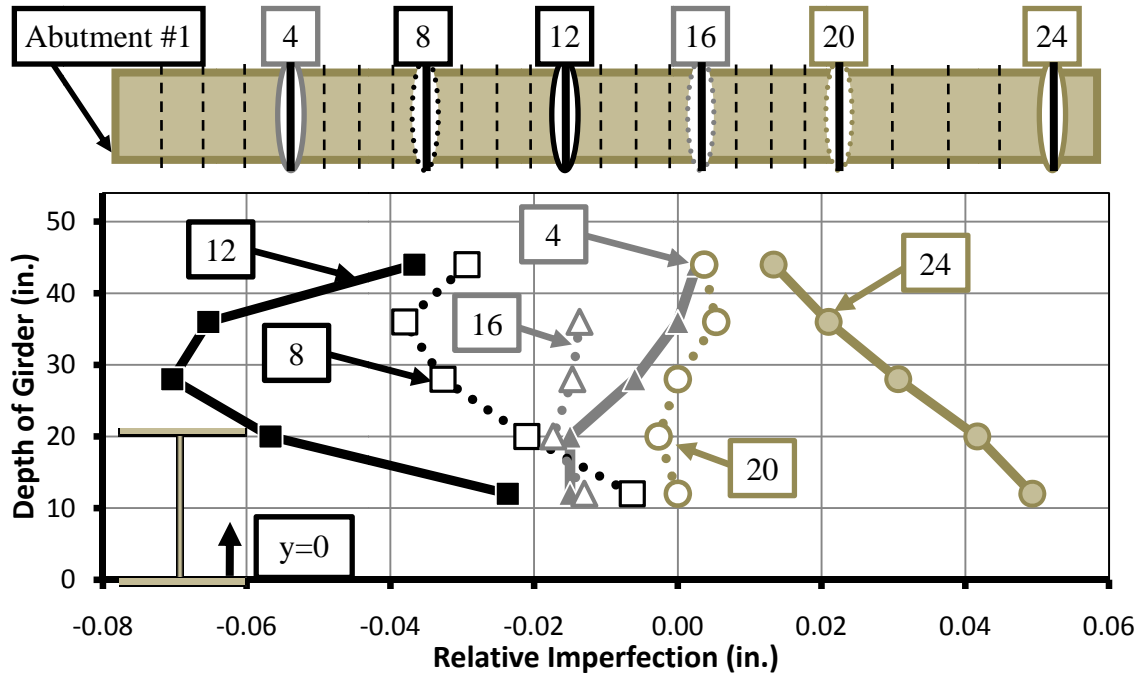
Figure 4-30 Relative Imperfection of Fascia Girder at Cross Frame Locations

Figure 4-30 shows the relative imperfection of the exterior girder at the cross frame locations. This graph supports the idea that struts/cross frame locations are negative due to the force in the struts/cross frames being larger than the overhang force. According to Wang and Helwig (2005), the brace forces are a function of the moment at the brace location. Thus, the largest brace forces will occur at the regions with the

highest moments. Due to its position on the bridge, Location 12 is expected to have the highest cross frame forces and it has the highest relative imperfection of all of the cross frame/strut locations. Location 24 is expected to have the lowest cross frame/strut forces and it has the lowest relative imperfection of the cross frame/strut locations.

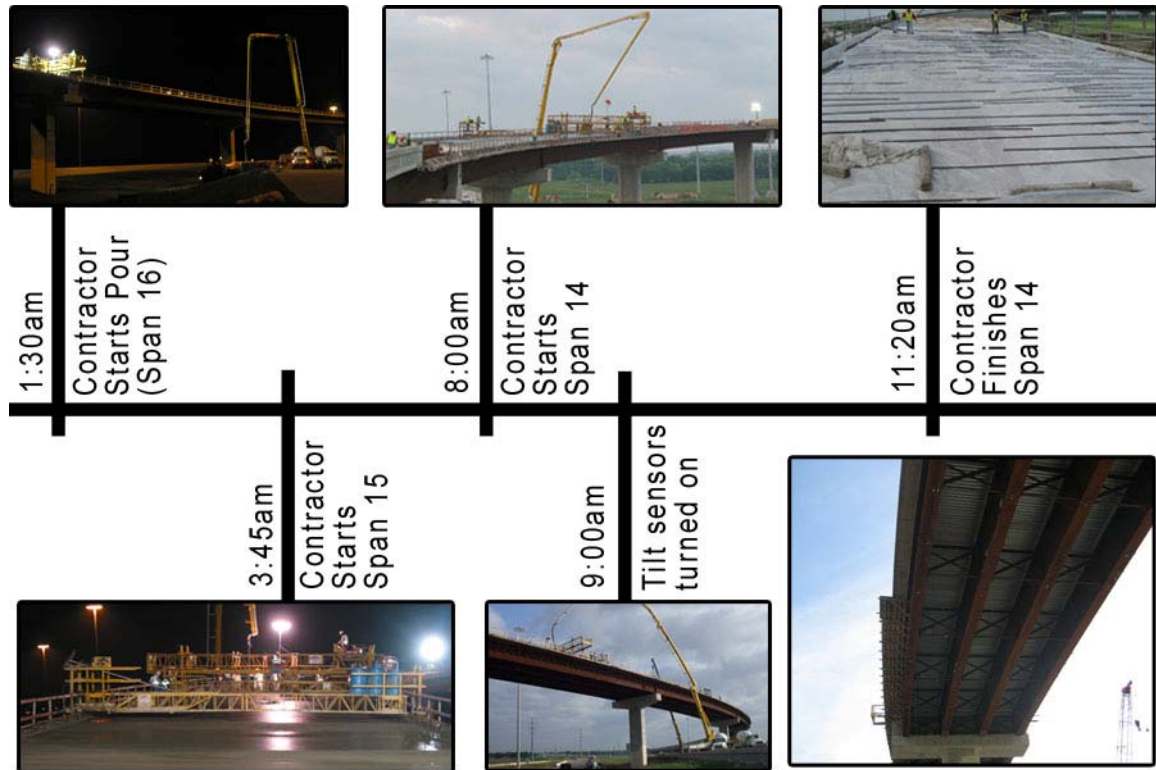
Figure 4-31 Timeline For Deck Pour at SH 71-SH 130 (Span 14)

Torsional rotations and web imperfections were monitored during the deck pour of Span 14 at the direct connector from SH 71 to SH 130 to obtain a measure of the impact from the loading on the overhangs. The concrete deck for Span 14 was poured on April 16, 2008. Figure 4-31 highlights the timeline for the deck pour. The deck pour started at approximately 1:30am and finished nearly 10 hours later. The contractor poured three spans in reverse order, starting with Span 16 and finishing with Span 14. The total volume of concrete needed for the three-span continuous steel bridge was over

650 cubic yards. The contractor used one screed and two finishing bridges during the deck pour. The screed weighed approximately 13 kips, while both finishing bridges weighed nearly 4 kips each. The contractor did not preload any of the sections, as was done on the 19th Street Bridge in Lubbock.

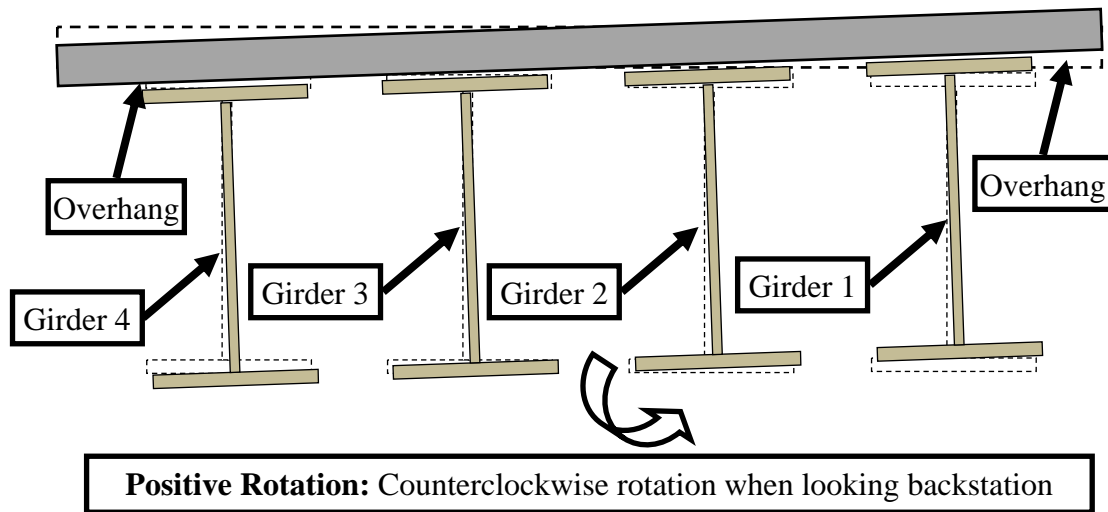
Figure 4-32 Sign Convention for Rotations at Span 14

Sixteen tilt sensors were installed on Panel 5, as described in Section 3.3.1.1. A slightly different rotation sign convention was used at Span 14 since the entire width of the bridge was instrumented. As seen in Figure 4-32, it is revised by defining the direction relative to the entire bridge, rather than just a single overhang. When looking toward Bent 14 (backstation), Girder 4 is located on the left and Girder 1 is on the right. Any twist that causes the girders to rotate counterclockwise is considered positive with this sign convention.

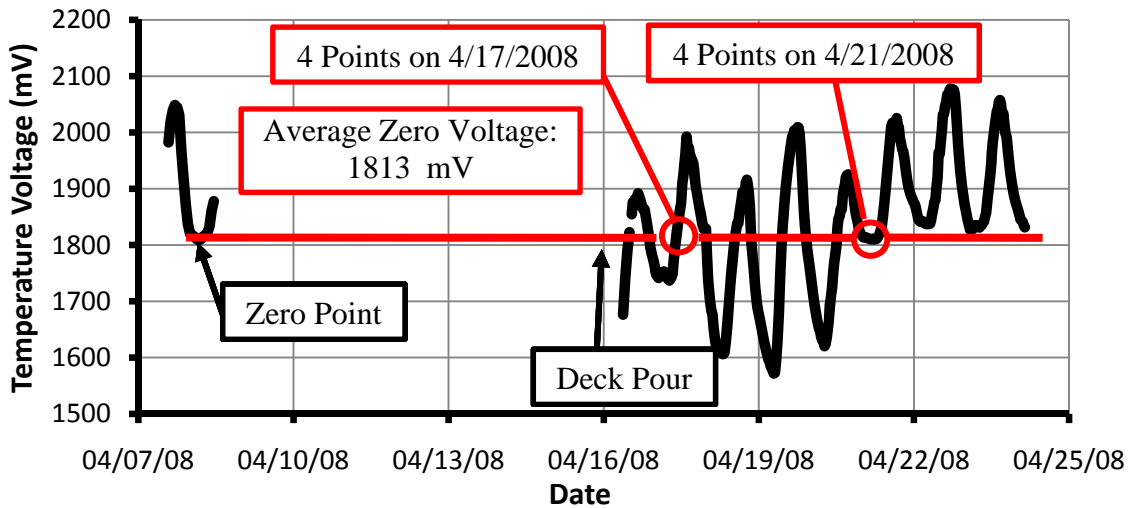
Figure 4-33 Example of TS-G1-1 Temperature Voltage at Span 14

Figure 4-33 shows the temperature voltage for TS-G1-1 from April 7, 2008, through April 24, 2008. In analyzing the data, only two mornings were found to be at adequate temperature voltages. In the graph, the mornings are highlighted by the bottom of each dip, at which the temperature is relatively constant. Typically, only data before the sun rises is used since thermal gradients can cause local and global twisting in the girders. On April 17, 2008, four data points were used between 9:00am and 10:30am. Though the sun had risen, the temperature did not change quickly during this time frame. Four days later on April 21, 2008, four data points were used between 12:00am and 1:30am. Looking at the other mornings, data with temperature voltages that matched the zero point could not be found.

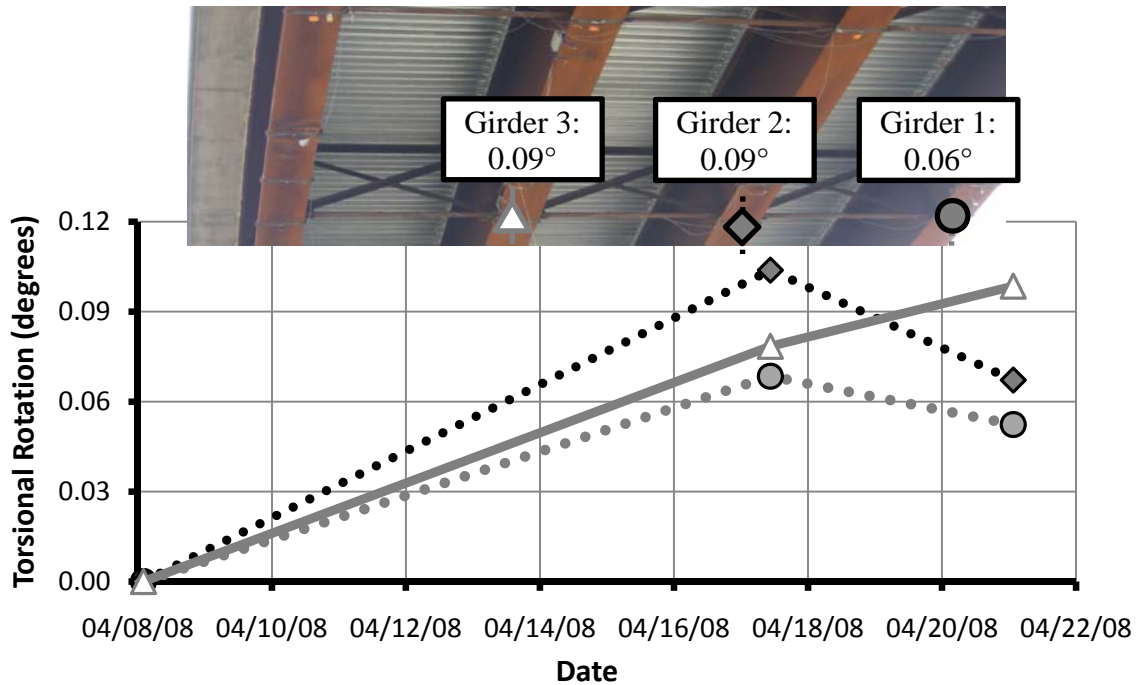
Figure 4-34 Change in Torsional Rotation After Deck Pour (Span 14, Location 1)

Figure 4-34 through Figure 4-37 show the variation of the tilt sensors with the two days chosen for comparison. Location 1 is positioned at the fourth bracing line from Bent 14 which marks the beginning of the fifth panel, while Locations 2 and 3 are located at the first quarter point and midspan of the fifth panel, respectively. Finally, Location 4 is at the end of the fifth panel, which corresponds to the fifth bracing line. At Location 1, the tilt sensor on Girder 4 (TS-G4-1) malfunctioned; thus, the data is not shown. However, all of the other tilt sensors are within 0.03° of each other, reinforcing the idea that the tilt sensors move together at a bracing line. As seen from Figure 4-34, the rotations vary from each day, yet always within an error of $\pm 0.03^\circ$. Thus, the rotations enclosed in the boxes were calculated by averaging the rotation on April 17, 2008, with the rotation on April 21, 2008.

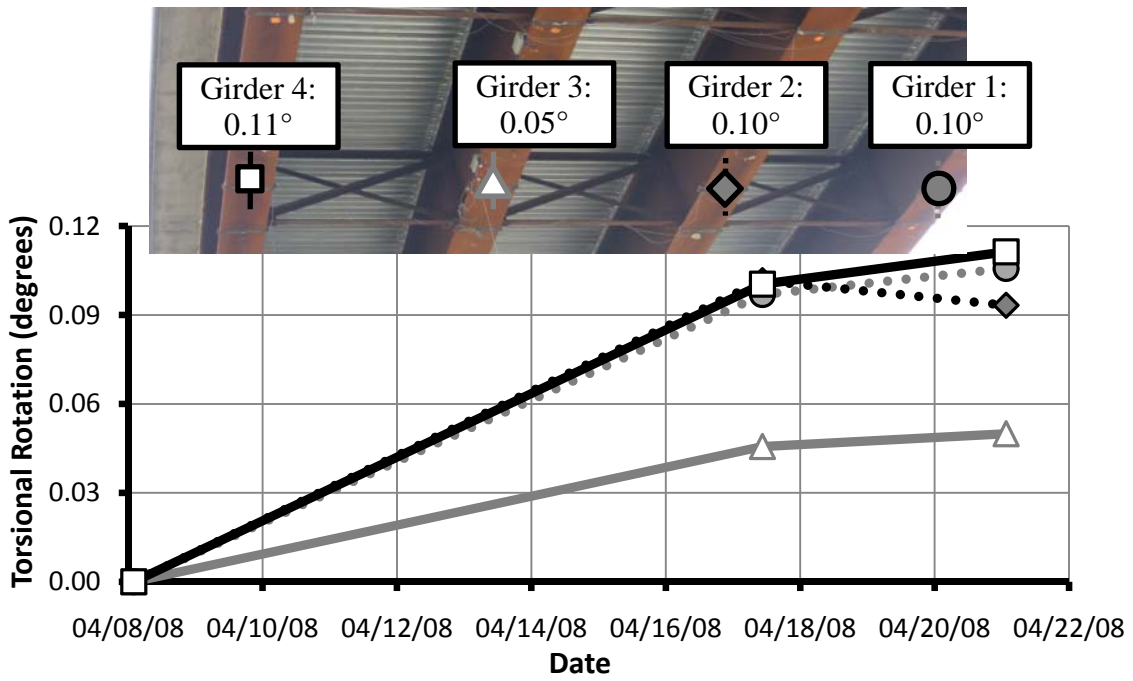
Figure 4-35 Change in Torsional Rotation After Deck Pour (Span 14, Location 2)

Between bracing lines, the rotations at Locations 2 and 3 are not expected to be uniform across the width of the bridge and are expected to be larger than the rotations at adjacent bracing lines. Figure 4-35 shows the rotations at Location 2, which, with the exception of Girder 3, are larger than the rotations at Location 1. Though it is possible that the tilt sensor at Girder 3 drifted, it is within 0.06° of the other locations.

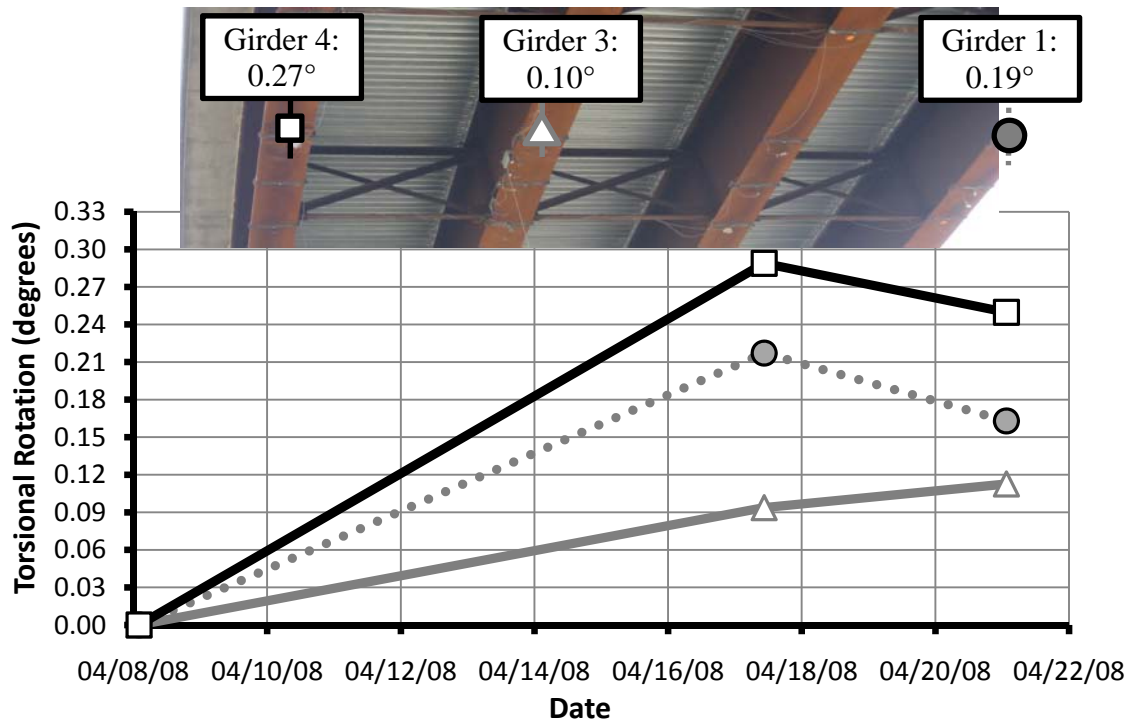
Figure 4-36 Change in Torsional Rotation After Deck Pour (Span 14, Location 3)

At Location 3, higher maximums were found at the exterior girders, Girders 1 and 4, while the tilt sensor at Girder 3 was near its rotation at Location 1 (Figure 4-36). The tilt sensor at Girder 2 was not reported, as it malfunctioned while on the bridge. Due to the geometry of the system, curved girders naturally want to twist. For locations of positive rotation, an overhang at Girder 4 will amplify the twist as the torsional load acts in the direction of twist. In contrast, Girder 1 should rotate less than Girder 4 at locations of positive rotation, as the overhang at Girder 1 counteracts the twist. In general, it is expected that a fascia girder will twist more than an interior girder due to the torsional load of the overhang.

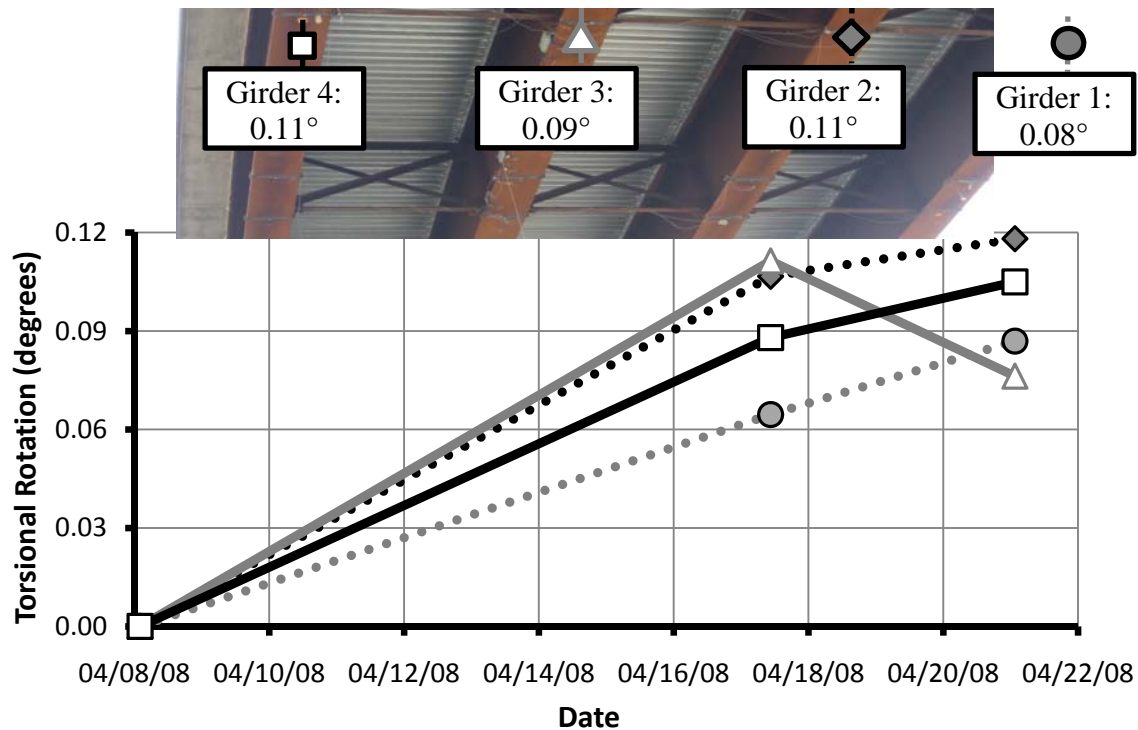
Figure 4-37 Change in Torsional Rotation After Deck Pour (Span 14, Location 4)

The final instrumented location was positioned at the fifth bracing line. The presence of the cross frames should cause the rotations to be fairly uniform across the width. After averaging the data from the two days (April 17 and April 21, 2008), it can be seen from Figure 4-37 that all of the sensors are within an error of $\pm 0.03^\circ$ of each other. Thus, the girders behaved as expected.

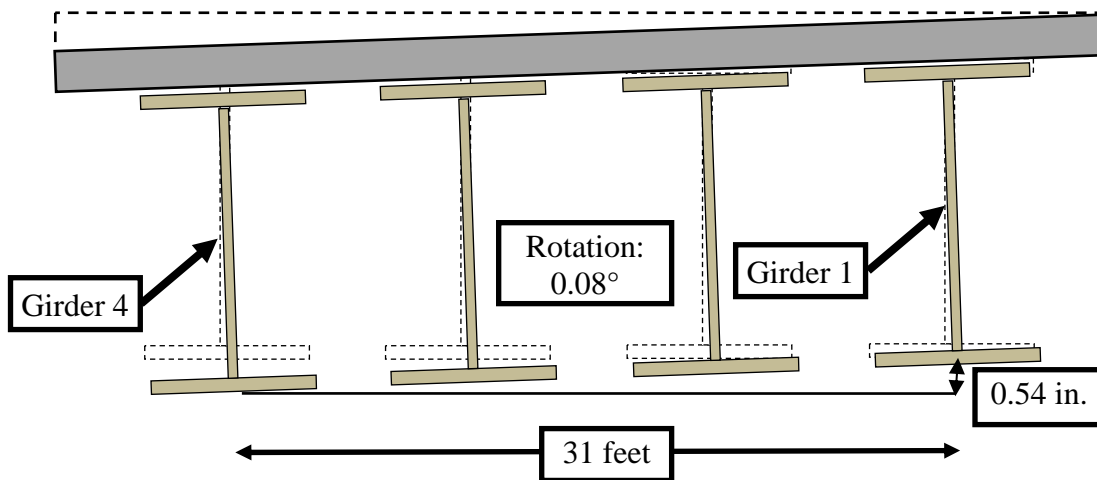
Figure 4-38 Summary of Measurements After Deck Pour

Due to the uncertainty of the zero point for the tilt sensors, it is beneficial to determine the validity of the readings. To help in validating future computer models, deflections were measured at ten locations along Span 14. In particular, deflection measurements were determined at the fifth bracing line, which corresponded to Location 4 of the tilt sensors. As seen at the 19th Street Bridge, the rotation at a bracing line is nearly the same for all of the girders due to the presence of cross frames. Therefore, the relative deflection between girders can be used to estimate the twist of the bridge. Table 4-6 shows the deflection for all of the girders at bracing line 5 and the rotation for each relative to Girder 1. With the largest spacing between girders (31 feet) and relative

deflection (0.54 inches), the rotation (0.08°) at Girder 4 is likely the best estimate of the twist of the bridge (Figure 4-38). The error was determined by assuming a 1/16 inch resolution with each measurement. Since the error can occur at each end of the bridge, a maximum error of 1/8 inch is possible. It should be noted that the rotations are an estimate only, as this method does not taken into account any independent twisting of the girders. Comparing the rotation derived from the deflections with the values obtained with the tilt sensors at Location 4, varying from 0.08° to 0.11° , it can be seen that the rotations are very close. Thus, the deflection measurements confirm the procedure used to calculate the tilt sensor rotations.

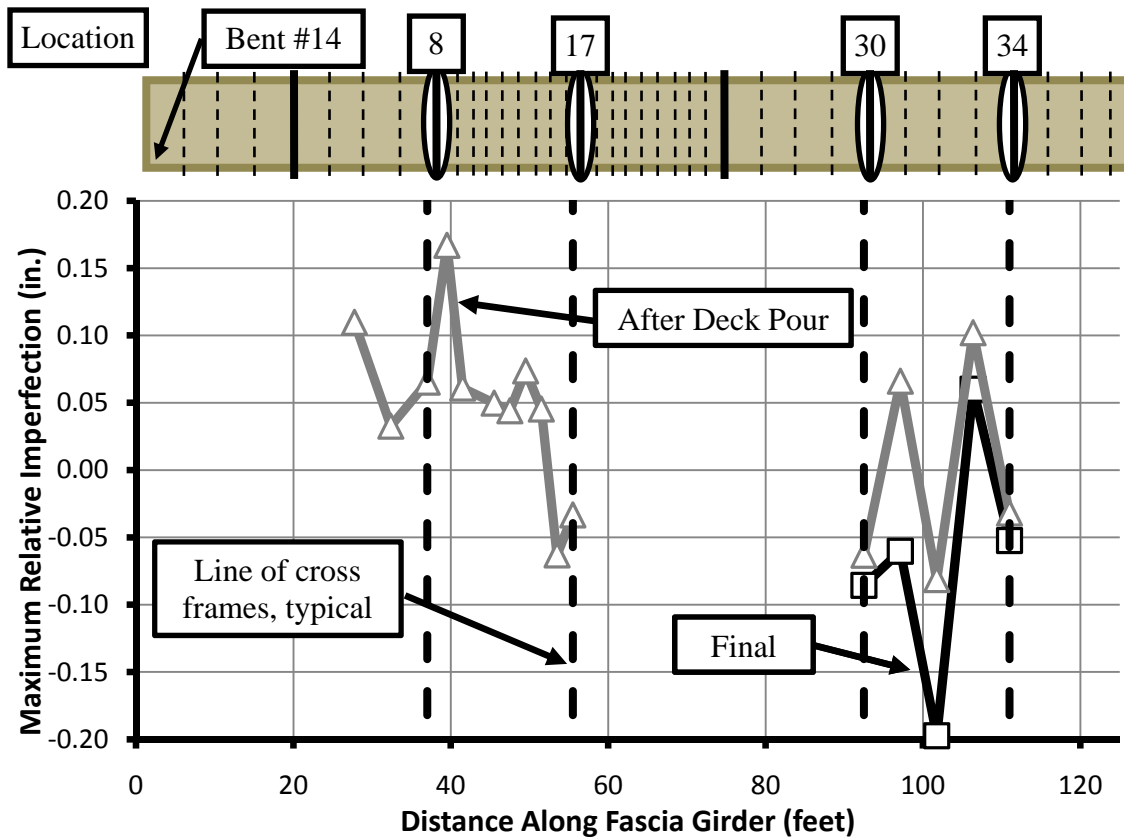
Figure 4-39 Maximum Relative Imperfection of Fascia Girder (Span 14)

Though the position of the overhang bracket was expected to have a larger impact, the range of relative imperfections is only slightly larger than the 19th Street Bridge deformations. As seen from Figure 4-39, the imperfections at the fascia girder vary from 0.15 inches to -0.20 inches. As with the 19th Street Bridge, the figure above the graph is a legend of the girder, in which each line represents a web imperfection measurement location. Correcting for the depths of the girders, 0.15 inches (D/560) of imperfection at Span 14 is approximately equivalent to 0.10 inches (D/540) at 19th Street Bridge. Therefore, despite having worse-positioned brackets at Span 14, the positive imperfection at both sites was nearly the same. The overhang brackets at the 19th Street Bridge were heavy-duty brackets positioned at a more ideal location on the web (near the bottom flange), yet spaced further apart and delivering more force to the web. This higher force could have compensated for the better-positioned brackets, making the imperfections similar to Span 14. Yet, as discussed earlier, since the removal of the brackets did not cause a huge recovery, it is more likely that neither of these webs were critical sections for local web imperfection problems. In terms of the D/150 fabrication limit, four locations (Location 9 on Girder 4 and Locations 14, 15, and 31 on Girder 3) were found during the initial measurements to exceed the allowed 0.56 inches.

The same sign convention as used at the 19th Street Bridge was used at Span 14. As such, since the force from an overhang bracket is expected to cause the web to bend inward, inward movement is considered a positive imperfection. The D/150 fabrication limit allowed for Span 14 is 0.56 inches. In addition, this limit can be used as a benchmark to evaluate the significance of relative changes in the imperfections as a result of the overhang.

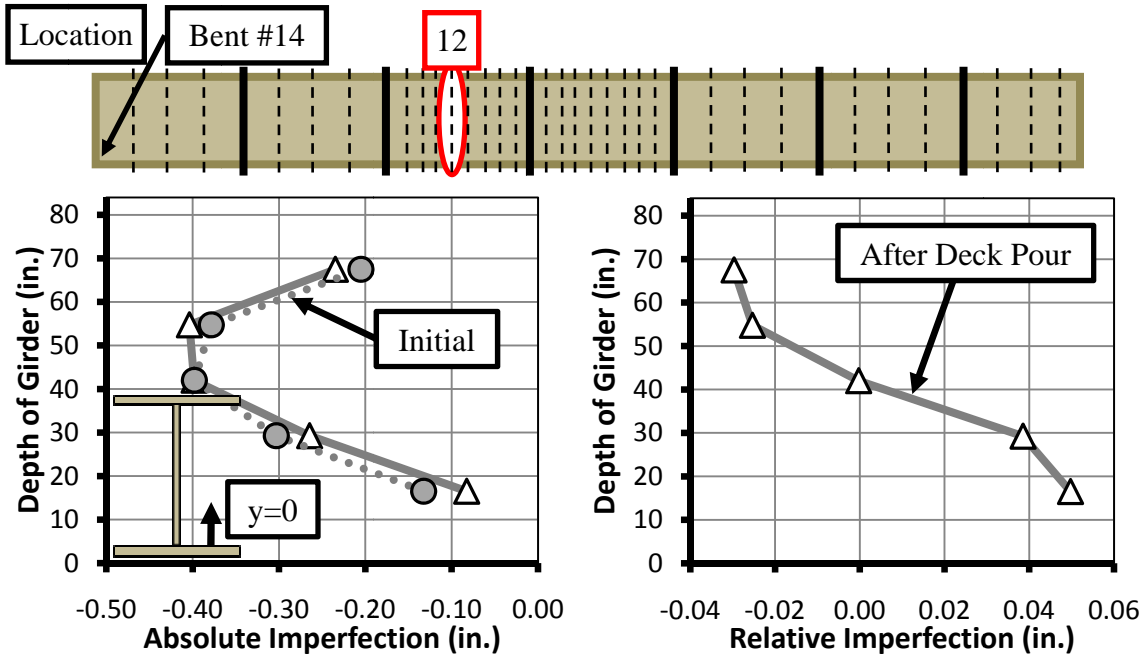
Figure 4-40 Imperfection of Fascia Girder at Location 12 (Span 14)

Figure 4-40 shows the imperfections due to the deck pour for Location 12 (fascia girder), which was located near the midpoint of Panel 3. From the absolute imperfection graph, the initial profile was a negative half-wave shape. The change in imperfection from the deck pour caused the web to bend in an S-shaped curve, with positive imperfection at the bottom and negative at the top. Since the overhang bracket was positioned near a height of 40 inches, the bracket seems to act as a brace point, causing

the web to bend around the bracket. Location 13 of the fascia girder had a very similar negative half-wave initial imperfection and behaved in the same manner, with an S-shaped curve change.

From the relative imperfection profile at Location 32, the data suggests that web imperfections could be affected by global effects as well. For instance, Location 12 (Figure 4-40) is near the midpoint of the Panel 3 and has a negative initial imperfection, like Location 32. Therefore, if the problem were only a local problem, both locations should have similar figures. Yet, there is a large difference between the relative imperfection graphs, as Location 32 does not have any positive relative imperfections. Locally, the locations have a very similar initial imperfection and relative panel position. Instead, the differences at these locations are of a global nature. For instance, Location 32 was more exposed to thermal changes due to its position along Span 14; Location 32 was oriented along more of an eastern plane than Location 12. An increase in temperature would cause Girder 4 to bend outward, causing higher negative imperfections at Location 32. The stresses at these two locations are also slightly different, which could have affected the imperfections. Finally, the position of the overhang brackets could have influenced the behavior if Location 12 was positioned at a bracket and Location 32 was positioned between adjacent brackets.

- The differences in profile shapes for Locations 12 and 32 along the fascia girder suggest that web imperfections could be affected by global effects in addition to the local effects of the overhang brackets.
- For the fascia girder, the initial profile gave an indication of the relative imperfection profile. In general, the deck pour caused an S-shaped relative change in imperfection profile for the locations measured.
- Where the initial shape at a location gave an indication of the changed shape for the fascia girder, the initial shape for the interior girder rarely followed a trend, which also suggests that imperfections are influenced by global properties, such as temperature and girder stress.

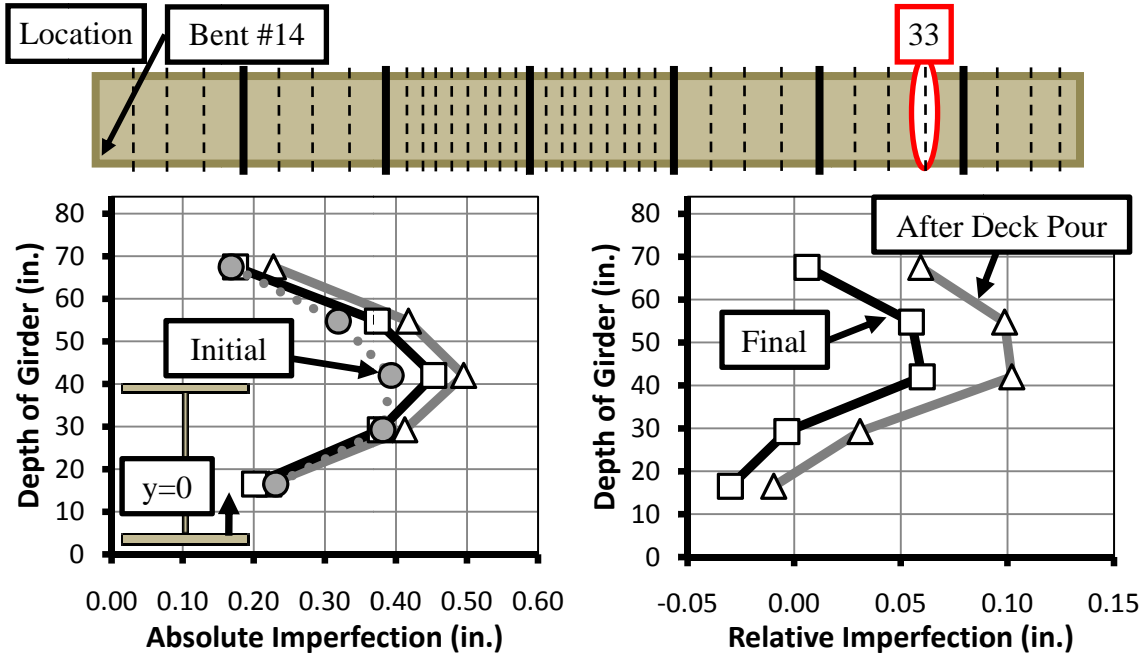
Figure 4-41 Imperfection of Fascia Girder at Location 33 (Span 14)

Ten of the sixteen locations at the fascia girder behaved similarly to Location 33 from initial imperfection profile to relative imperfection shape. Two other locations had a similar initial imperfection profile, yet the change in shape was different, most likely due to the presence of cross frames. As such, Location 33 is an important location because all three measurement phases were performed and it can summarize most of the trends. Figure 4-41 details the shapes of the imperfections in the web. As seen from the absolute imperfection graph, the web had a half-wave shape with positive imperfections. Yet, looking at the relative imperfection profiles, the change in imperfection at the top is positive and negative at the bottom, causing an S-shaped change. The overhang bracket was positioned approximately 40 inches from the bottom of the web, which is where the maximum relative imperfection occurs (0.10 inches). Thus, the overhang bracket appears to have an influence on the shape of the web imperfections at Location 33, causing the

web to move inward. Nonetheless, the relative imperfection is on the order of $D/840$, much smaller than the $D/150$ limit. It should also be noted that when the overhang bracket is removed, the web recovered by 0.04 inches, nearly one half of the original change in imperfection.

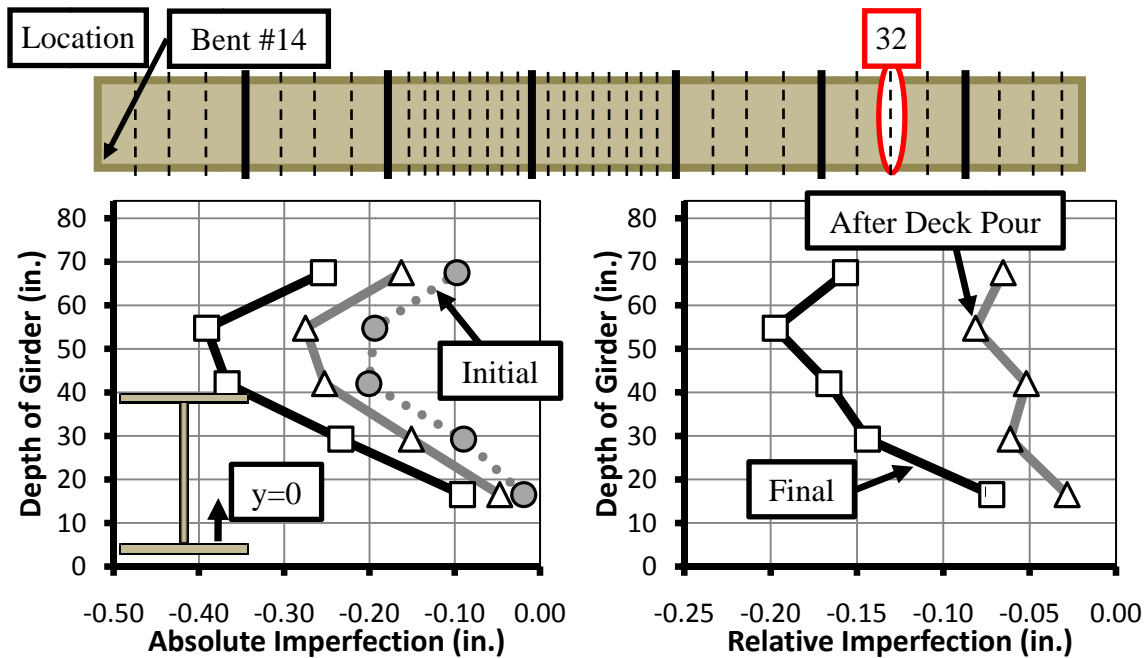
Figure 4-42 Imperfection of Fascia Girder at Location 32 (Span 14)

Figure 4-42 shows Location 32 of the fascia girder, which is an interesting location because the shapes are in the opposite direction as expected. As noticed, the absolute imperfection graphs had half-wave shapes, yet with a negative imperfection. Located in the middle of Panel 6, the impact of the overhang brackets was expected to be the largest since the effect of cross frames forces should be minimized. However, the relative imperfection profile is a negative single-wave shape, the opposite as expected.
