1. Report No. FHWA/TX-08/0-4586-2		2. Government Accession No.	3. Recipient's Catalog No.	
4. Title and Subtitle Field Testing of Cantilevered Traffic Signal Structures under Truck-Induced Gust Loads		5. Report Date March 2007, Revised November 2007

Field Testing of Cantilevered Traffic Signal Structures under Truck-Induced Gust Loads

CTR Technical Report:	0-4586-2
Report Date:	March 2007, Revised November 2007
Research Project:	0-4586
Research Project Title:	Revision of AASHTO Fatigue Design Loading for Signs, Luminaries, and Traffic Signal Structures for Use in Texas
Sponsoring Agency:	Texas Department of Transportation
Performing Agency:	Center for Transportation Research at The University of Texas at Austin

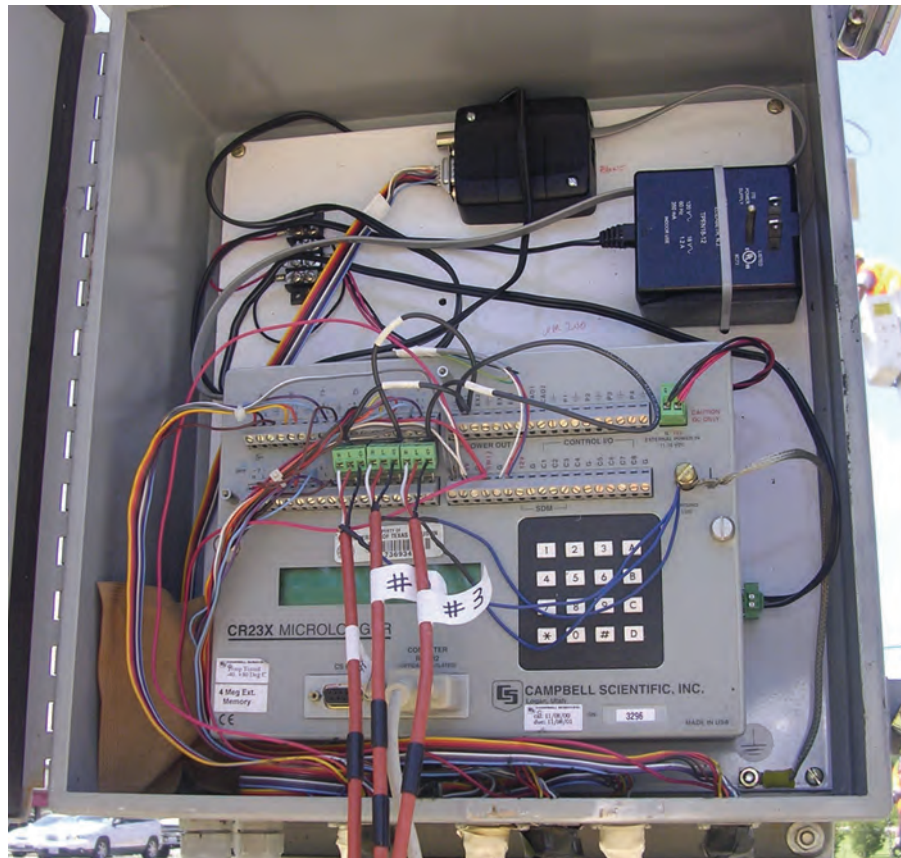
A Campbell Scientific CR23X Micrologger data acquisition unit was used to collect the short-term data in the field. This unit was selected because of its positive performance in earlier field tests for galloping of cantilevered traffic signal structures (Florea, 2005). The CR23X, shown in Figure 3.8, is a compact, self-contained datalogger that was easily attached to the traffic signal base. The unit was able to record up to twelve channels; however, at the field test site on RM 620 at Home Depot Blvd, only three channels were used, one for each of the strain gauges. At the field test site on US 290 at SH 95, nine channels were used—six for strain gauges and three for the anemometer (discussed in Section 3.2.4). To communicate with the CR23X datalogger, the Campbell Scientific PC208W software was used and the program used at the second site (US 290 at SH 95) is presented in Appendix E. The only difference between the programs used at the two sites was that at the site on RM 620 at Home Depot Blvd, the data from the three strain gauges was recorded every 0.04 seconds or at a sampling rate of 25 Hz, while at the site on US 290 at SH 95, the data was recorded from six strain gauges and the anemometer (wind speed in three directions) every 0.07 seconds or at a sampling rate of 14.286 Hz. At each site, these data sampling rates were the fastest that could be obtained across all the channels. During the field tests, it was powered by its own batteries and then recharged at night. The CR23X datalogger performed exceptionally well in the field.

Figure 3.8: CR23X Datalogger

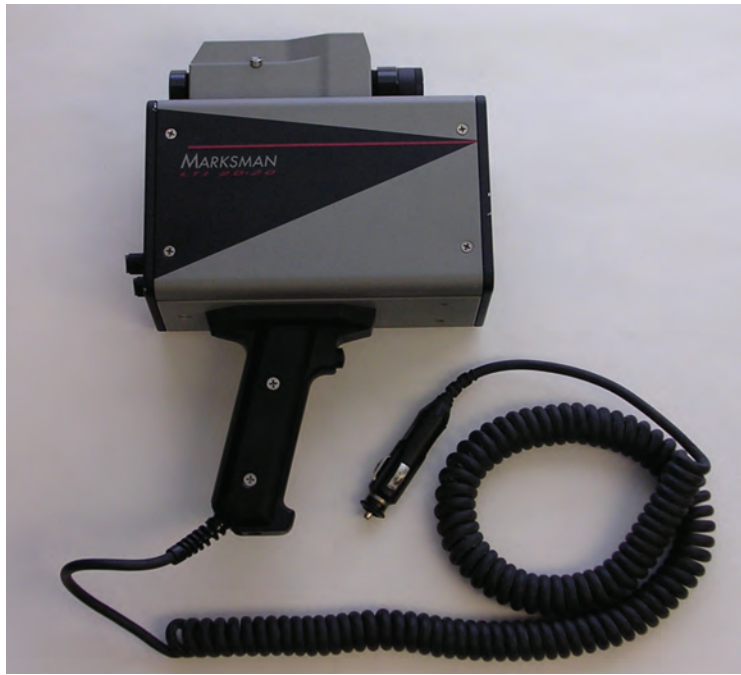
A Marksman model of the LTI 20-20 laser speed detection system from TxDOT, shown in Figure 3.9, was used to record the speed of trucks that passed beneath the instrumented structure. The Marksman model was different from the more conventional radar guns in that it uses a laser light beam instead of microwaves to detect the speed of a vehicle. This Marksman model was able to measure speeds up to 200 mph (89.41 m/s) from as far away as 2,500 ft (762 m). However, for this project, the speeds were recorded as close to the mast arm as possible in order to obtain the speed as the truck passed beneath the arm. The Marksman model was very easy to use and the only concern for future researchers is that it required a vehicle's cigarette lighter socket for power. A battery-powered radar gun would work just as well and would allow for a wider range of movement for the test personnel involved in recording the truck speeds.

Figure 3.9: Radar Gun

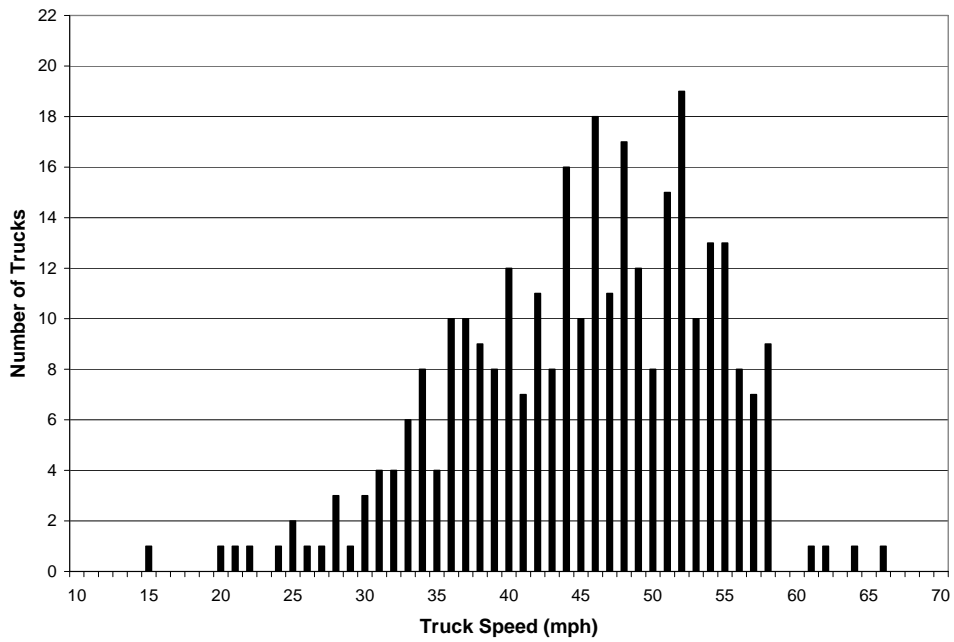
Figure 4.9: Histogram of Speeds for Trucks Traveling in Lane 1 Based on Data from Both Field Test Sites

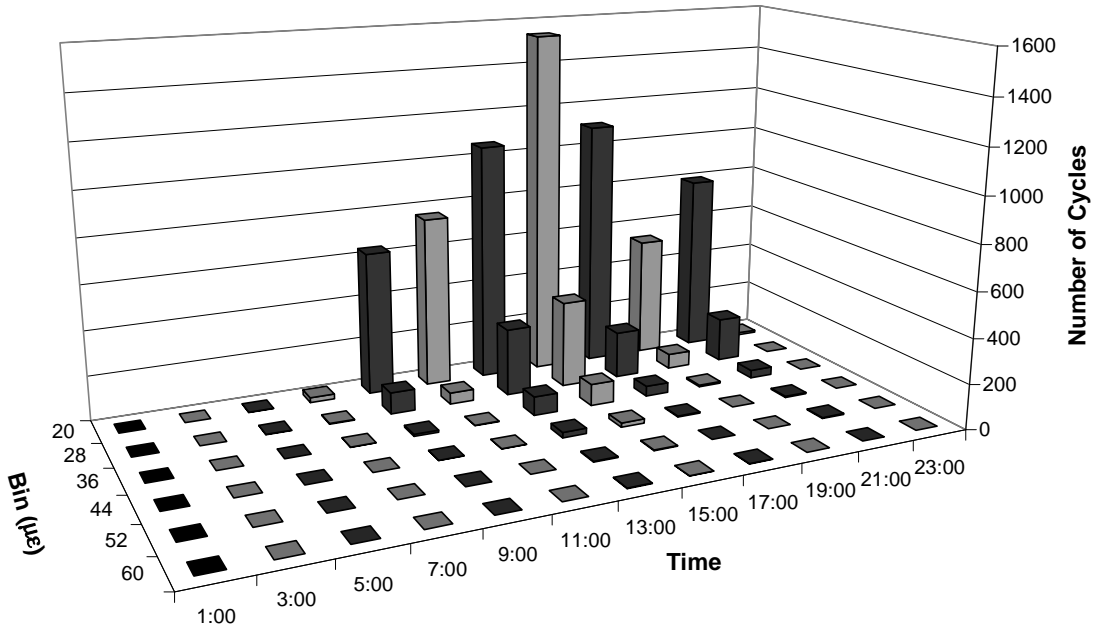
Figure 4.33: 3-D Rainflow Cycle Counts Histogram for March 15, 2006 at the Field Test Site on US 290 at SH 95

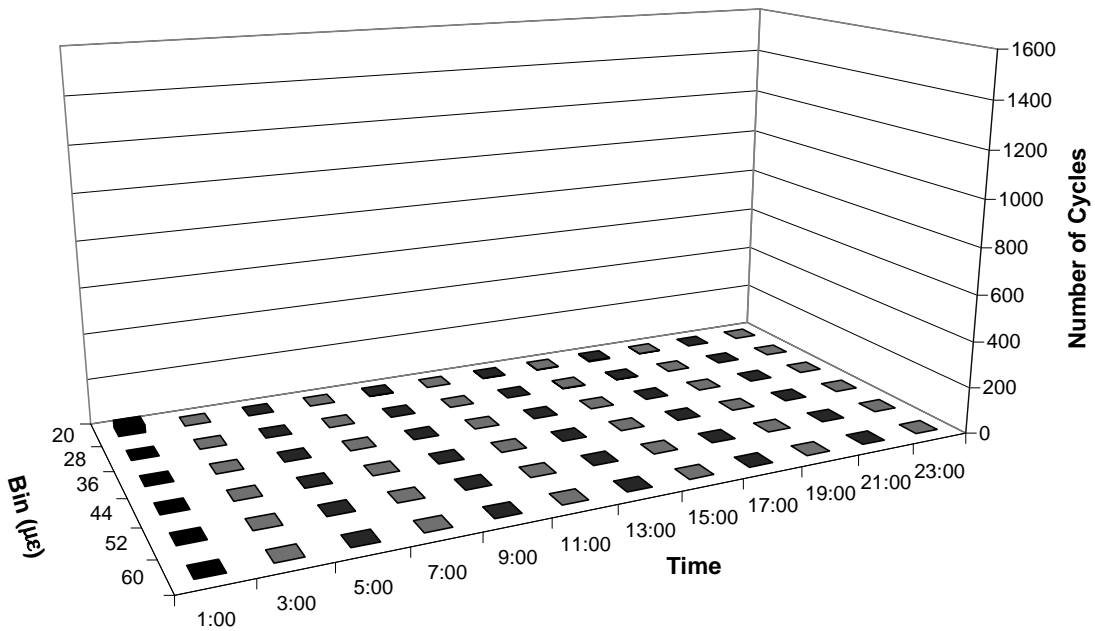
Figure 4.34: 3-D Rainflow Cycle Counts Histogram for March 16, 2006 at the Field Test Site on US 290 at SH 95
