**CESRL REPORT NO. 77-4
DECEMBER 1977**

**DESIGN AND CONSTRUCTION OF A
FLOOR-WALL REACTION SYSTEM**

**Report on a Research Project
Sponsored by
Research Applied to National Needs Division
The National Science Foundation
Grant ENV75-00192**

**DEPARTMENT OF CIVIL ENGINEERING / Structures Research Laboratory
THE UNIVERSITY OF TEXAS, AUSTIN, TEXAS**

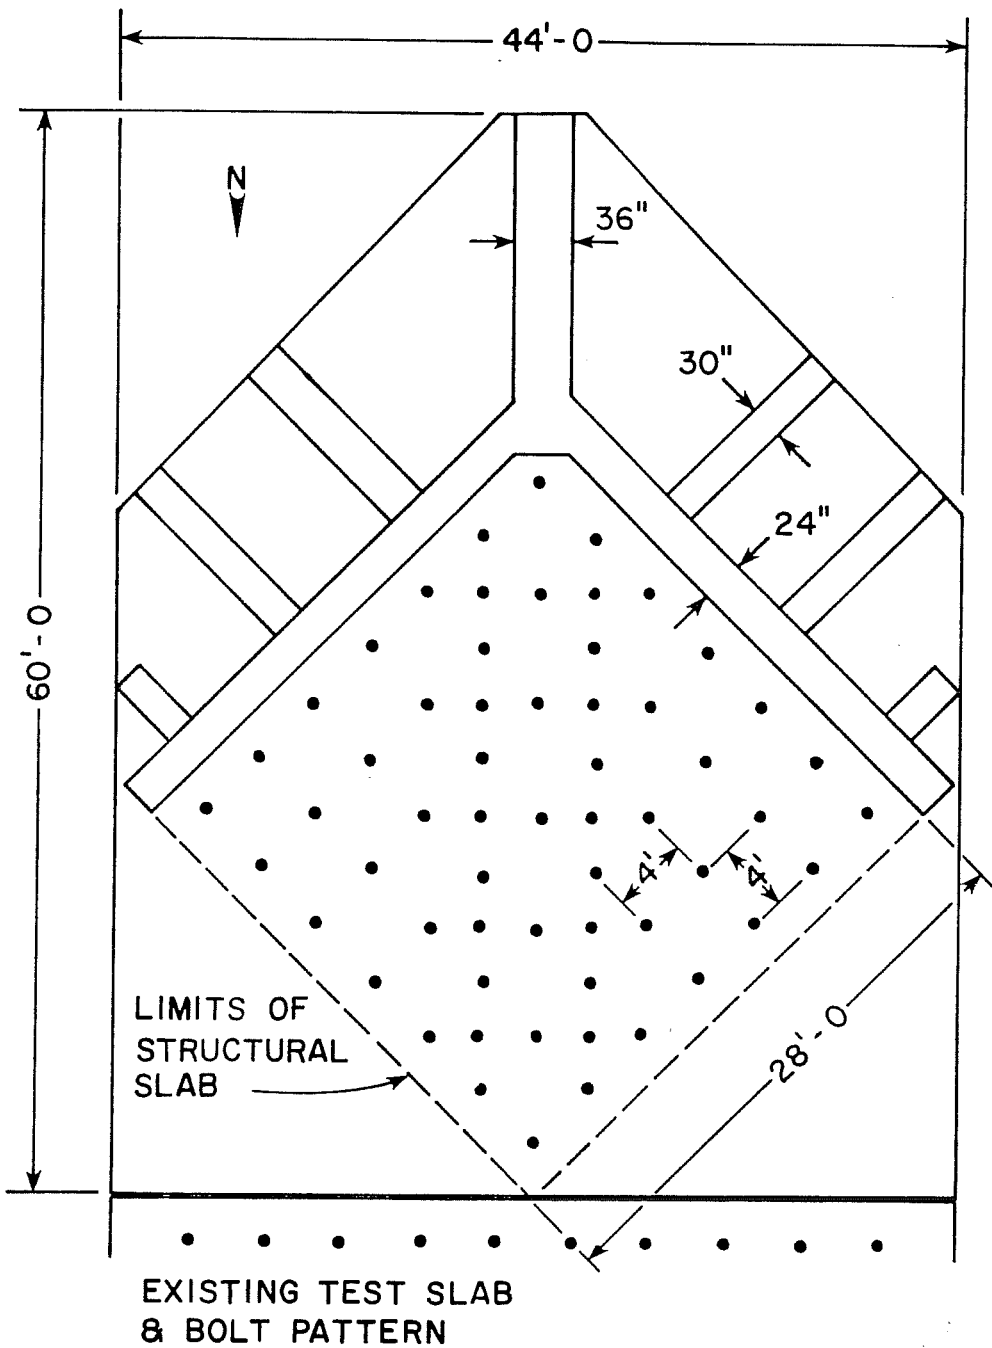
Fig. 2.1 Initially proposed configuration of Reaction Wall

Using the results of the economic study, a specific configuration for the Reaction Wall was proposed. As can be seen in Fig. 2.1, it had a biased strength axis with a very large buttress at the intersection of the walls. The main function of this buttress was to provide a way of testing uniaxially large shear walls using high loads. However, there were three drawbacks to this first configuration that prompted a reevaluation of the design. The first drawback was the varying load capacity along the wall because of the buttress layout. The second drawback was the inefficient use of the available floor area. A large part of the slab area could not be used to anchor test frame members, which limited the adaptability of the Reaction Wall to changing test requirements. The third drawback was that the floor bolt groups in the proposed slab could not be aligned with the floor bolt groups in the existing test slab. A new configuration was proposed which eliminated these drawbacks and embodied much of what was actually built.

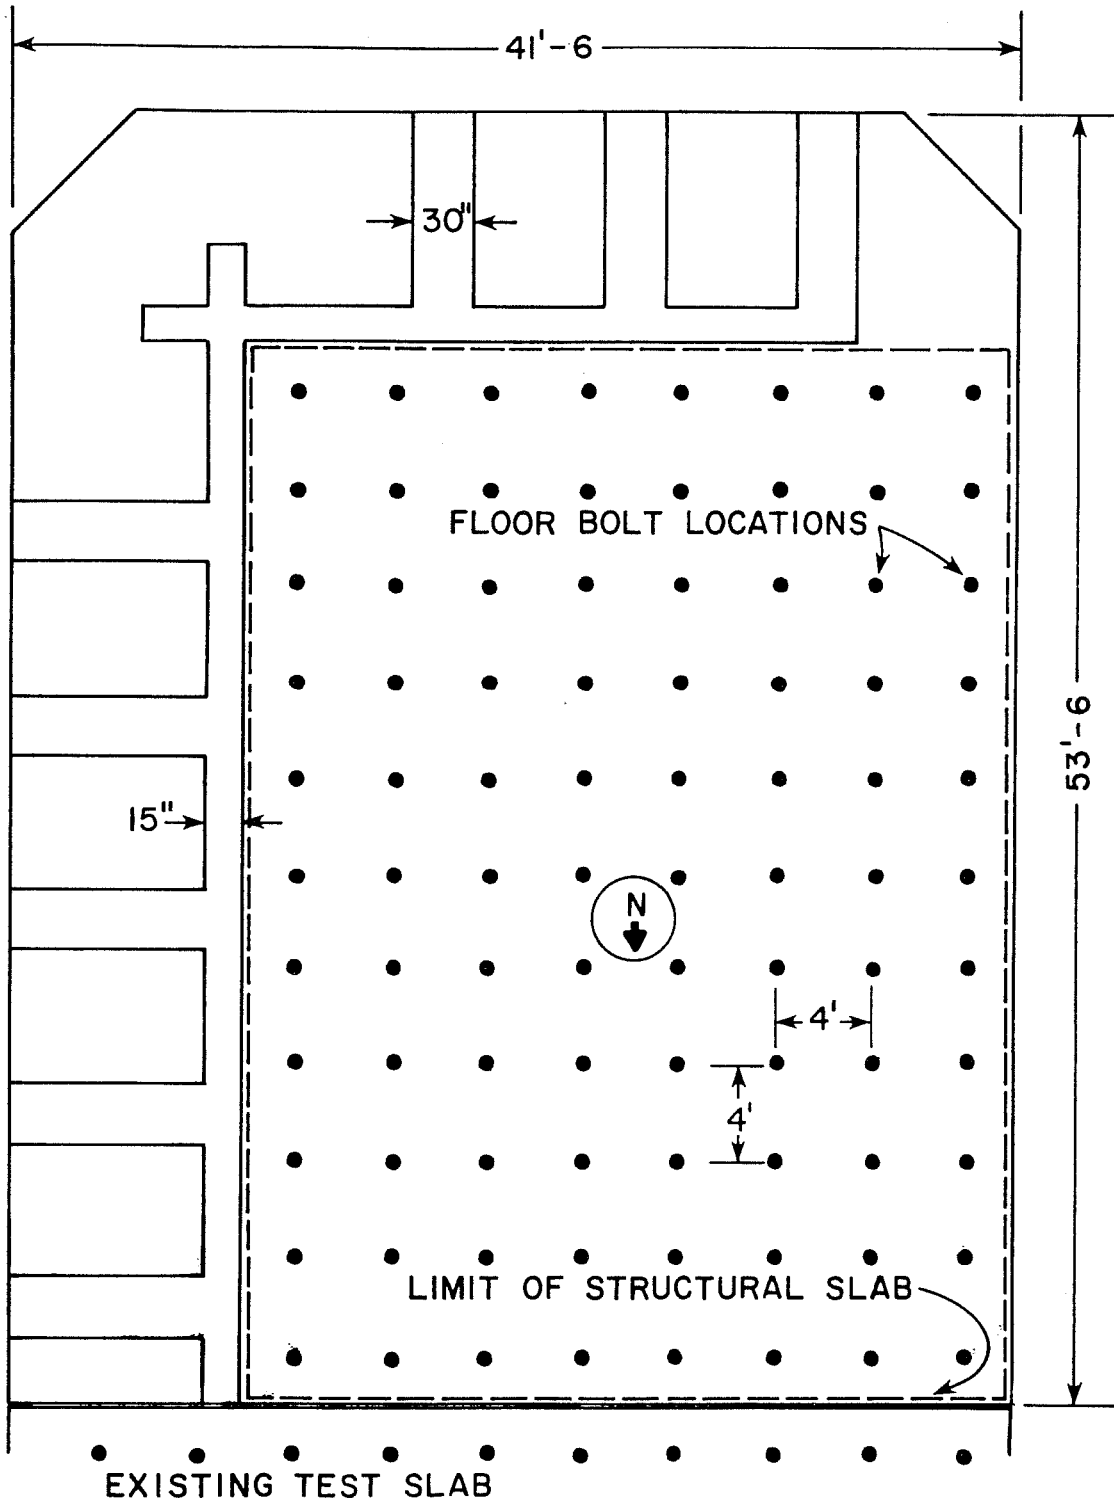
Fig. 2.2 Final proposed configuration of Reaction Wall

The new configuration (Fig. 2.2) made better use of the floor space by shifting the walls to a north-south east-west orientation and extending them the length of the slab. Also, the wall capacity was made uniform by having identical buttresses around the wall. A drop in the maximum uniaxial load capacity resulted from these changes, but it was not large enough to outweigh the advantage of uniform load capacity along the walls and more uniform construction details. The extension of the walls at their intersection eliminated the need for bending the reinforcement around the corner, a difficult and costly detail.

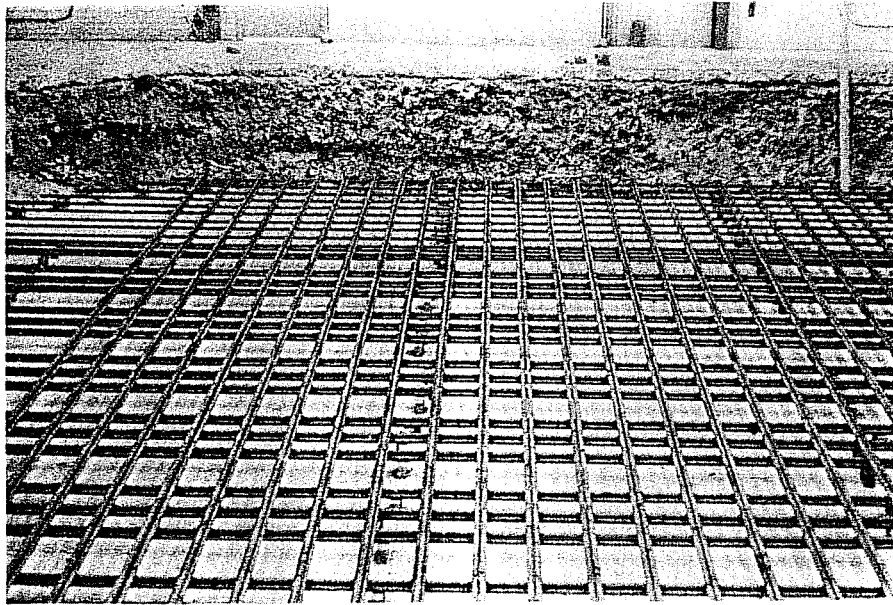
Fig. 3.1 Bottom layer of slab reinforcement

At both the top and bottom of the slab a layer of #11 bundled rebars was placed in each direction, as illustrated in Fig. 3.1.

Each layer had a bundle spaced every 12 in. This spacing provided sufficient clear space for concrete placement and ensured that the rebars did not interfere with the anchor bolt patterns in the floor slab, which were on 4 ft. centers. The spaces between groups of three bundles in Fig. 3.1 indicate the planned locations of the floor anchorage details.

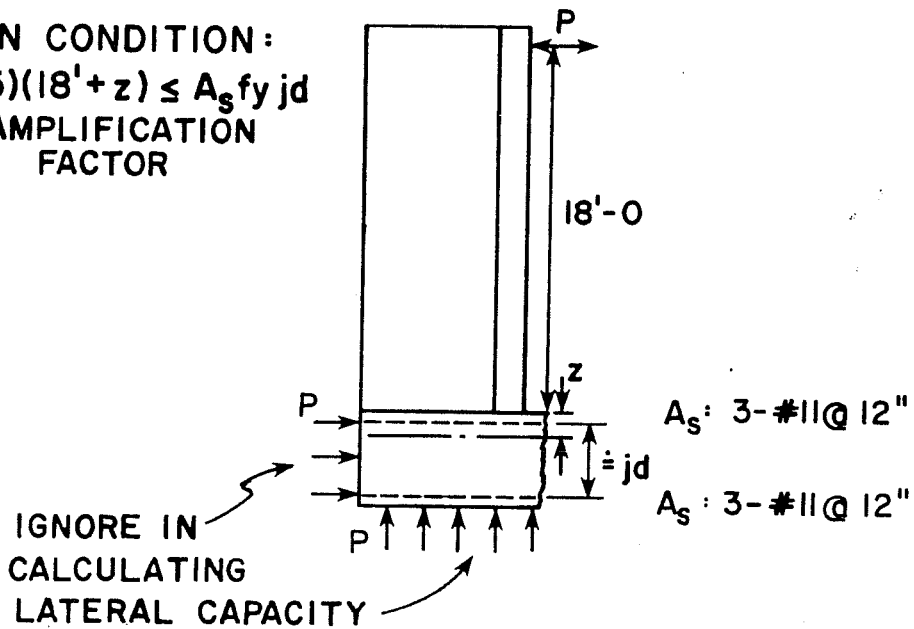
Fig. 3.3 Lateral load capacity determination

DESIGN CONDITION:
 $P(1.35)(18' + z) \leq A_s f_y j d$
 1.35 = AMPLIFICATION
 FACTOR

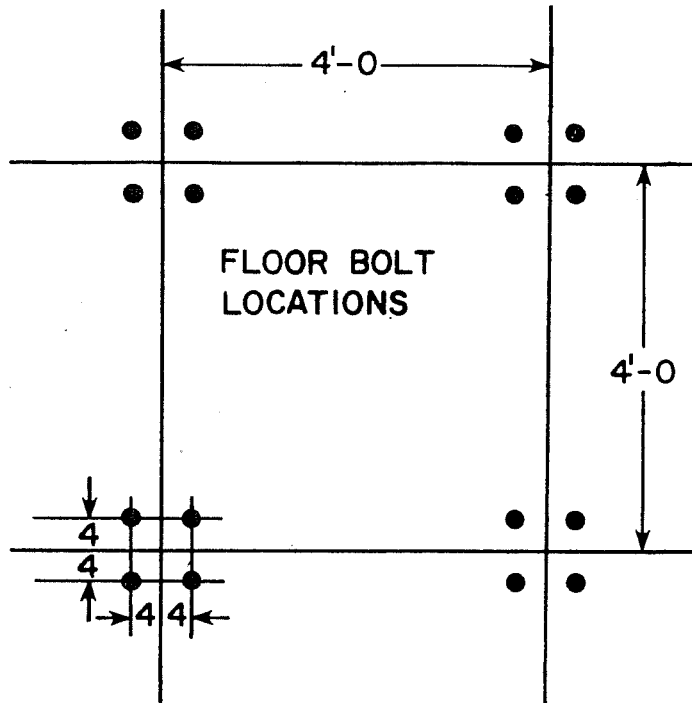
Fig. 3.4 Floor slab bolt pattern

The floor slab bolt pattern was a continuation of the pattern used in the existing test slab, since the two slabs were contiguous. The pattern shown in Fig. 3.4 consists of bolt groups on a 4 ft. grid with each group made up of four bolts on an 8 in. square pattern.

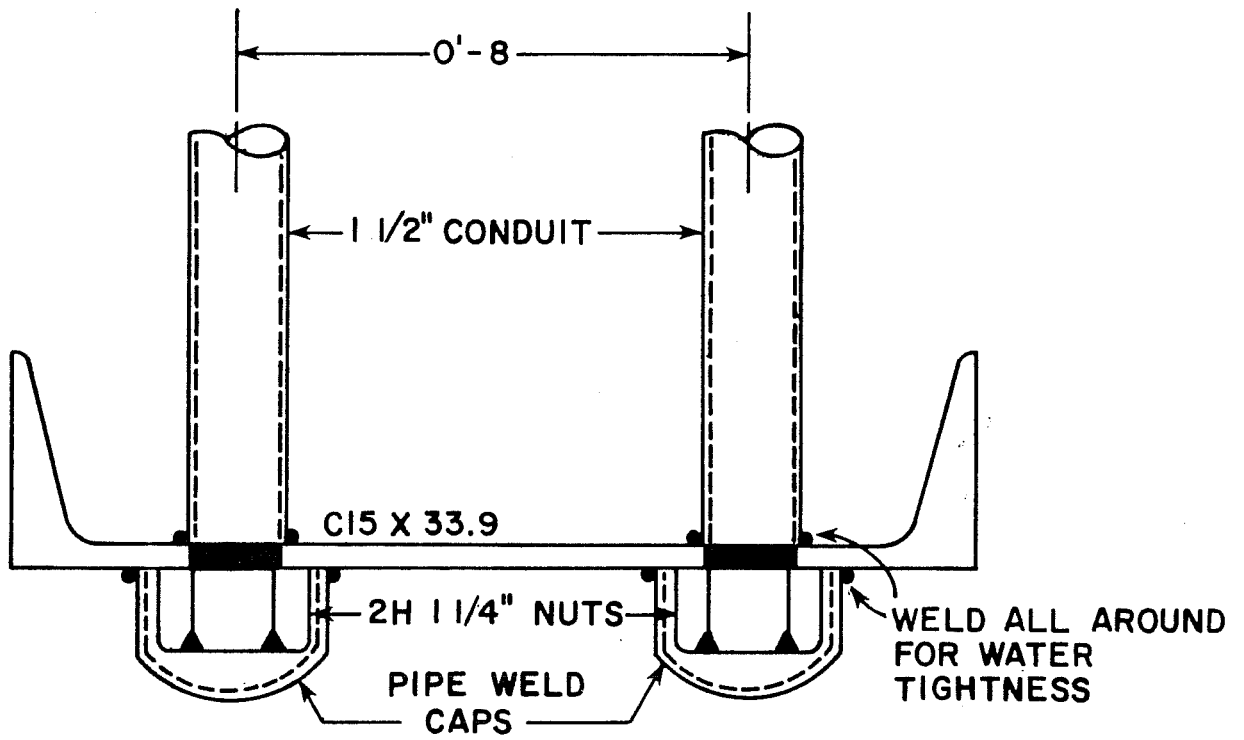
Fig. 3.5 Floor slab anchor bolt assembly

The detail at the channel is shown in Fig. 3.5. Each group was designed for a 200 kip load. A 1-1/4 in. diameter bolt was selected and 2H heavy hex nuts were welded to the underside of the channel. Metal caps and galvanized conduit were welded to the channels for watertightness to prevent cement paste from intruding and filling the void. A bolt with a yield strength of 60 ksi would provide around 50 kips tensile strength. The 2H nuts have greater strength and could be used with higher strength bolts to increase the anchorage capacity. The channels were 40 ft. long to extend the length of the floor slab in an east-west direction. The channel replaced every fourth bar bundle in the bottom layer of slab reinforcement in the east-west direction. To provide anchorage at the end under the wall and permit the channel to be fully developed as tension reinforcement, studs were welded to the channels.

The contractor elected to have a fabricator provide the entire anchorage assembly for placement in the floor slab. The fabricator drilled holes in the channels to form the pattern of a bolt group. On the underside of the channels, nuts were welded at each of the holes and a metal cap was then welded over the nut to seal it. Although the specifications did not require the nuts to be held tightly in place during welding, it would have been desirable to have done so because a check showed that some nuts became skewed during welding and would not permit the threaded anchor rods to

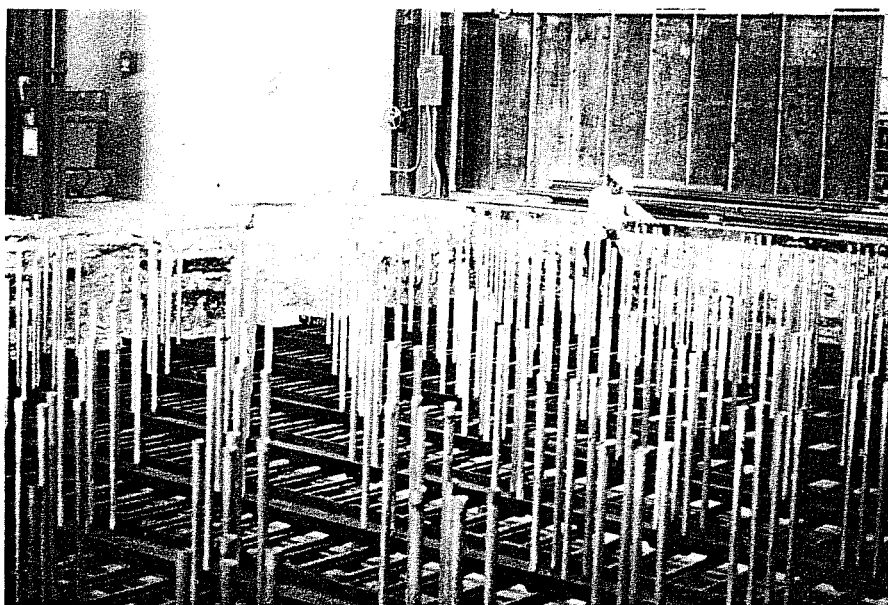
Fig. 3.6 Channel assemblies in place

engage the threads. These problems will be discussed in Chapter 4. On the top of each channel, conduit was welded at each hole location to provide the passageway through the floor slab for the threaded rods. At one end of each channel shear studs were attached to provide the necessary shear transfer capacity along the channels. These channels were placed at 4 ft. intervals in the bottom of the floor slab with the reinforcing steel thus forming the bolt groups at 4 ft. intervals. The channels are shown in place in the floor slab in Fig. 3.6.

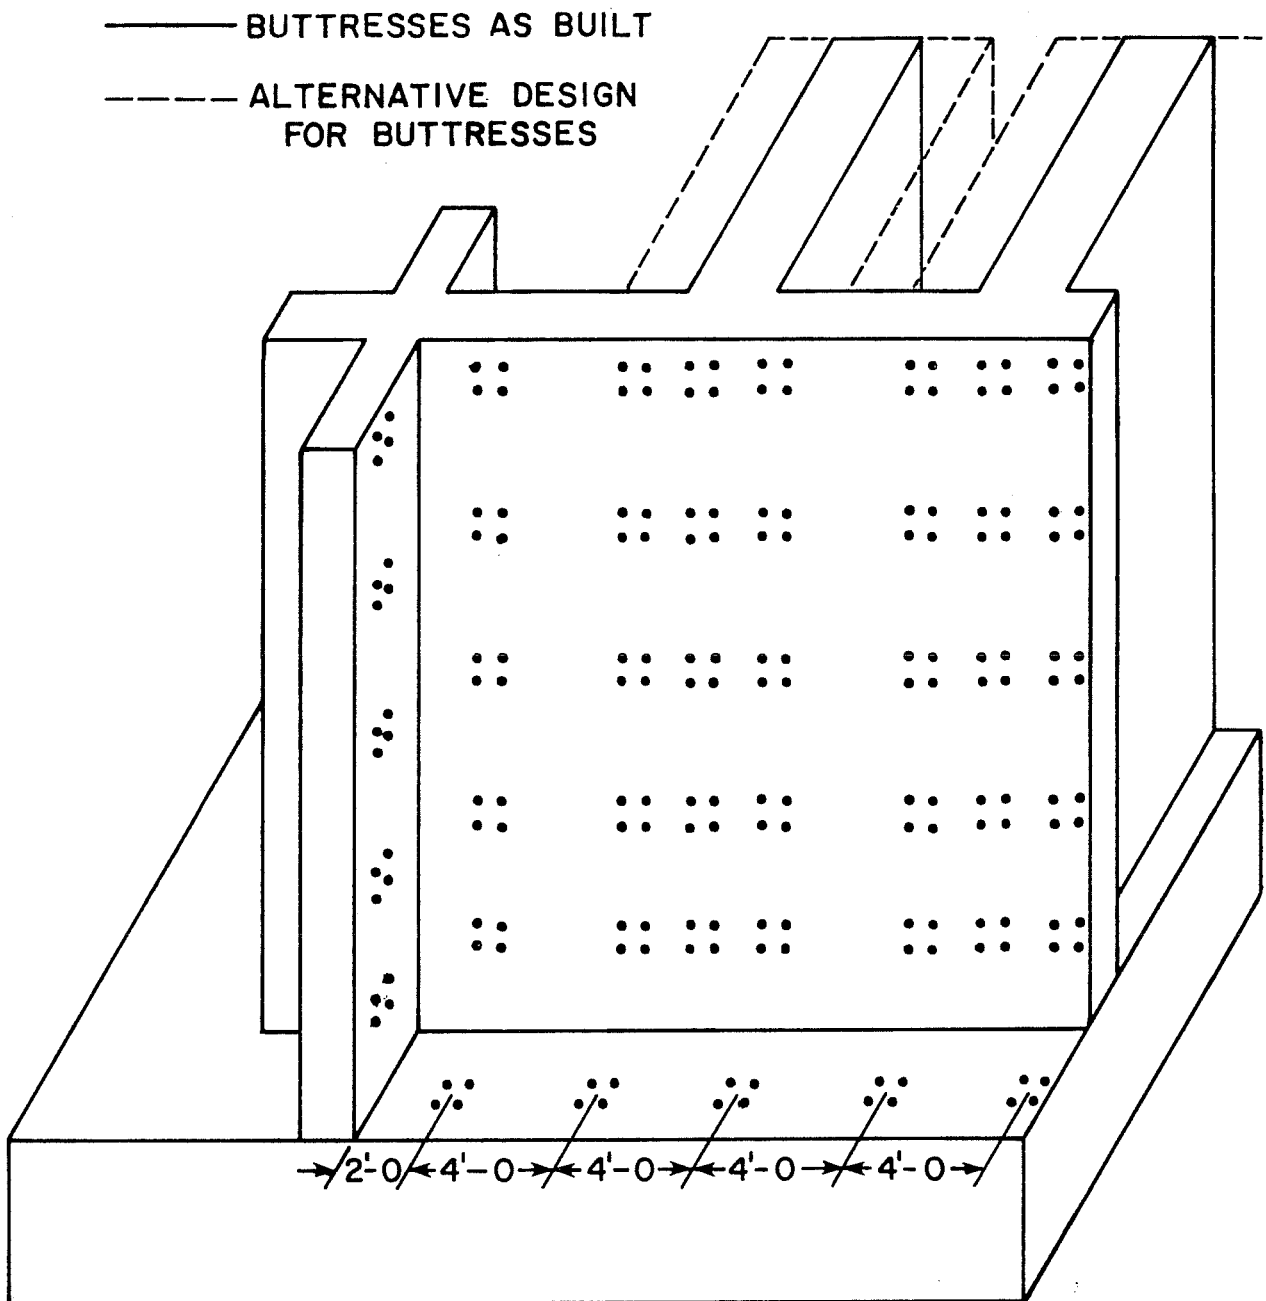
Fig. 3.7 Buttress width alternatives

The dimensions of the buttresses were set for reasons other than load capacity because there were preconditions which limited the options available to the designers. One precondition was that the wall bolt groups, holes in the walls to pass a bolt through, but not threaded in any way, were to be aligned with the floor slab bolt groups. This meant that there would be 4 ft. between bolt groups so that a buttress would either have to fit within the 4 ft. distance or extend far enough to encompass two wall bolt groups (see Fig. 3.7). It was quickly obvious that the less thick buttress combined with a medium thick wall was the most desirable choice. Therefore, the buttresses were dimensioned to fit within the 4 ft. spacing. Subtracting the required clearances for the wall bolt groups resulted in buttresses 30 in. wide. Next, the depth was selected through a very similar process of elimination.

Since the floor slab bolt spacing was 4 ft. between bolt groups, the buttress depths could only be changed in 4 ft. increments in order to add or delete rows of floor slab bolt groups efficiently. Using the available space, the buttresses could be 4 ft., 8 ft., 12 ft., and so on, but the 4 ft. depth was eliminated immediately as being unrealistically short and providing too small a lateral force capacity. It was also decided that anything larger than 8 ft. would reduce the available floor space too much. This left only one choice--8 ft.

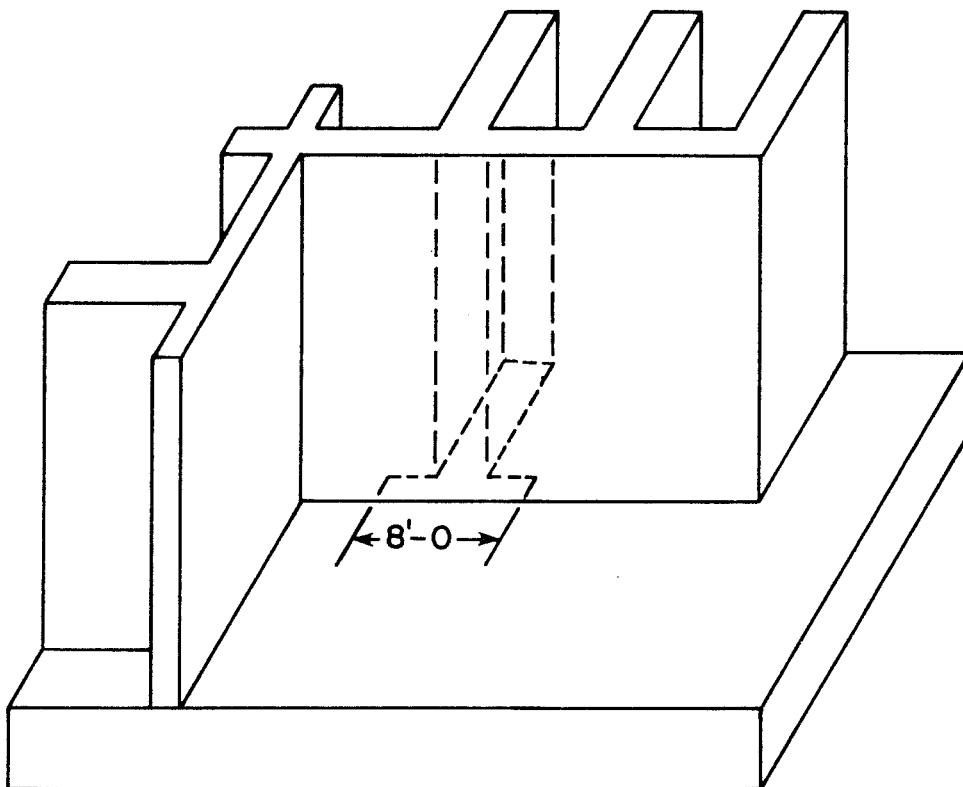
Fig. 3.8 Buttress design section

floor slab. The design lateral load was assumed to act at the top buttress load point and as it was the only load the shear would then be constant along the height of the buttress with a linearly varying moment diagram having its maximum value at the base of the buttress. To analyze the buttress, a tee-shaped section was selected at the base of the buttress, which included 4 ft. of wall on either side of the buttress centerline, splitting the distance between buttresses on either side. The section analyzed is illustrated in Fig. 3.8.

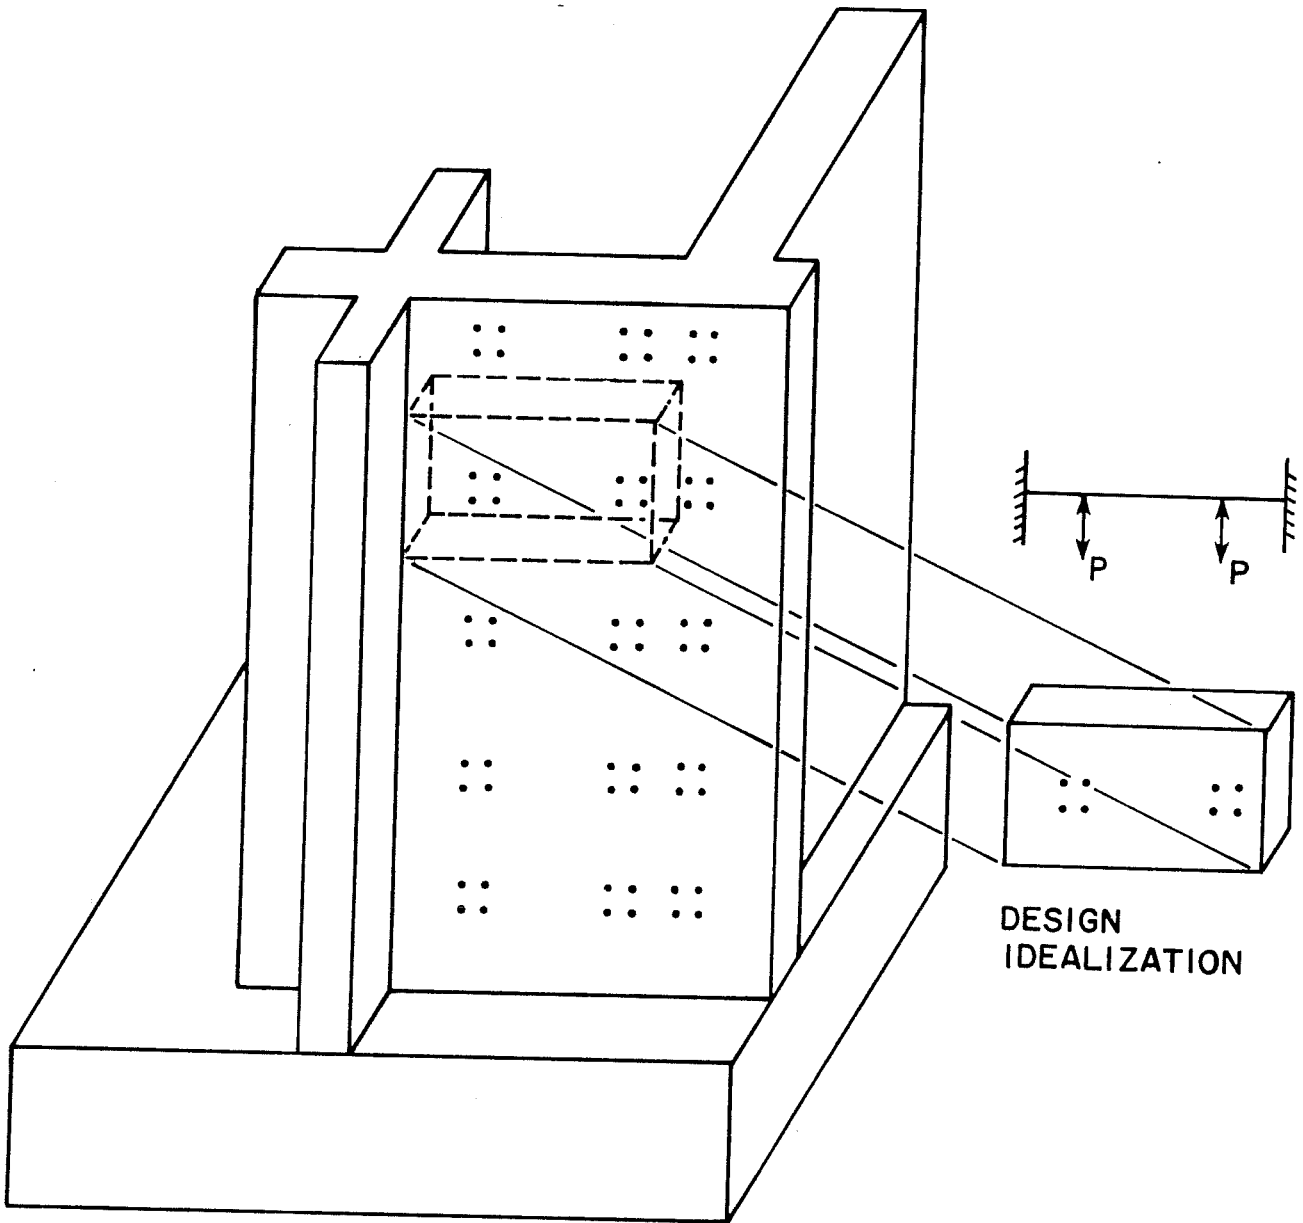
Fig. 3.9 Wall design section

The wall was analyzed in a simplistic manner by taking a strip of the wall between the intersection of the walls and an adjacent buttress and treating it as a beam fixed at each end. Design loads were applied at the wall load points. The strip had its centerline along a bolt group centerline and extended 2 ft. on either side of it to split the distance between bolt groups on either side (see Fig. 3.9). The ultimate shear capacity at the buttress wall intersection was deficient for a critical load case (Fig. 3.10) and rather than increase the post-tensioning force, bent bars were used at the intersection, which extended from the walls into the buttresses forming hangers, as shown in Fig. 3.11. A minimum amount of temperature and shrinkage reinforcement was provided vertically and horizontally (#5 bars at 12 in.) in the walls for serviceability and shear capacity.

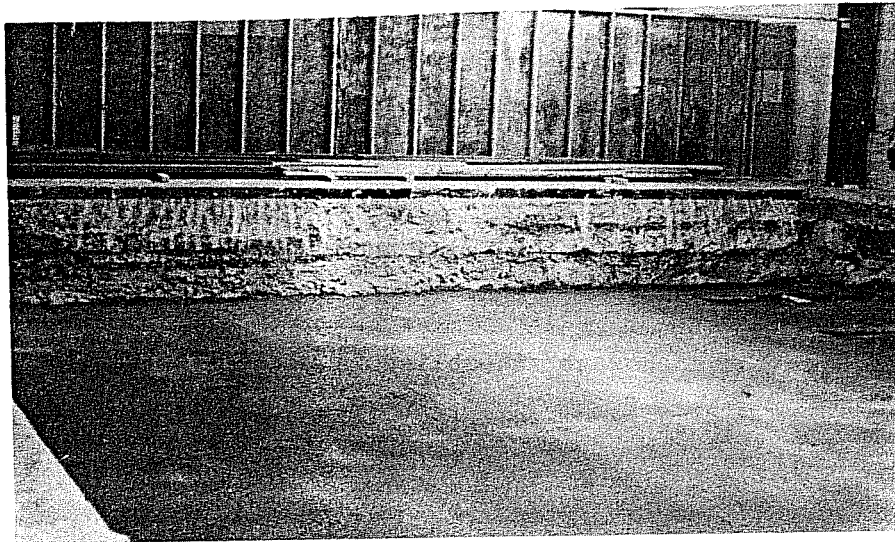
Fig. 4.1 Hardened mud slab

With the mud slab cast and hardened (Fig. 4.1), placement of the floor slab reinforcement began. For proper cover on the bottom layer (3 in.) brick chairs were used. To form the bundles of rebars, the contractor began "tack" welding rather than tying the bars together with wire. Welding was stopped as soon as it became known to the project staff, but not before thirteen bundles were tack welded (Fig. 4.2). The decision was made immediately to replace all welded bars. Although such a practice was not anticipated, it would have been desirable to expressly prohibit any welding of bars during fabrication.

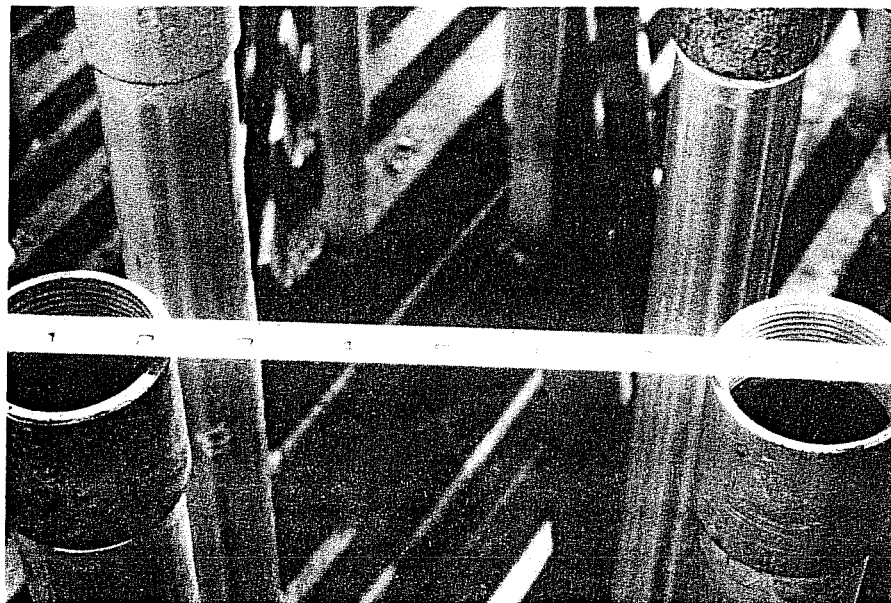
Fig. 4.3 Conduit misalignment

discovered that the conduits were not always properly aligned at right angles with the channel to form the 8 in. square pattern at their free ends (Fig. 4.3). In order to correct the problems, the assemblies were returned to the fabricator to be thoroughly inspected and repaired. In most cases the problem could be alleviated by running a tap into the threads and cleaning the nuts. In some cases the nuts were skewed during welding and had to be replaced. Conduit misalignment was not corrected because the contractor felt he could provide proper dimensional tolerances prior to casting.

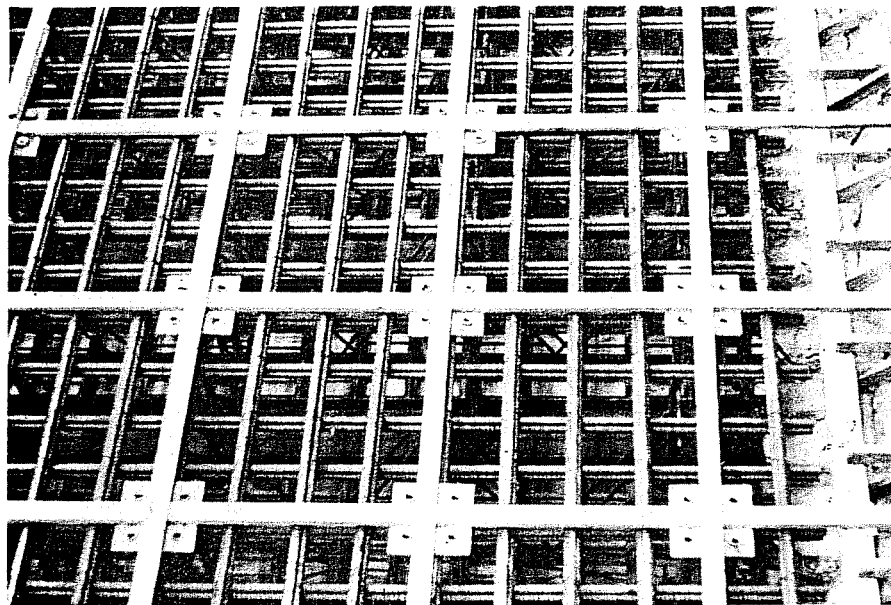
Fig. 4.4 Conduit alignment framework

To ensure the 8 in. pattern, a square wooden template drilled with holes to go over the conduits was used to position the conduits. With the square templates in place, lengths of 2x4 boards were nailed to position the groups at 4 ft. centers and to prevent the group from rotating. As shown in Fig. 4.4, the result was a large framework designed to keep everything in its proper place.

The framework could not be kept in place during the entire casting of the floor slab, since the templates were below the floor slab surface. This meant that in order for the conduits to remain in their correct positions the concrete that was placed prior to

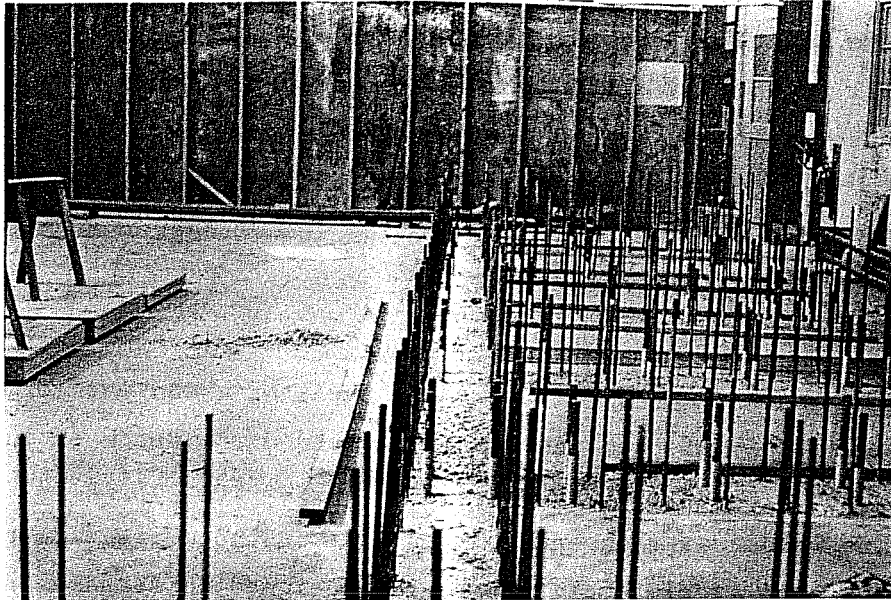
Fig. 4.5 Dowels in slab

The buttresses were formed after the floor slab had hardened, but provisions had been made during construction of the floor slab to provide continuity between the buttresses and the floor slab. Dowels were cast in the floor slab to provide anchorage for the vertical supplemental steel in the buttresses and lengths of thread-bars were also cast into the floor slab (see Fig. 4.5).

extended above the slab so that a second threadbar in the buttress could be spliced to it. Threadbar extensions can be seen in Fig. 4.5 with the sheathing about a foot below the end of the threadbar. The "A" bell anchor was a circular band of steel which had a nut welded at its center (see Fig. 4.7). The circular band provided confinement to the concrete against which the nut was bearing. The threadbar was screwed into the nut to provide load transfer from the threadbar to the concrete.

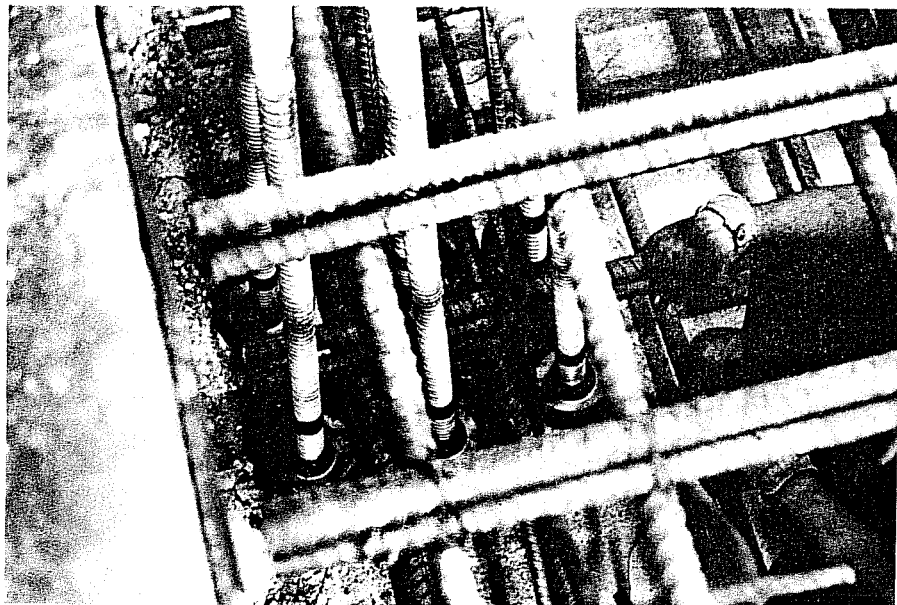
Fig. 4.6 "A" bell anchors in place

The threadbar, surrounded by sheathing, was anchored at the bottom of the floor slab by "A" bell anchors (Fig. 4.6) and

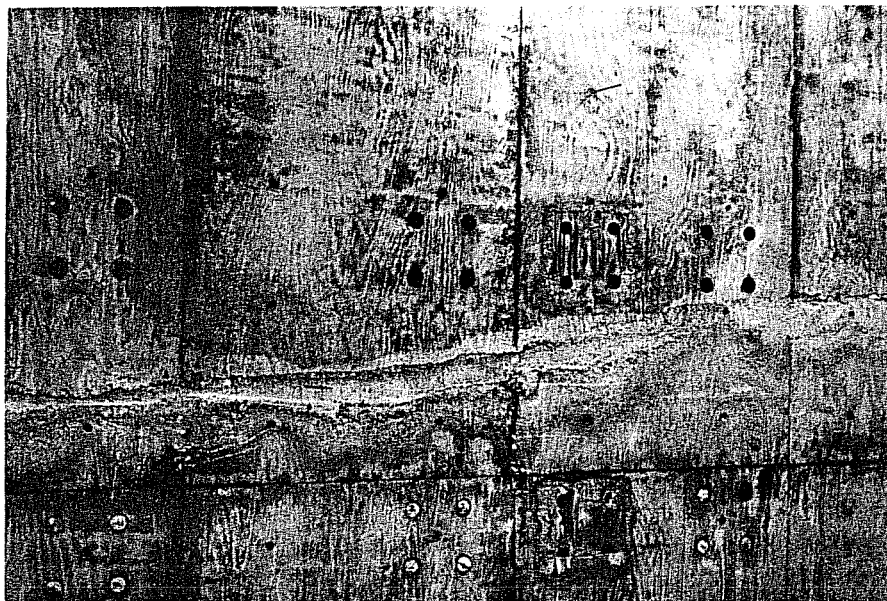
Fig. 4.10 Wall cold joint

buttresses or walls the resulting delay allowed a cold joint to form, as shown in Fig. 4.10. After removal of the forms from the first lift, some superficial honeycombing was found (Fig. 4.11), but it was quickly repaired using a sand and cement mix. The second lift went smoothly with no problems during or after the pumping.

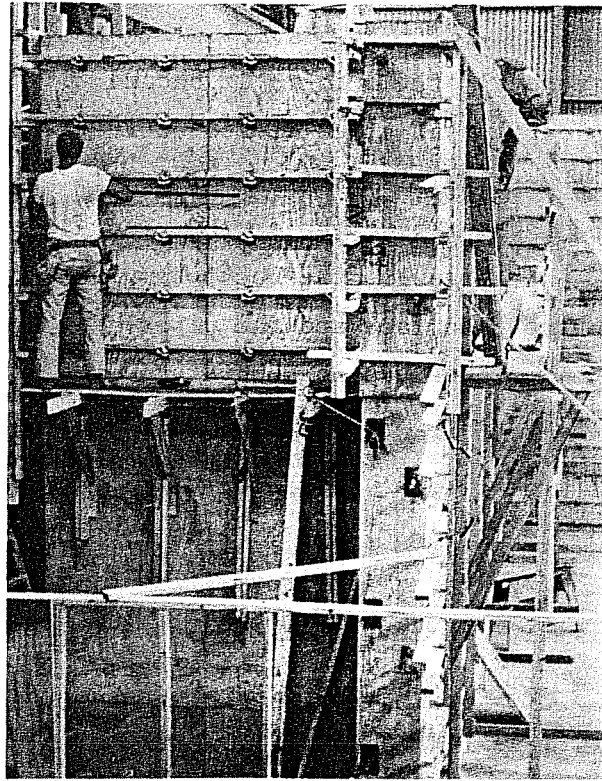
Fig. 4.14 Second stage formwork

After the first stage had been cast and sufficiently cured, the forms from behind the walls and around the buttresses were removed and moved upwards to the second stage (Fig. 4.14).

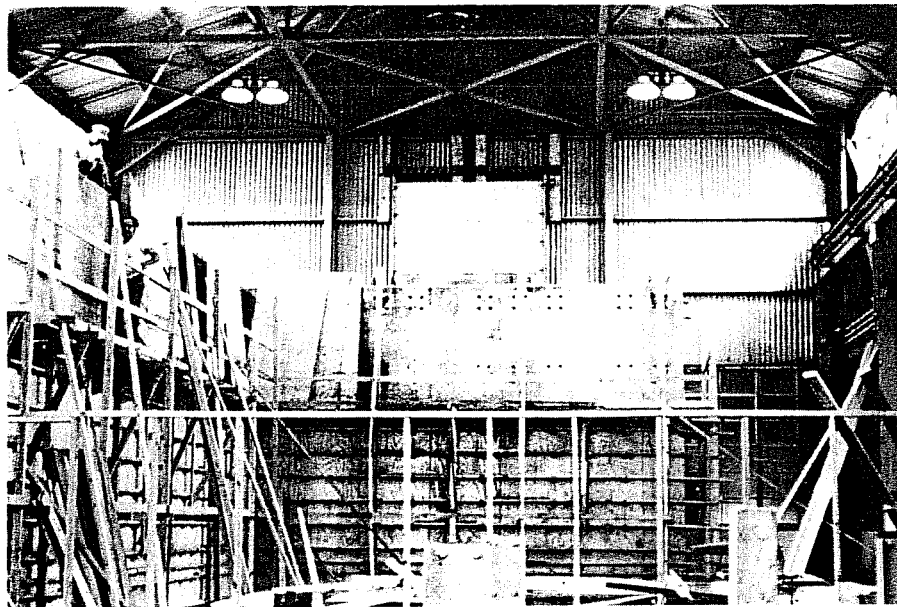
Fig. 4.15 Removing formwork

It should be noted again that the forms on the working surface, front face, of the walls were not moved or removed until the entire wall had been cast and cured (Fig. 4.15).

With the removal of the forms it became apparent that the formwork had only partly satisfied its objective. The working surfaces of the walls were fairly free from irregularities, but the forms had expanded under the weight of the concrete and vibration during placement. As a result, the buttress pipe templates were not flush with the concrete surface and the pipes had varying amounts of concrete in them. There was no concrete in the wall pipes; the plugs had effectively sealed the ends.

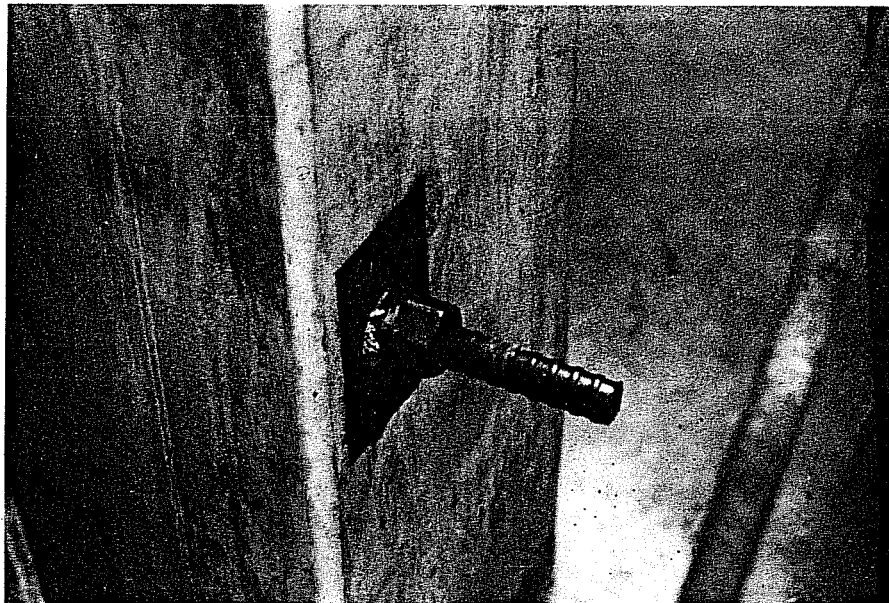
Fig. 4.17 Anchor assembly on wall

tensioning of the threadbars which were both irritating and time-consuming to fix. During tensioning the plastic ring would be drawn up into the plate and prevent the anchor nut from seating properly. Consequently, the plastic ring had to be dug out from the plate hole repeatedly for the same threadbar until enough of the ring had been removed to allow the anchor nut to seat properly. This meant that the threadbar might have to be tensioned and completely released several times before the problem was corrected. The plate was placed so that it fit flush with the concrete, as can be seen in Fig. 4.17, where a plate and nut on a wall threadbar is shown.

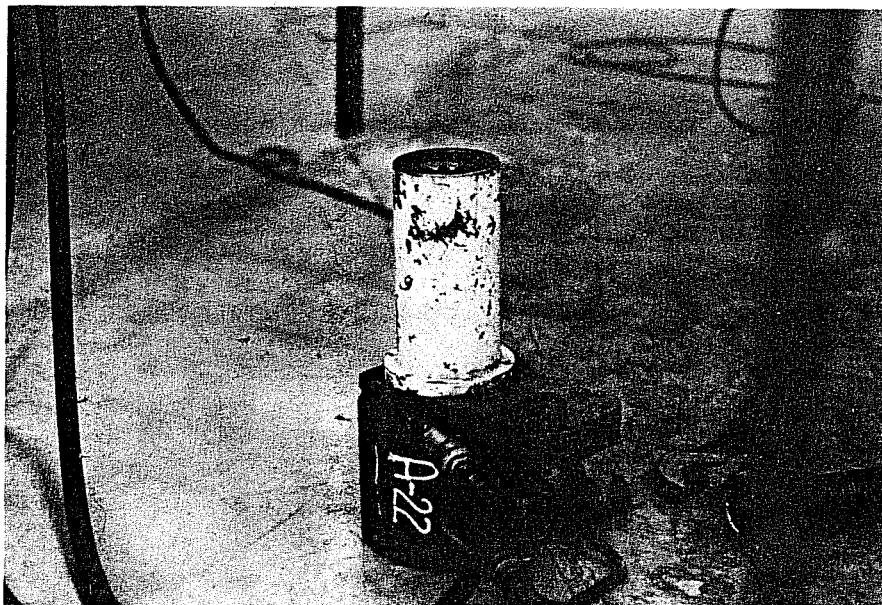
Fig. 4.18 Hydraulic ram

Tensioning the Dywidag threadbars was a very simple operation. The only equipment needed was a hydraulic pump, hydraulic centerhole ram (Fig. 4.18), mandrel, wrench, and calipers. The mandrel was screwed onto the threadbar to provide a length sufficient to pass through the hydraulic ram (Fig. 4.19). The ram was then placed over the mandrel, threadbar, and threadbar anchor nut so that it rested on the bearing plate. A large nut was then screwed onto the mandrel until it was seated against the ram's piston. The piston was extended using the hydraulic pump, elongating the threadbar. When the correct elongation was reached, the threadbar anchor nut was turned with a ratchet assembly, which was an integral part of the ram, until the nut seated against the bearing plate, preventing the threadbar from relaxing (Fig. 4.20). The piston was then retracted (Fig. 4.21) and the mandrel and ram removed from the threadbar and shifted to the next bar to be tensioned.

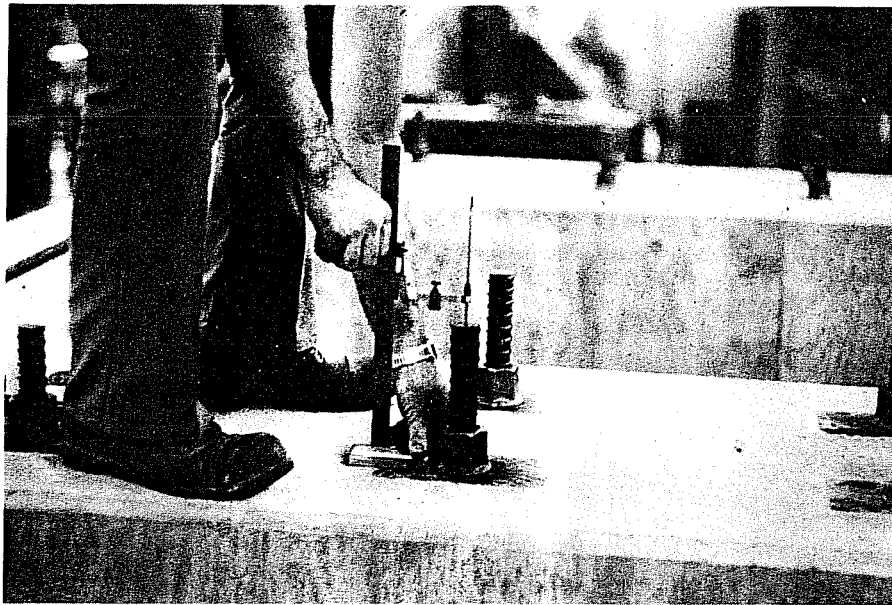
Fig. 4.22 Elongation measurement with calipers

The proper elongation for each threadbar was calculated before tensioning by the suppliers of the Dywidag system. The post-tensioning operation was monitored in three ways to provide safeguards against incorrect stressing. First, the force on the threadbar was determined by measuring the hydraulic pressure in the ram. Second, the number of turns of the anchor nut to seat it on the bearing plate was monitored. Third, elongation of the threadbar was measured using calipers (Fig. 4.22). After all stressing was completed, the ends of the bars were coated to prevent rust and corrosion.

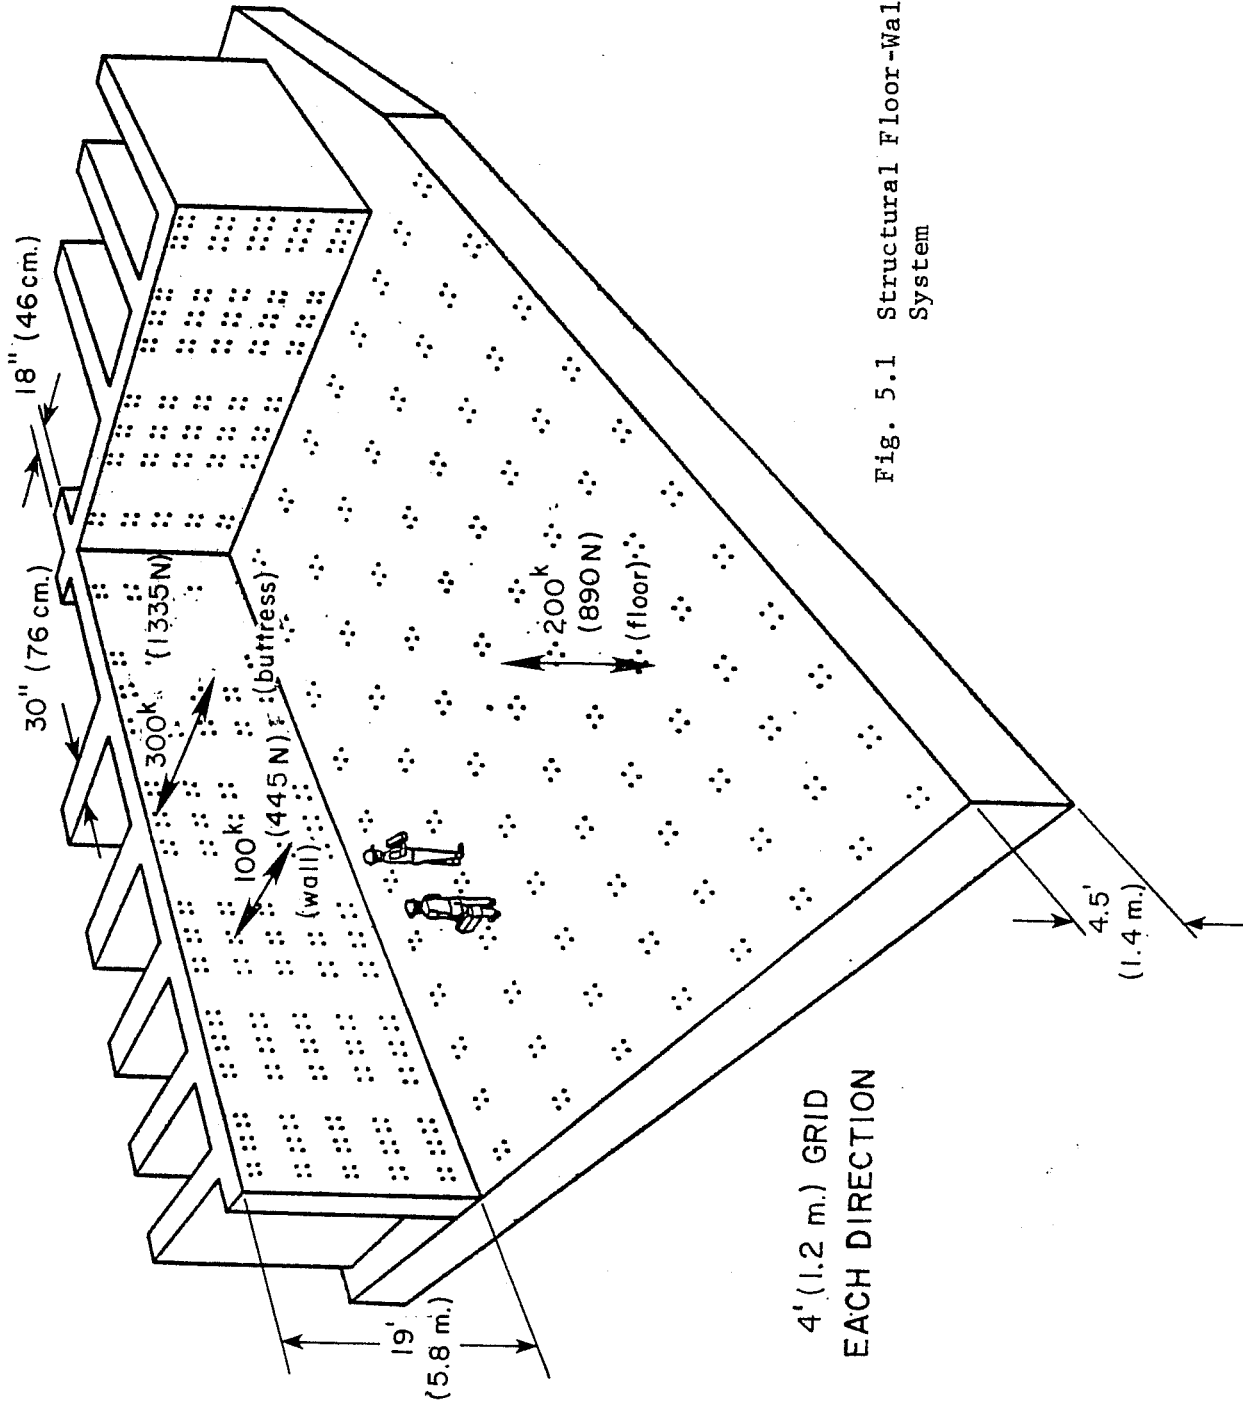
Fig. 5.1 Structural Floor-Wall Reaction System

A. At no time shall the applied load at any single wall load point exceed:

1. 100 kips when directed away from the working face of the wall
2. 100 kips when directed toward the working face of the wall
