**Measurement-Based Evaluation of Non-Composite
Steel Girder Bridges**

David Villegas Jáuregui, B.S., M.S.

Dissertation

The University of Texas at Austin

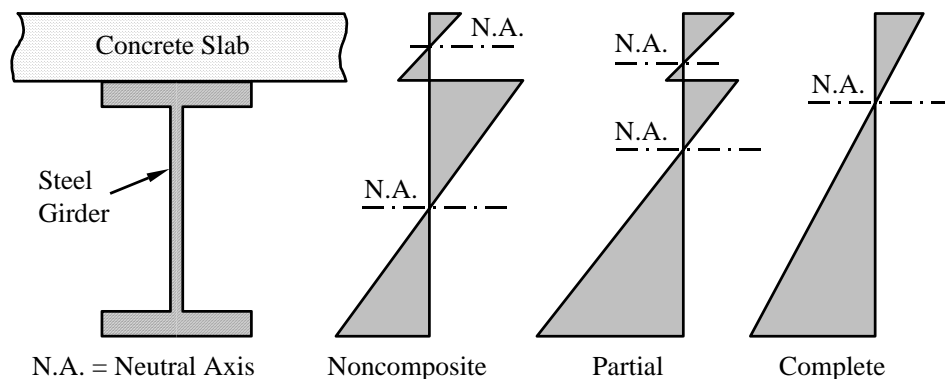
Figure 1.6 Strain Distribution for Various Levels of Composite Action.

A potential source of increased stiffness for non-composite beam-and-slab bridges is unintended composite action. Regardless of the absence of mechanical shear connectors at the girder-slab interface, several tests have shown evidence of interaction between the girders and slab (Suetoh et al. 1990). Two factors that contribute to this behavior are natural or chemical bonding between the steel and concrete and friction at the steel-concrete interface caused by the slab bearing down on the girder top flange under its own weight and under live load (Suetoh et al. 1990). Both of these elements restrain the slab from sliding freely relative to the girder thus causing either partial or full composite action. As shown in Figure 1.6, a strain discontinuity at the girder-slab interface distinguishes partial composite from complete interaction. Under full composite action, the neutral axis may lie in either the girder or the slab.

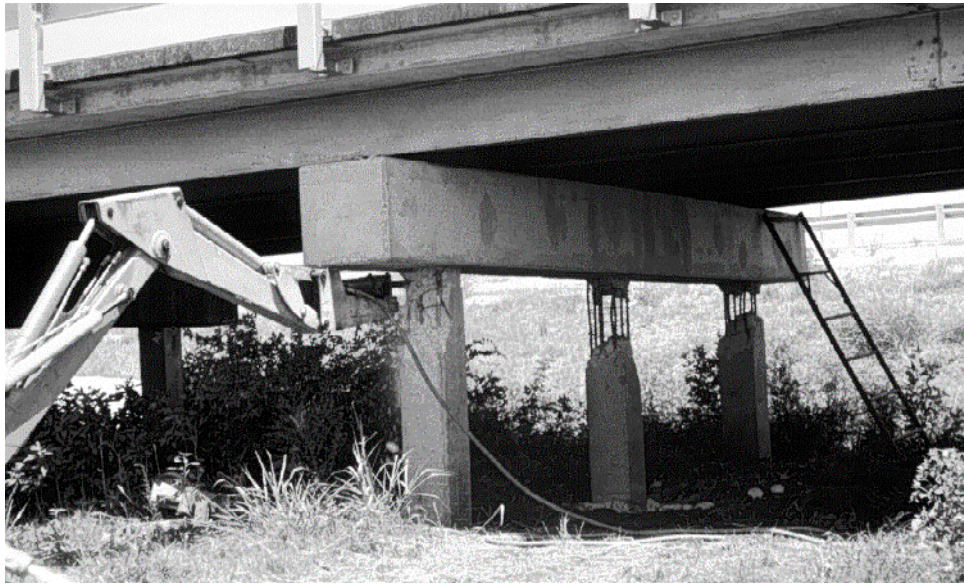
Figure 5.1 Removal of Bent Cap in Progress at Unit-N.

The same procedure was followed in removing both bent caps. First, the 25.4 mm (1 in) diameter bolts attaching the fixed bearing plates to the top of the cap were torch cut at the five girder locations. By severing the bolts, the girders were no longer affixed to the bent cap. Next, the concrete at the top of the three 410 mm (16 in) square piles was chipped away below the base of the bent cap to expose the rebar as shown in Figure 5.1. The exposed reinforcement was then torch cut and the bent cap removed. At Unit-S, deflection measurements were made using a theodolite to determine the amount of girder deflection caused by the bent cap removal. At a distance of 9.1 m (30 ft) from the abutment (i.e., mid-span of the longest span), the girder displacement averaged 49.3 mm (1.94 in).

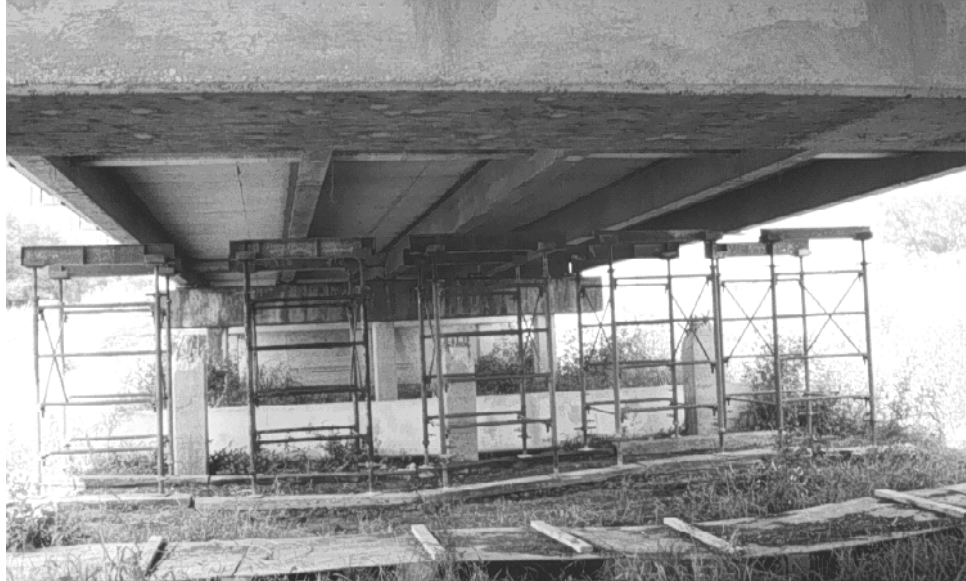
Figure 5.2 Temporary Shoring in Place under Unit-N.

Following removal of the bent caps, shoring was placed near the mid-span of the 18.3 m (60 ft) span as a safety precaution during testing and also for mounting instrumentation. Figure 5.2 shows the shoring in place under Unit-N. An 200 mm (8 in) clearance was left between the top of the I-beams and the bottom of the bridge girders.

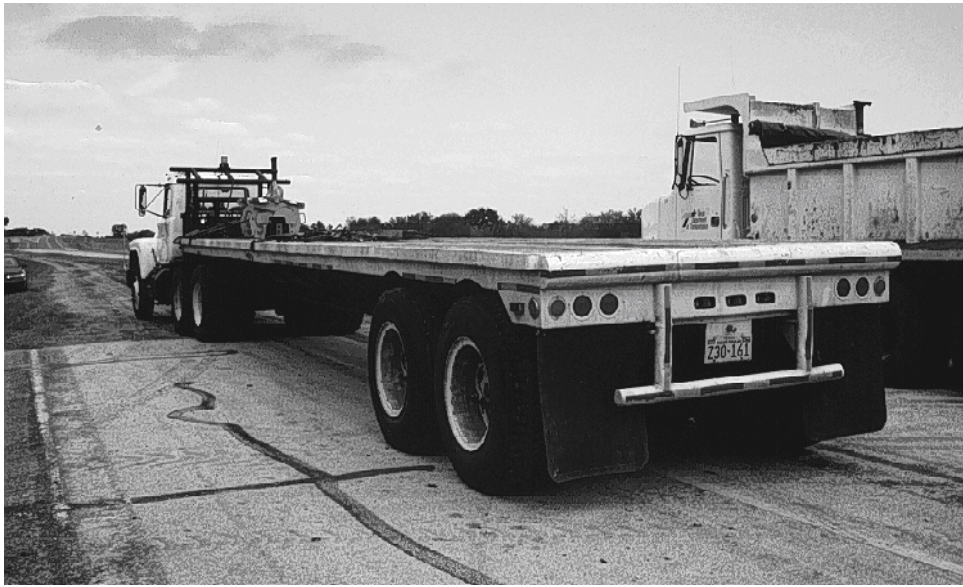
Figure 5.3 Tractor-Trailer provided by Contractor.

The loading system used to apply incremental levels of load to the bridge consisted of a tractor-trailer, a loading crane, and a number of concrete barriers. The trailer was equipped with a 222 kN (50 kip) capacity tandem axle at its back end and was attached to the tractor at its front end. The flatbed of the trailer measured 12.2 m x 2.4 m (40 ft x 8 ft) and extended past the centerline of the back axle a distance of 910 mm (3 ft). A distance of 8.5 m (28 ft) separated the tandem axle of the tractor from the tandem axle of the trailer. The axle group spacing was 1.2 m (4 ft) and the wheel pairs were spaced at a transverse distance of 1.8 m (6 ft). A side view of the tractor-trailer and a schematic of the wheel and axle spacing are provided in Figure 5.3.

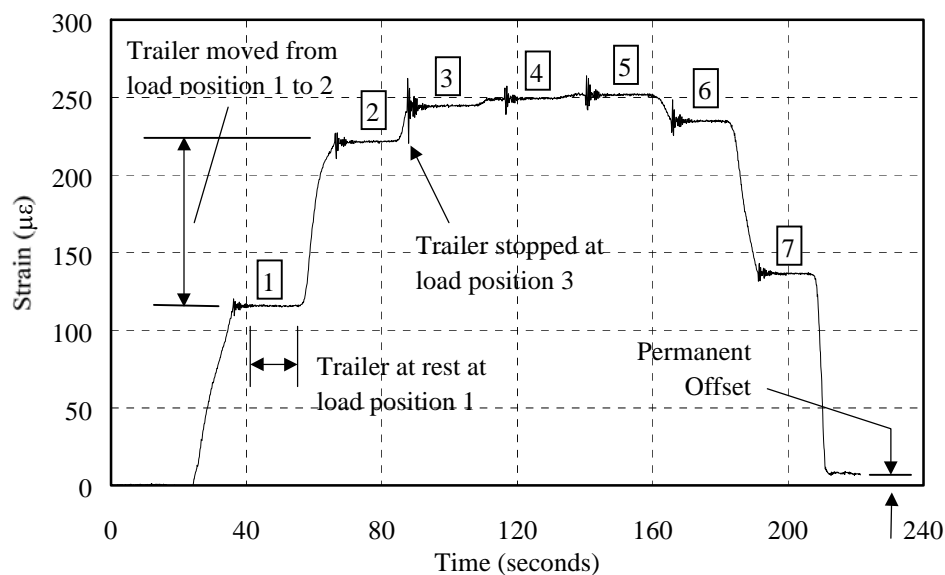
Figure 6.1 Typical Strain History during Trailer Load Sequence.

These sudden vibrations were short in duration and thus, were not considered in the evaluation of the data. Stopping the trailer provided a sample of readings at each load position, which were continuously checked for electrical noise and drift. The measurements were also examined for possible signs of girder yielding.

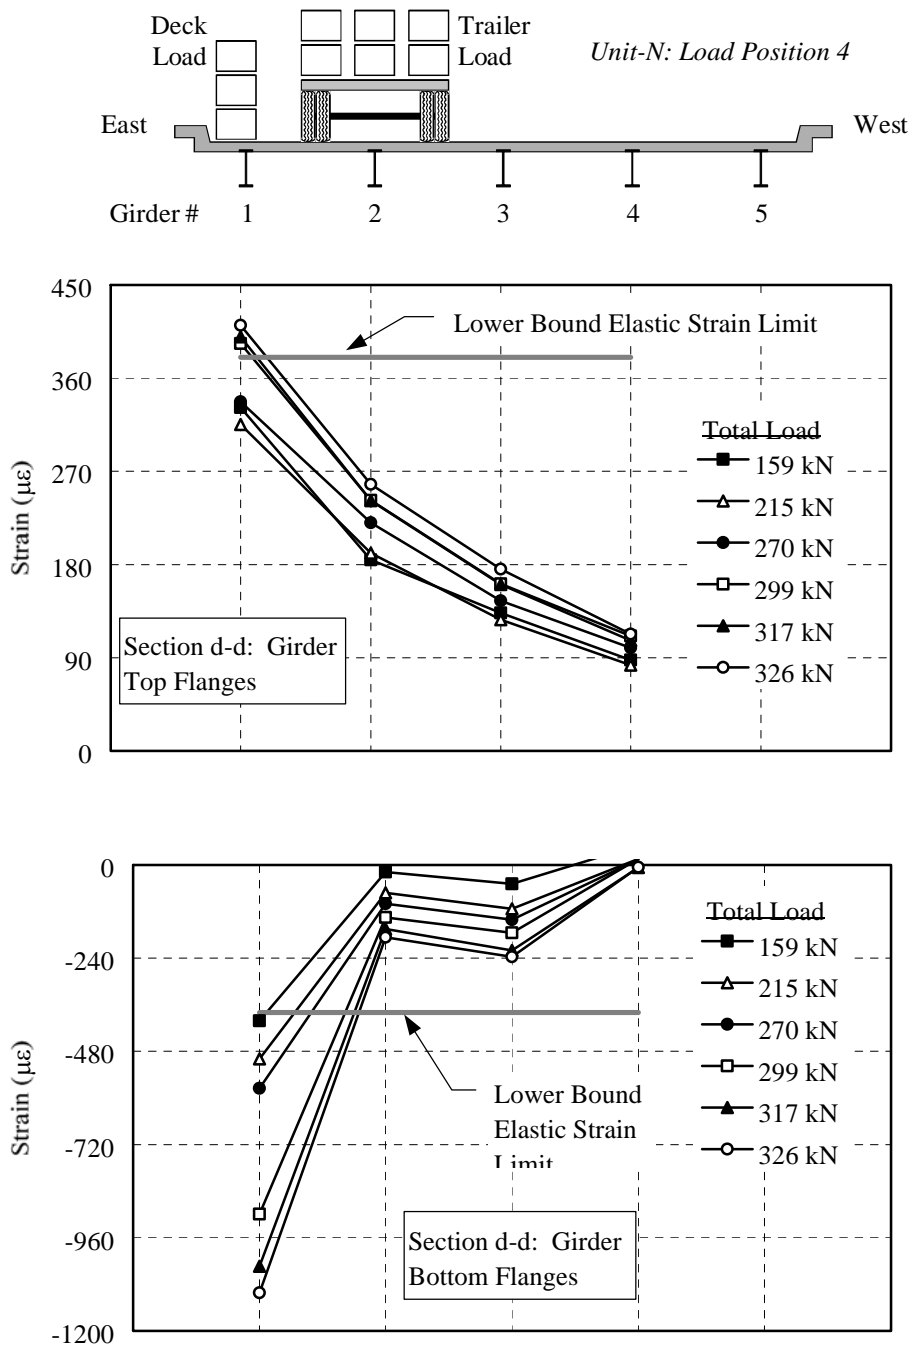
Figure 6.12 Girder Strain Profile at Section d-d of Unit-N during Stage 2 Loading.

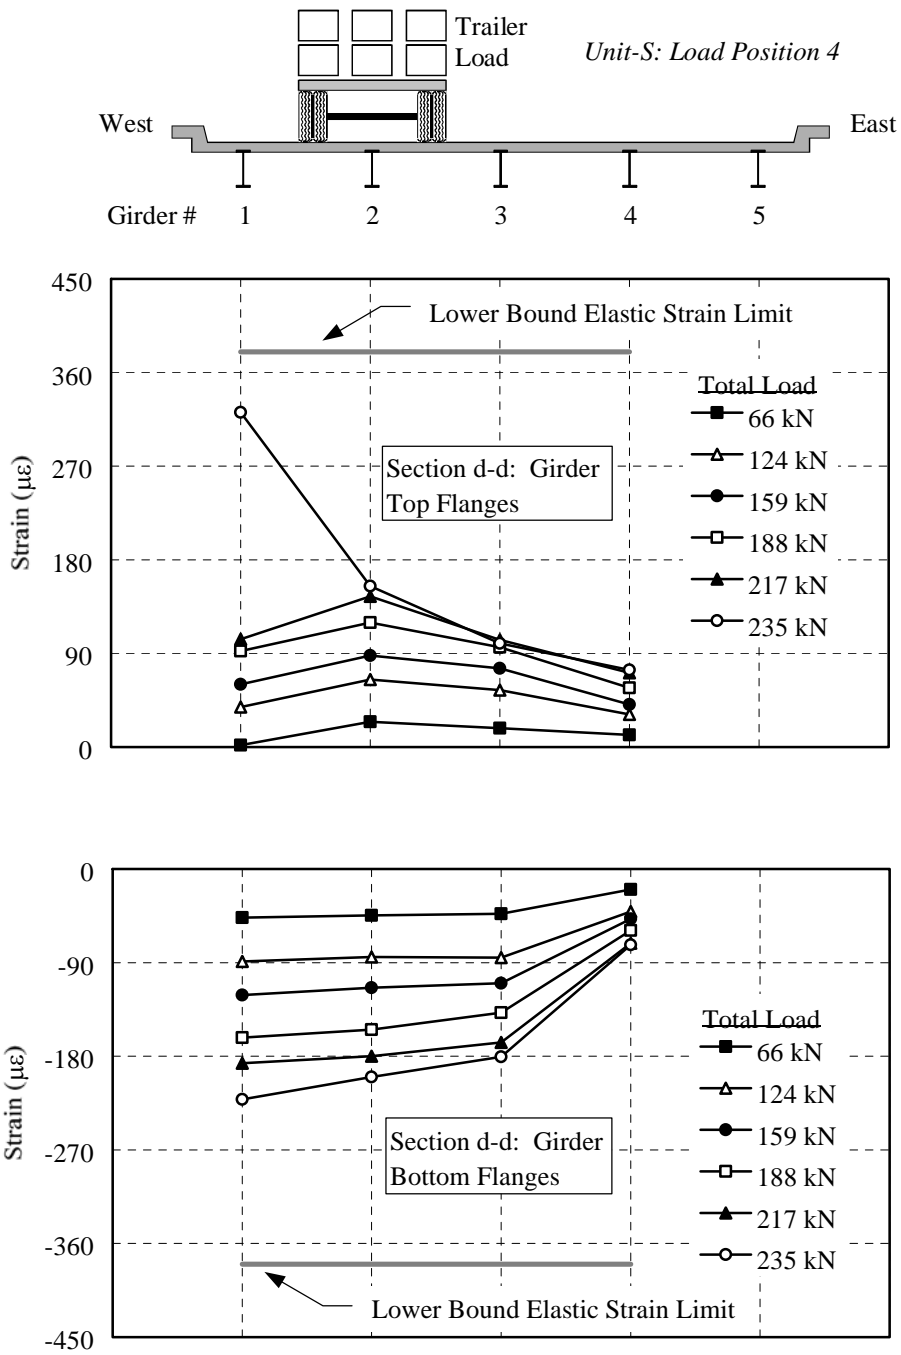
Figure 6.16 Girder Strain Profile at Section d-d of Unit-S during Stage 1 Loading.

Strain contours for girders 1 through 4 at Section d-d are plotted in Figure 6.16 and 6.17 for Stage 1 and Stage 2, respectively. Comparison of Figures 6.11 and 6.16 shows that yielding of girder 1 at Unit-N occurred at about the same load that girder 1 experienced a loss of partial composite action at Unit-S. The loss of partial composite action of girder 1 appeared to have little effect on the response of the remaining girders. For loads below the final load applied in Stage 1, the girders exhibited a rather uniform distribution. Bottom and top flange strains were nearly identical on girders 2 through 4, which indicated that the bending resistance of these three girders resembled a non-composite section. During Stage 2 loading, the loss of partial composite action resulted in top and bottom flange strains in girder 1 well above the lower elastic limit. As shown by the strains plotted in Figure 6.17 for Stage 2, the strain profiles were consistent between load levels although the flange strains for girder 1 were clearly inelastic. The equal strains on the top and bottom flange also show that girder 1 is non-composite.

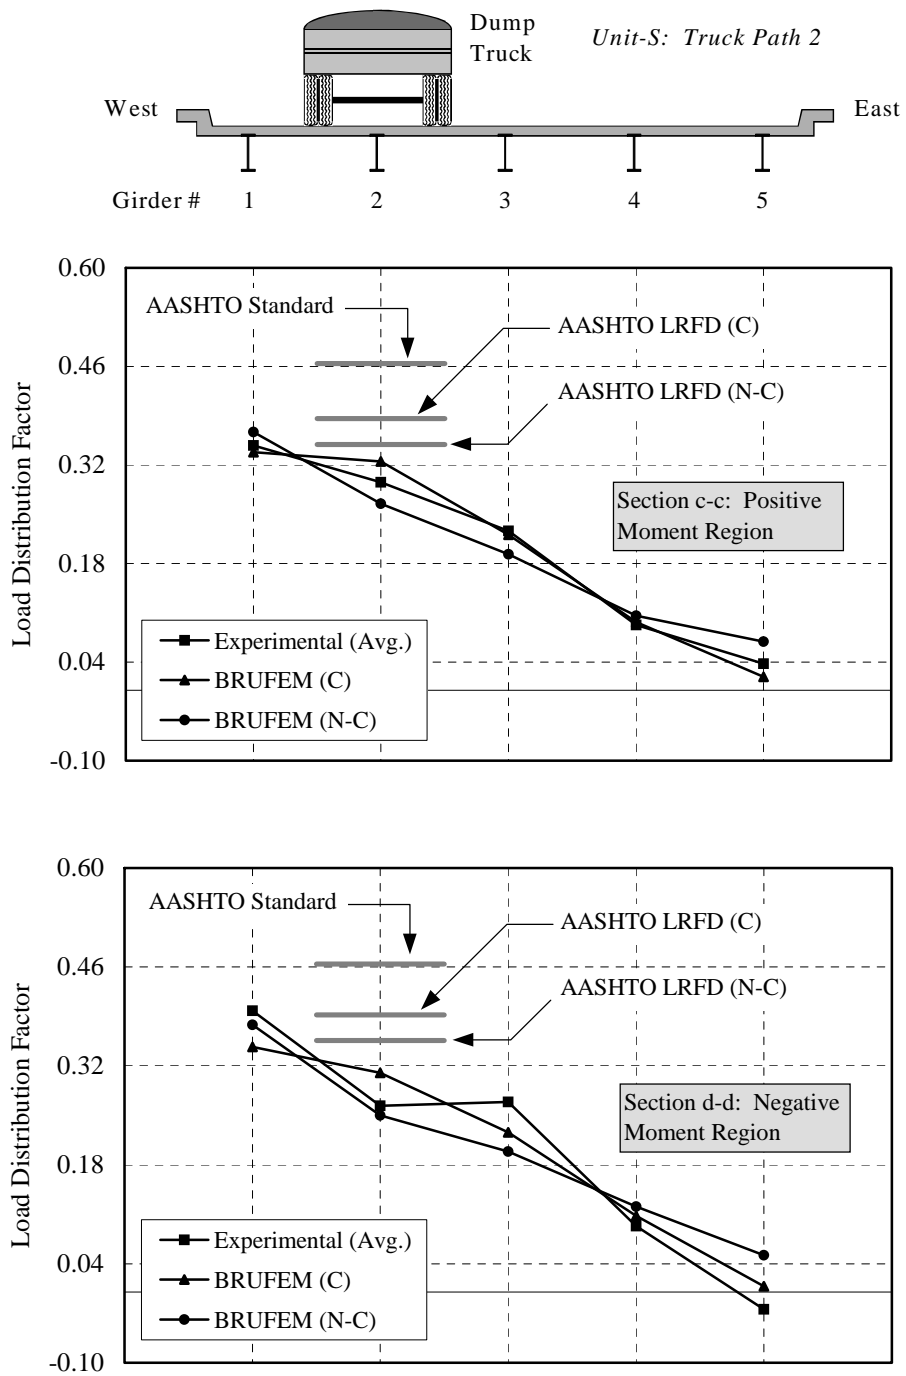
Figure 8.8 Load Distribution at Section c-c and d-d of Unit-S for Truck Path 2.
